INDEPENDENT OPERATIONAL REVIEW

**New Zealand International Convention
Centre fire**

Prepared for Fire and Emergency New Zealand

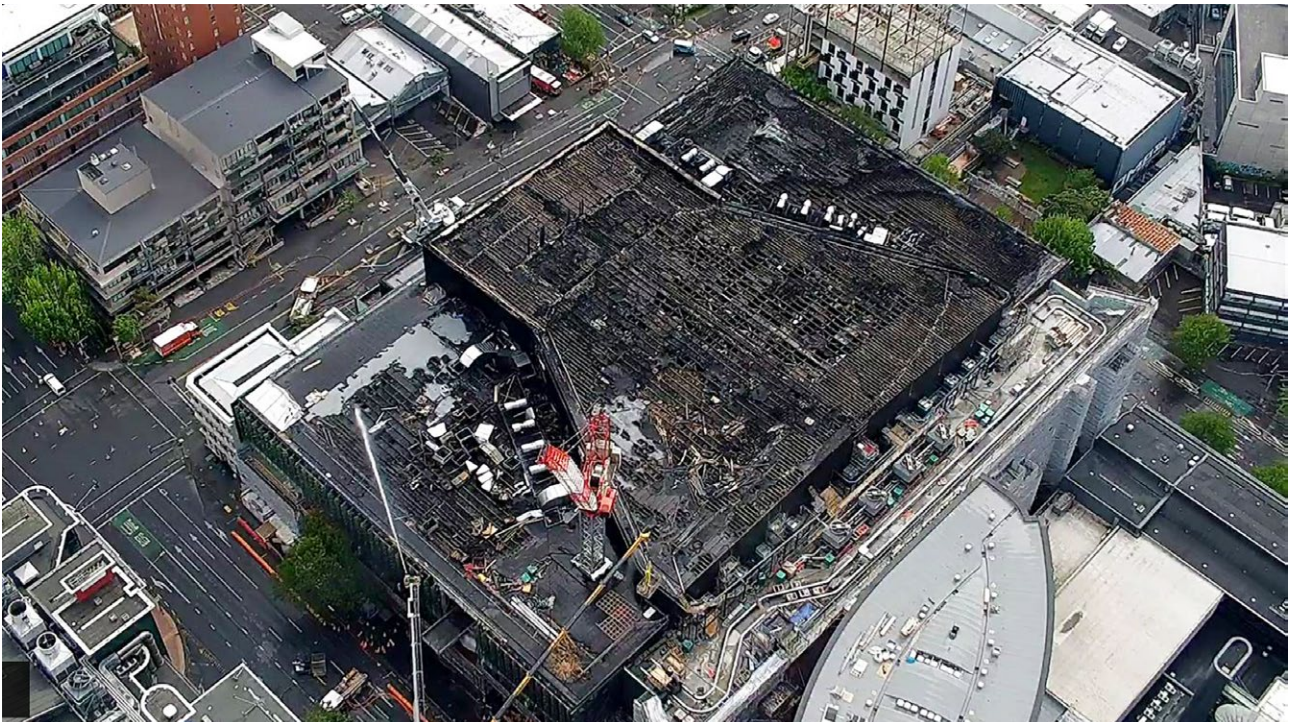
Drone photo of roof with fire nearly fully extinguished. Credit: Fire and Emergency New Zealand.

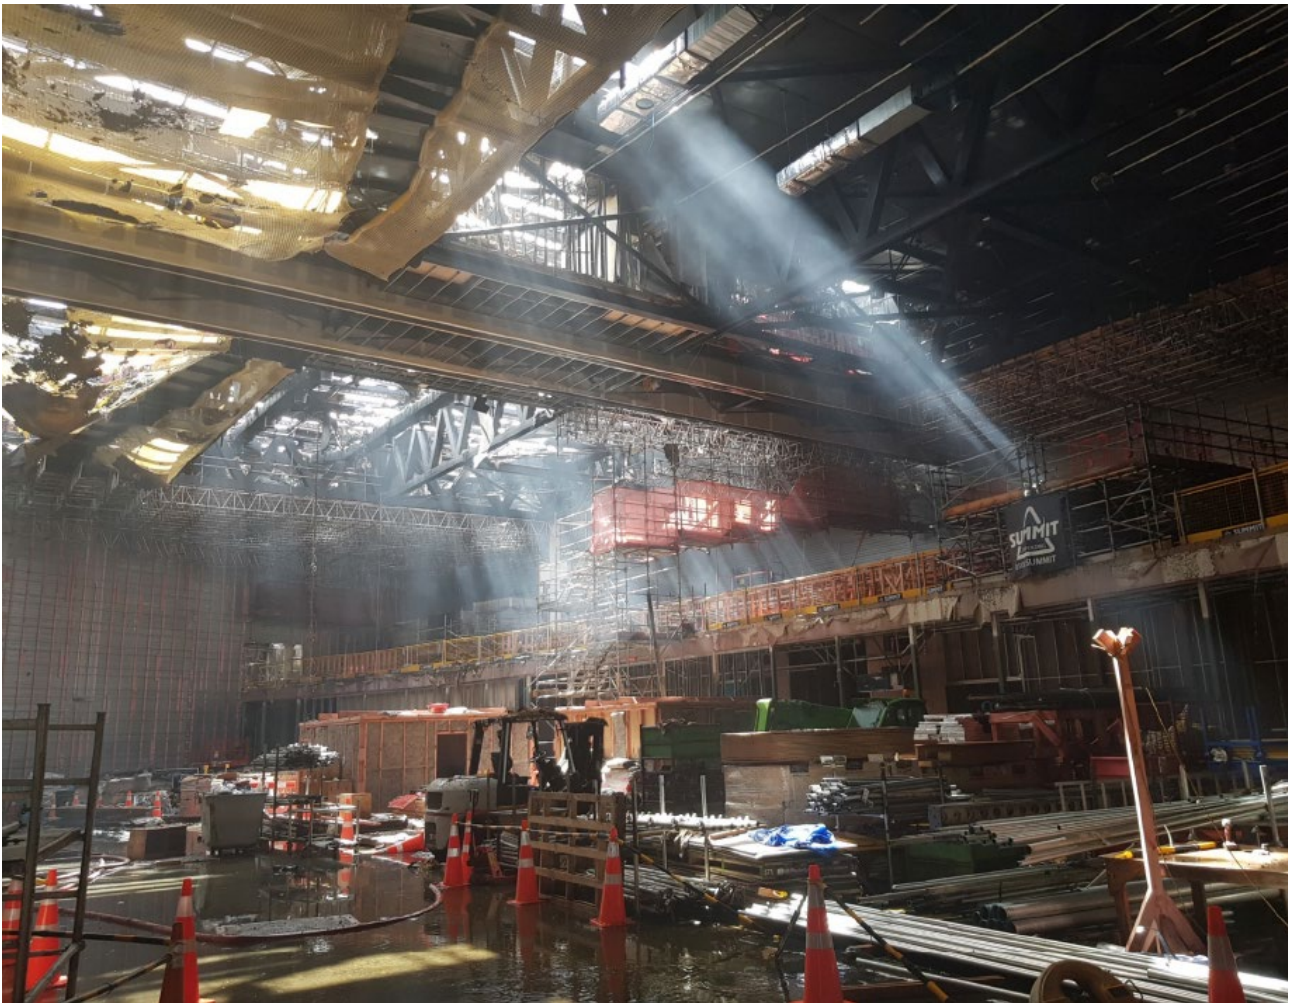
Auditorium with fire damage to roof. Credit: Fire and Emergency New Zealand.

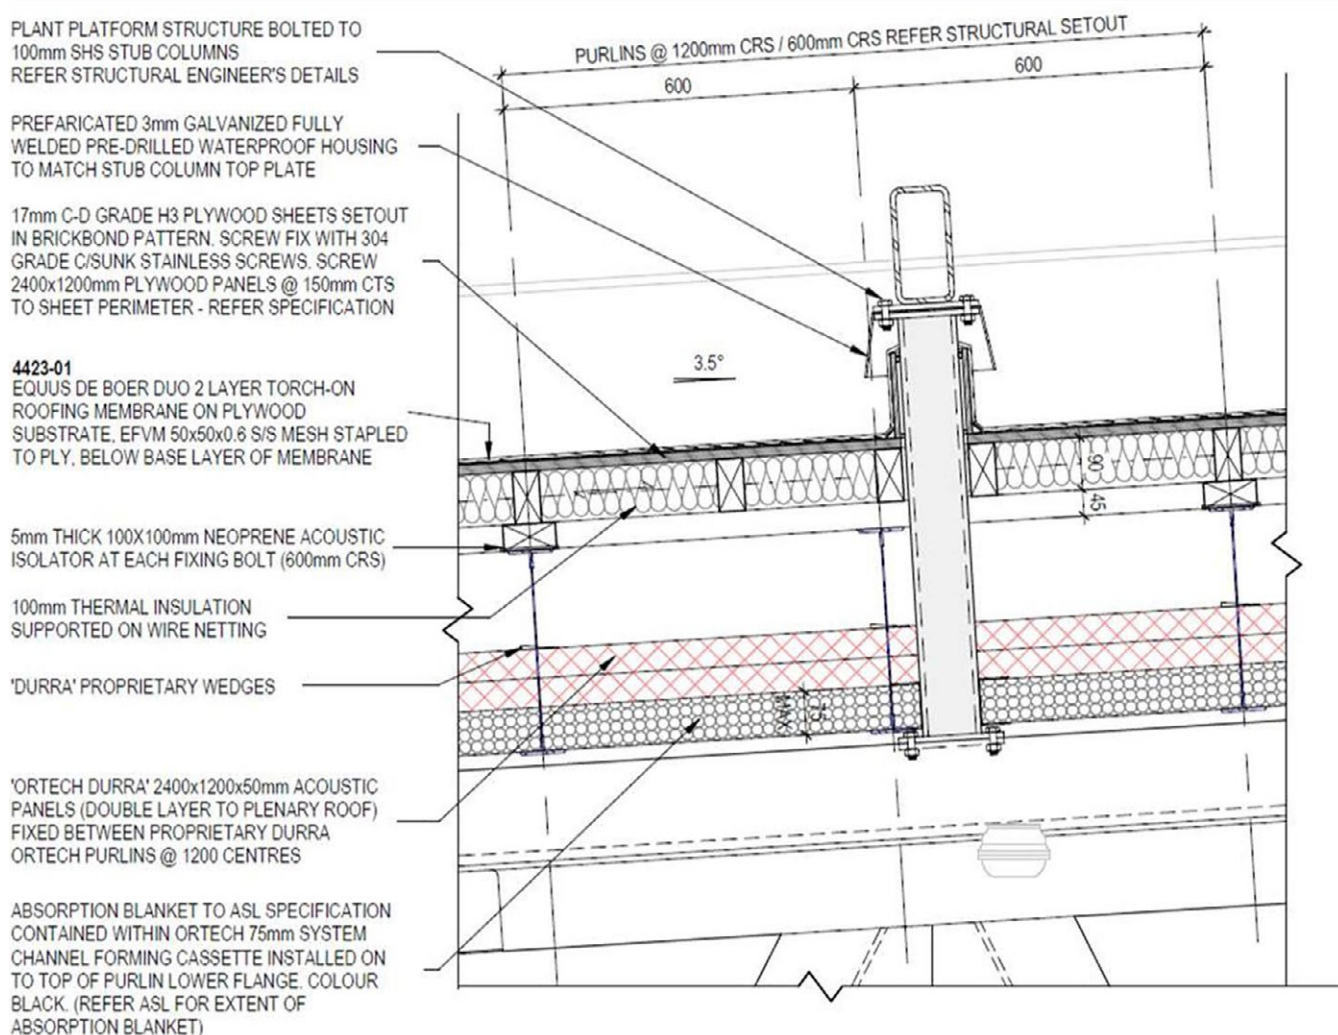
Figure 2: Side elevation of building materials and construction method of roof. Credit: Fletcher Construction.

- 3.38** The fuels burning in the fire were all products used in the construction of the roof. The skeleton of the roof had thousands of metres of high-grade timber to support the top layer of the roof. The roof was termed a 'non-walk on roof' that was engineered to carry a load not exceeding 75 kilograms per square metre.

- 3.39** The weather seal was a two-layer rubber membrane on plywood substrate. The plywood had a 50mm by 50mm stainless steel mesh stapled to it that the membrane lay on. Under this lay 100mm of thermal insulation supported on wire netting. This lay on hundreds of large joists packed with a compressed straw-like product to add further insulation properties. Below this again were acoustic panels on top of an absorption blanket.
