FIRE INVESTIGATION REPORT

This vegetation fire, which occurred opposite [REDACTED] Pigeon Valley Road, Nelson, New Zealand, was ignited on 5 February 2019. It destroyed or damaged around 2000 hectares of pine forest, destroyed one home, multiple outbuildings, fences, shelter belts and pastures, and caused the evacuation of around 2500 people. This report covers the investigation process into the fire's origin and cause.

Pigeon Valley Fire, F2704034

Opposite [REDACTED] Pigeon Valley Road, Nelson, NZ

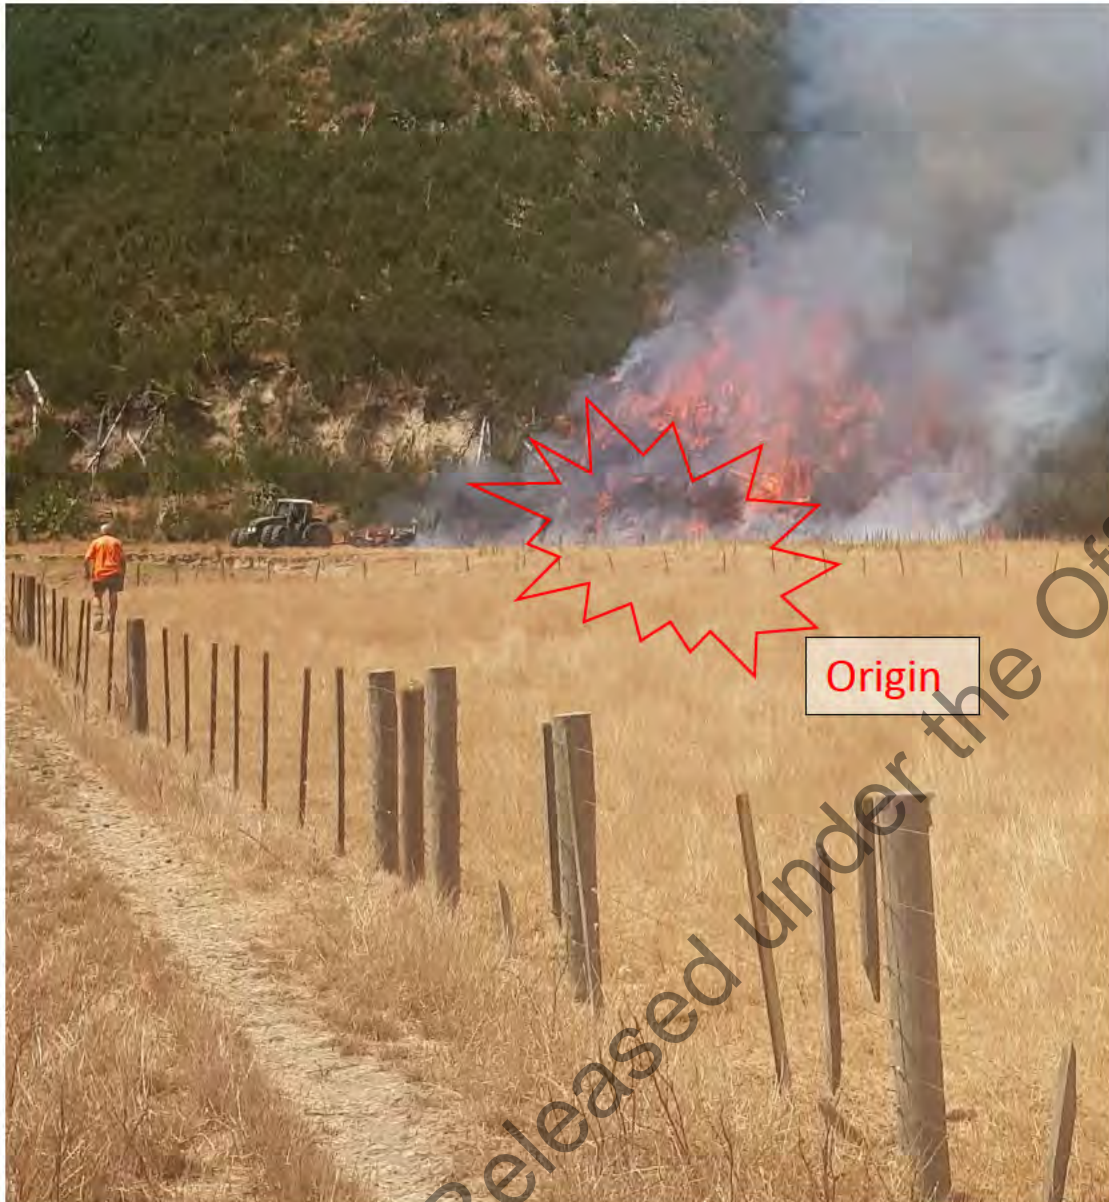
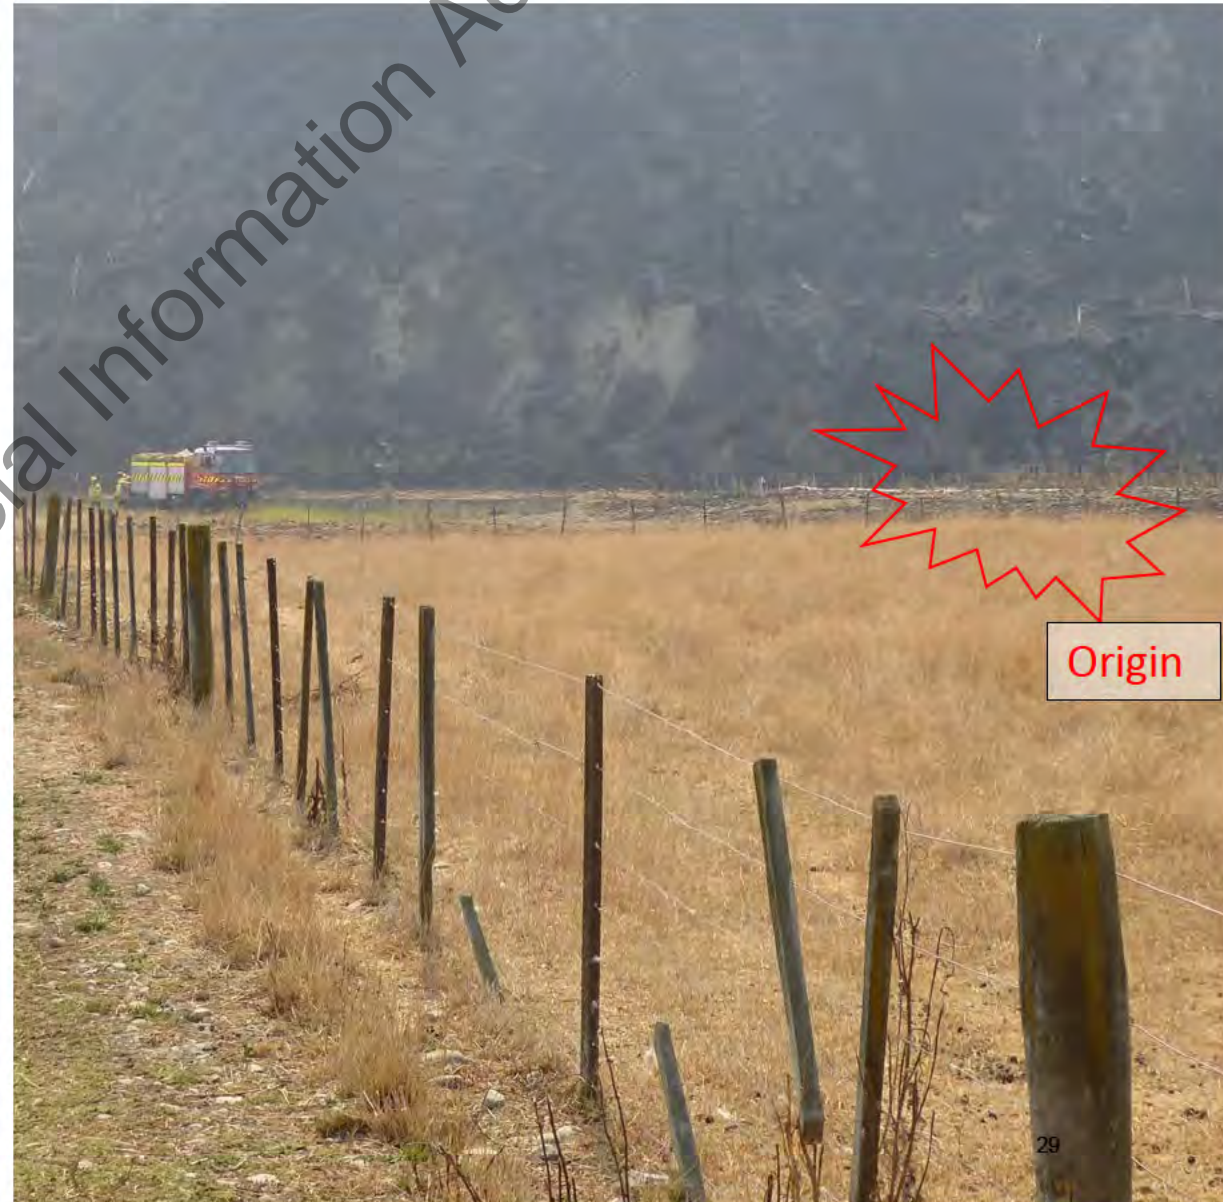
2, Blow up of photo taken by [REDACTED] against my re-created photo 799 (was taken from slightly different angle, however I have counted posts to align) (note grass curing at 90% to 100%)

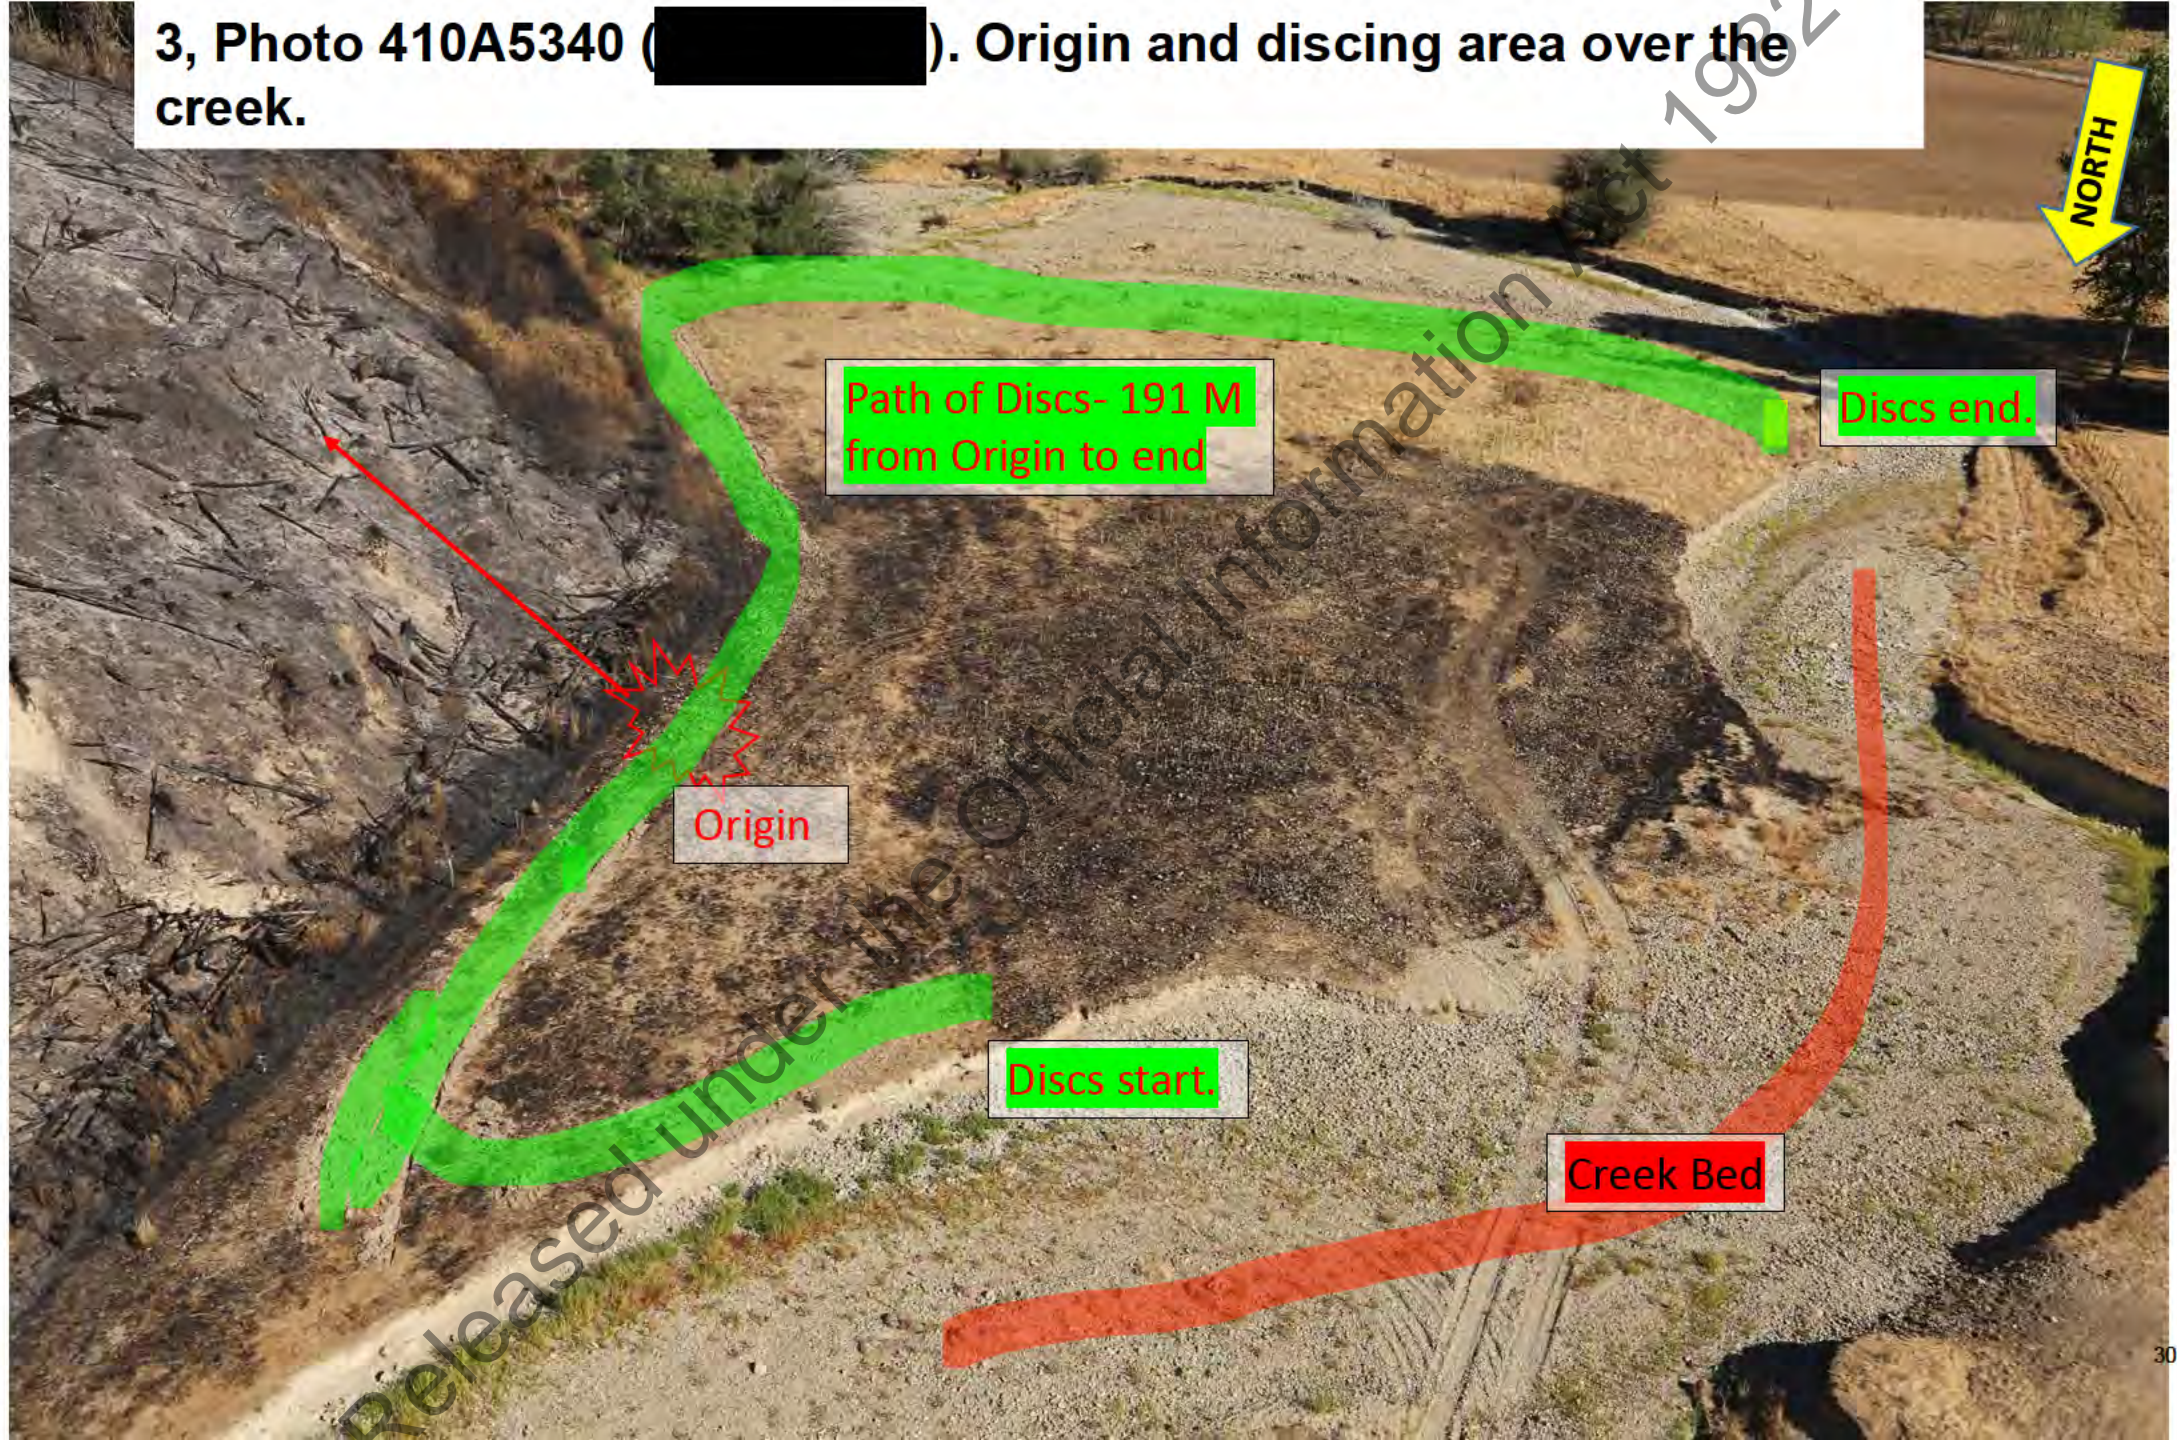
3, Photo 410A5340 ([REDACTED]). Origin and discing area over the creek.

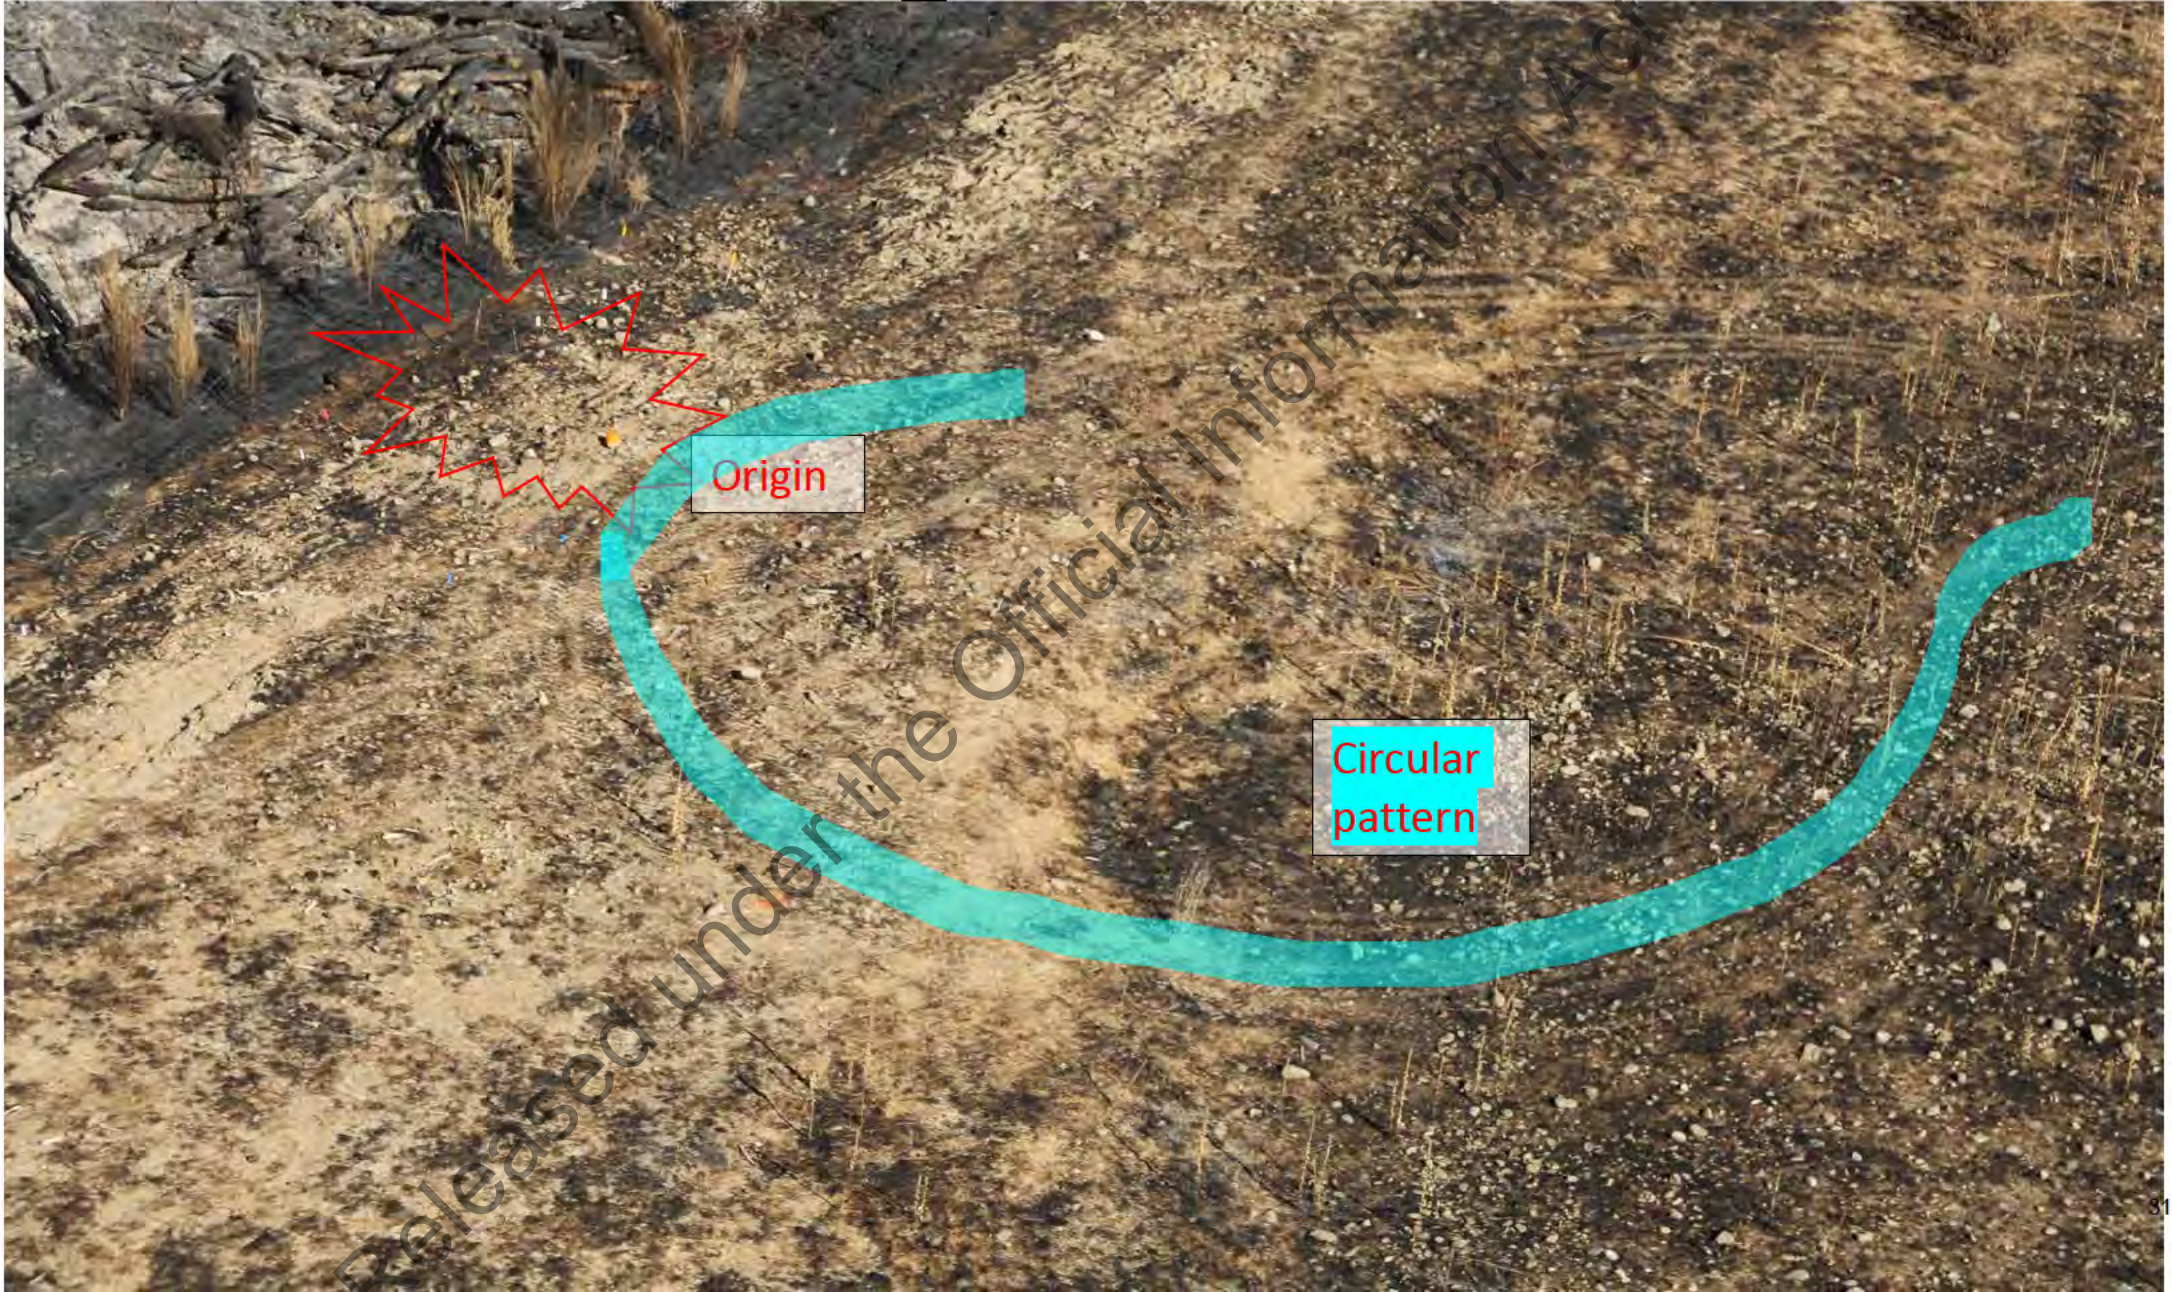
4, Photo 410A5343 ([REDACTED]). Origin and circular pattern believed to be created by discs when arriving at origin. (Witness [REDACTED] talked about trying to put out fire with discs)

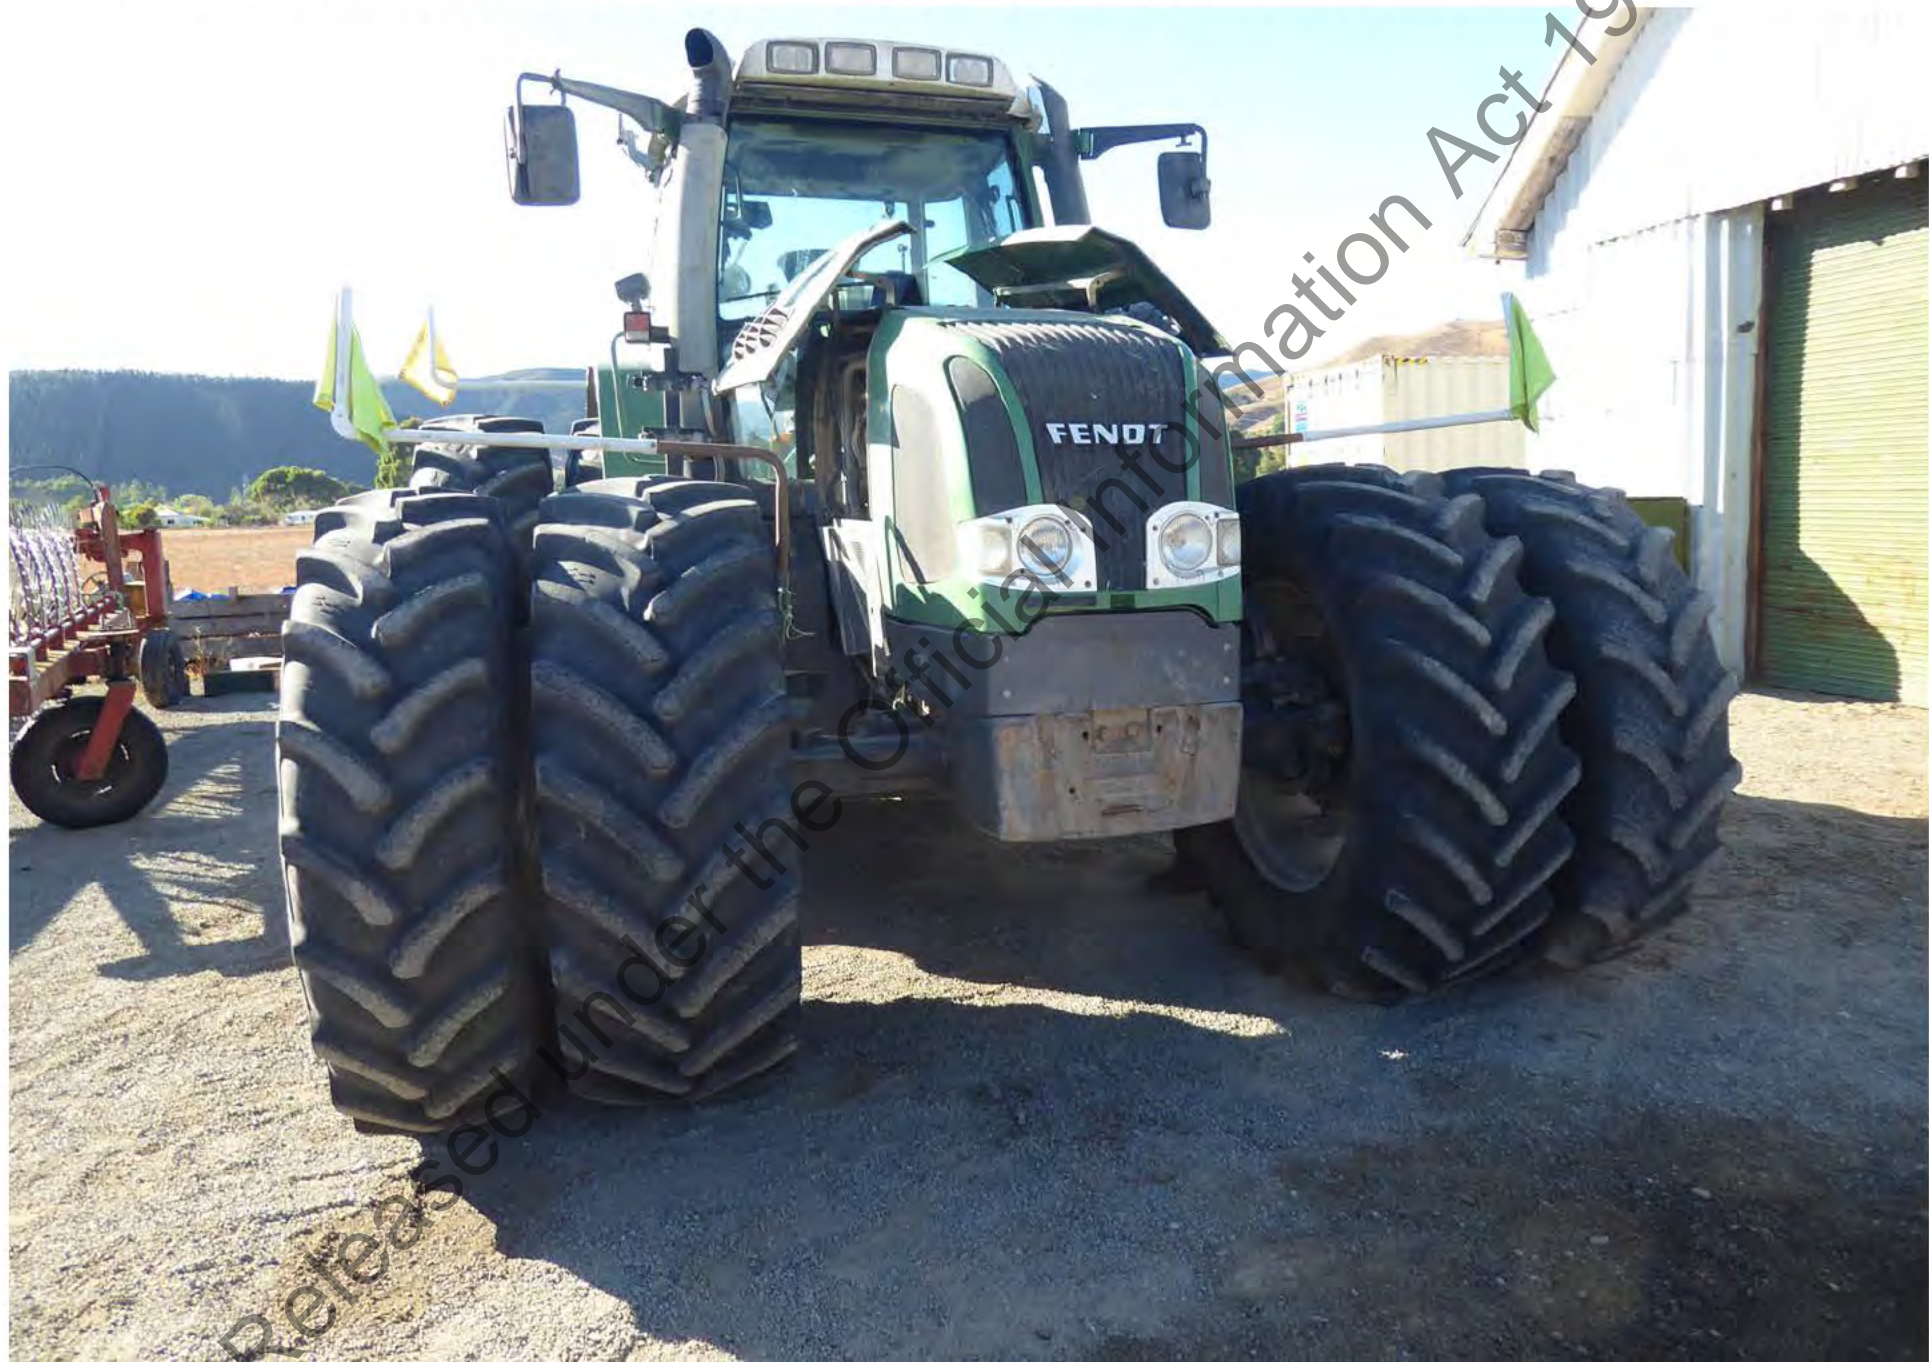
5, Photo 792. Fendt tractor that was pulling discs at the time of ignition.

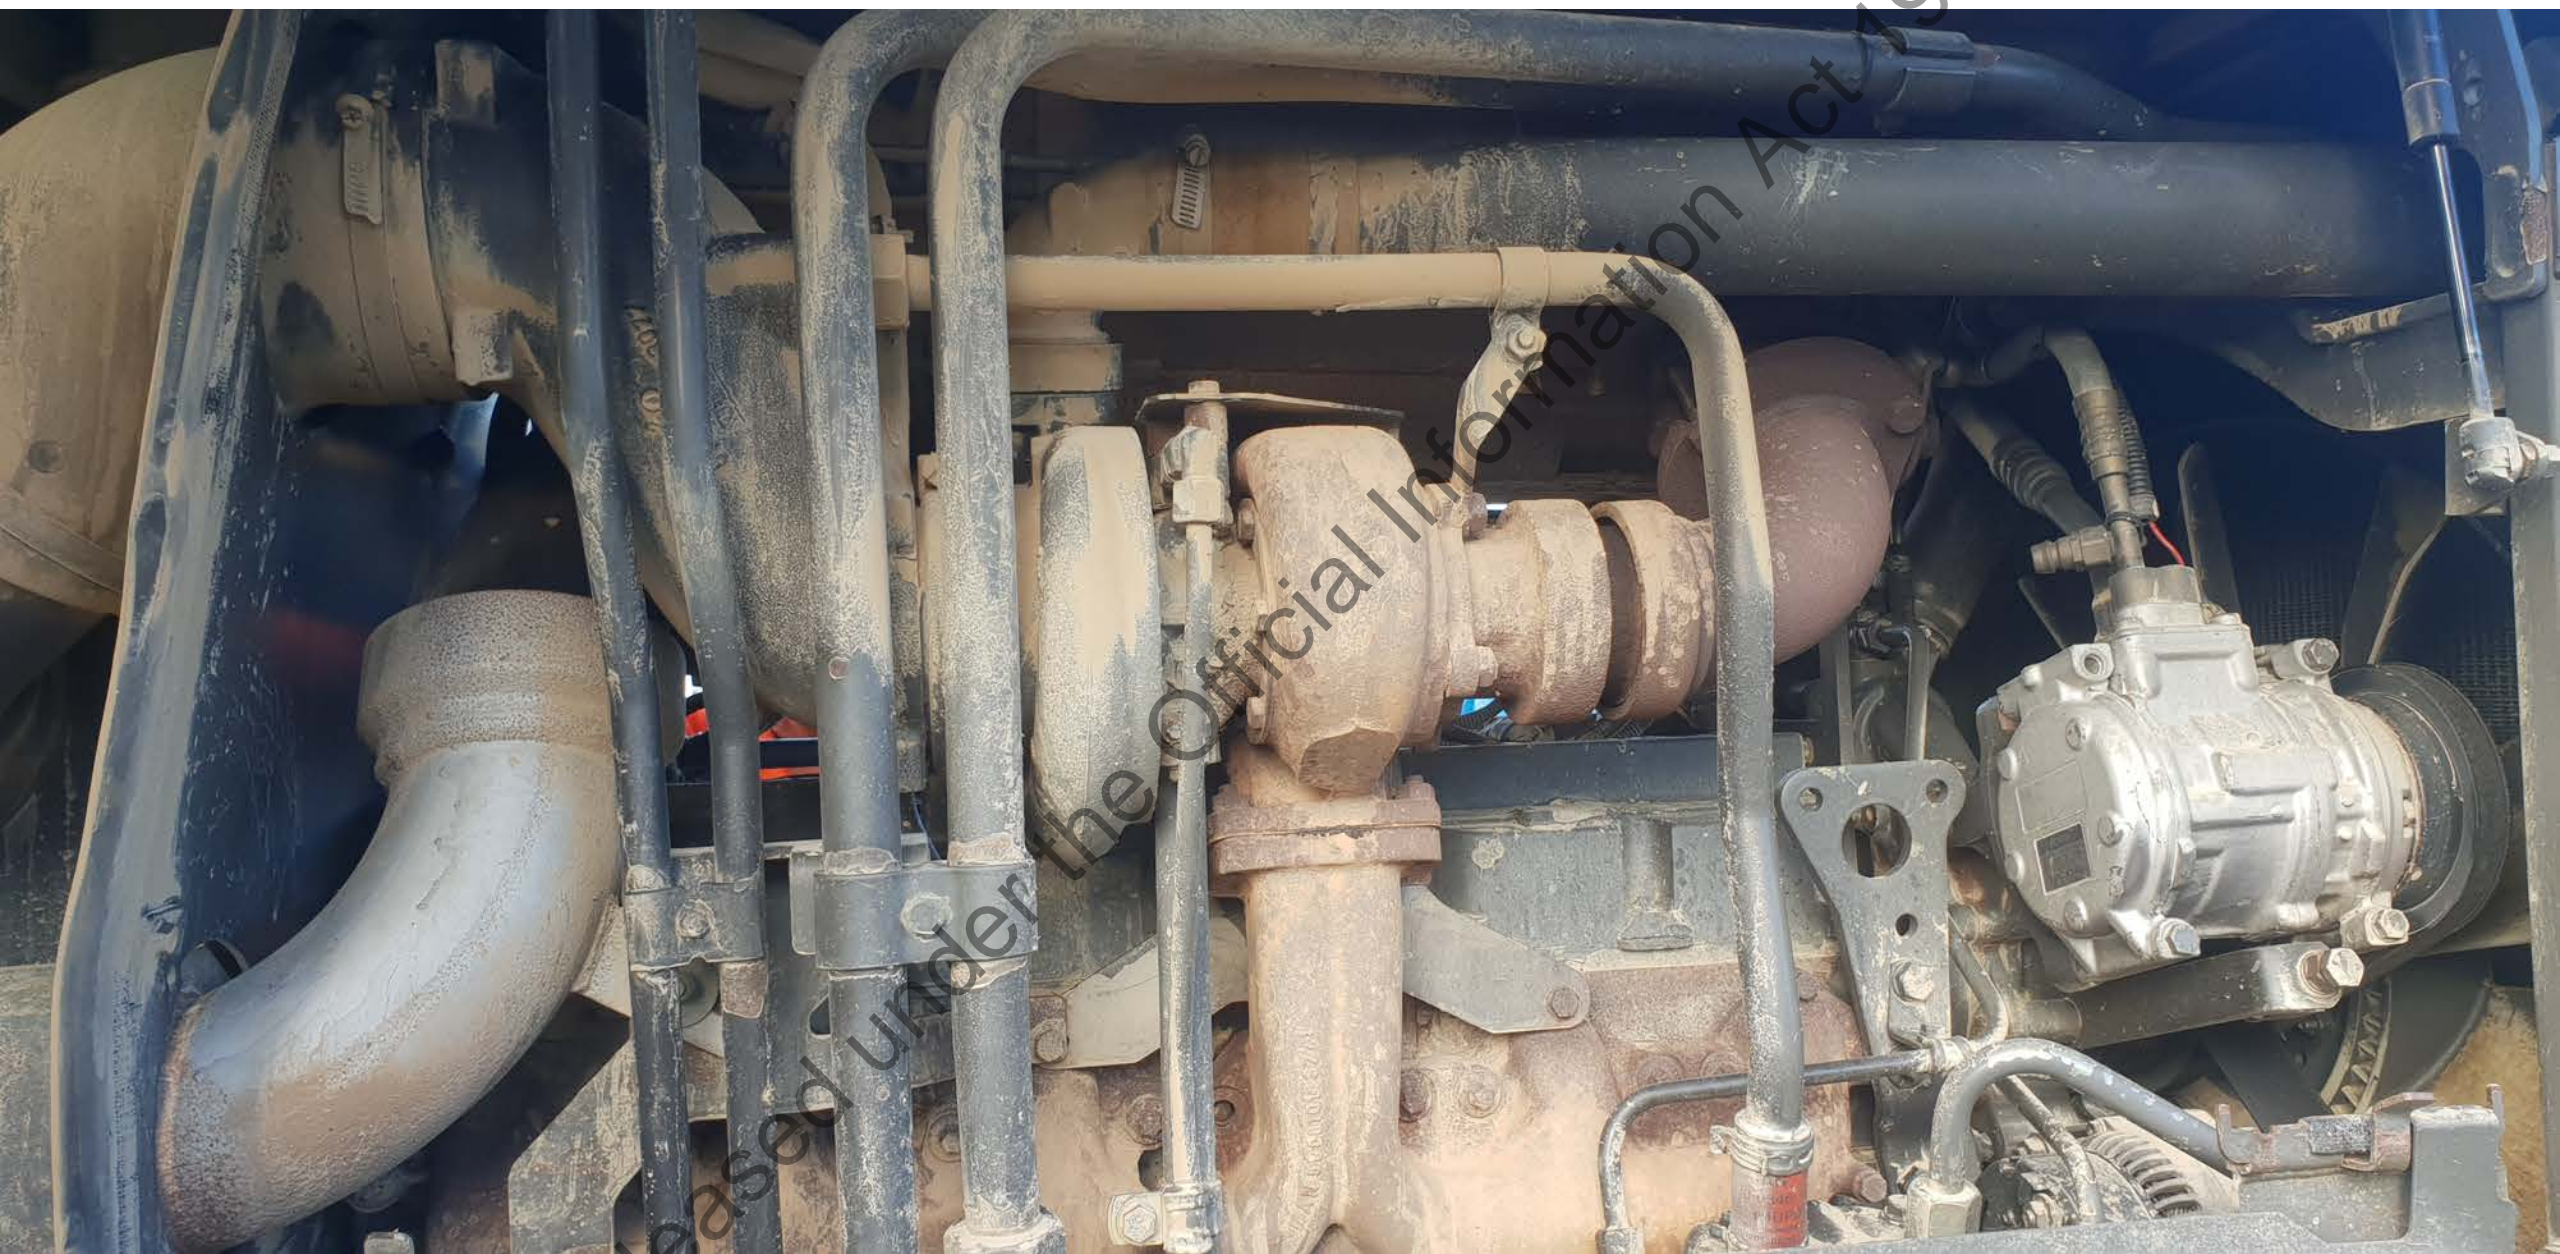
6.4.1.3.1 NFPA 27.15.6.2 identifies hot surfaces such as exhausts as competent ignition sources. As mentioned under Hypothesis 2 above, the mechanic checked under the bonnet with both Witness 3 and me present and we found no reason to suspect that grass had been allowed to build up under the bonnet or around the exhaust. We specifically discussed the possibility of birds' nests occurring and determined that it was too late in the season for nesting birds. The maintenance records provided by Witness ■ show that the engine bay had been accessed by an auto electrician on 29 January, an engineer on 30 January, and again on 4 February by the driver to top up hydraulic oil after a fitting repair. These instances don't include the daily checks by the driver. Any build-up of grass or birds' nests should have been found. NFPA 27.15.4.3 highlights the relevance of collecting maintenance records to determine if maintenance may have any relevance to the origin or cause of an equipment fire.

6, Photos 20190214-092250. Under bonnet of tractor showing exhaust manifold and turbo.

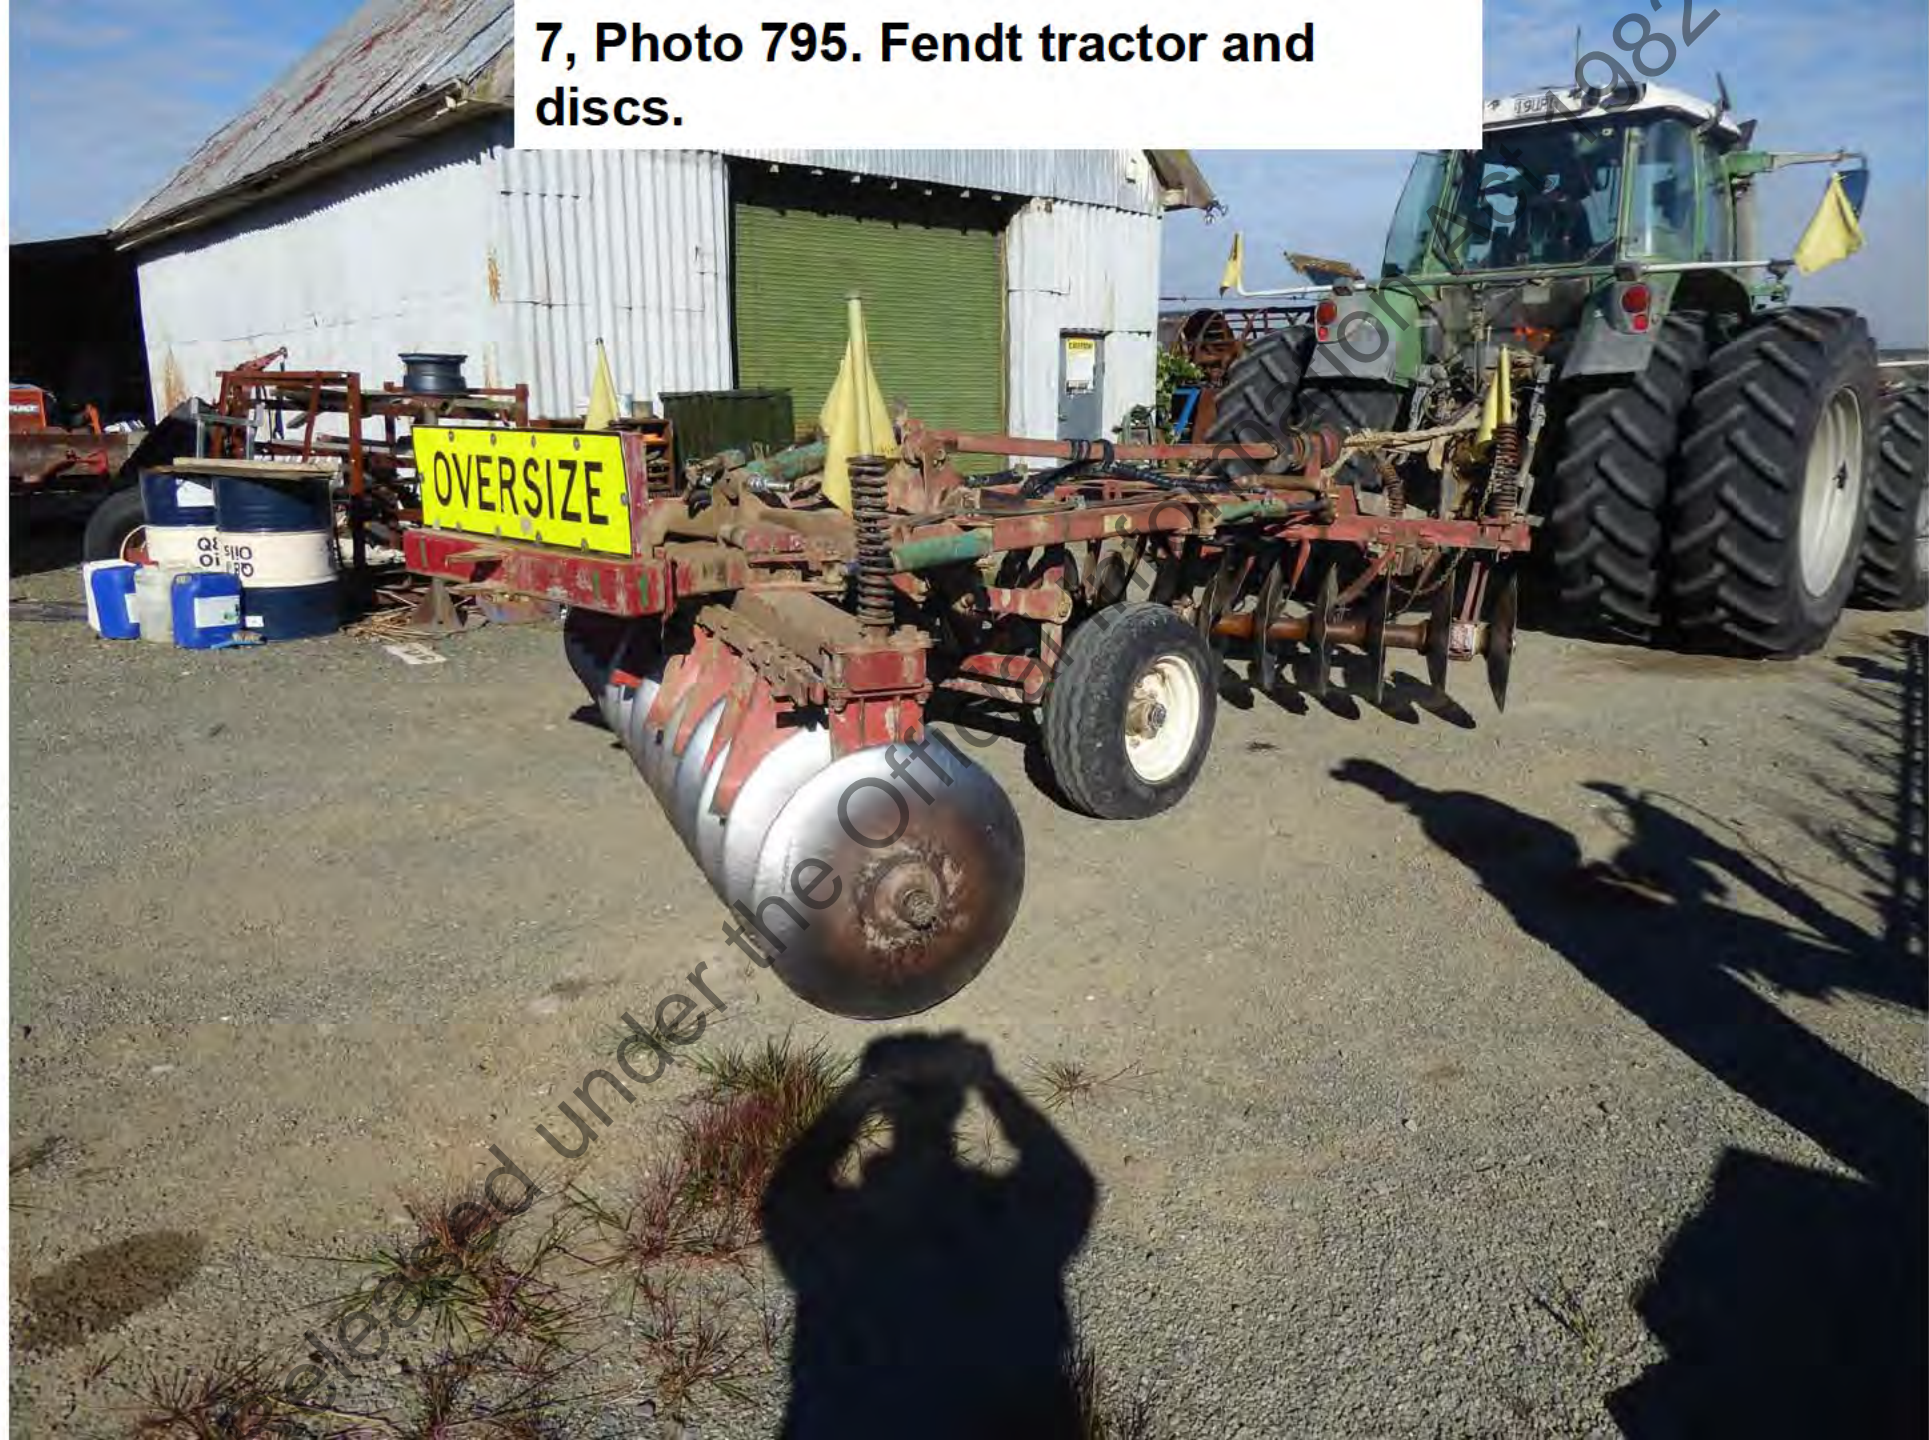
7, Photo 795. Fendt tractor and discs.

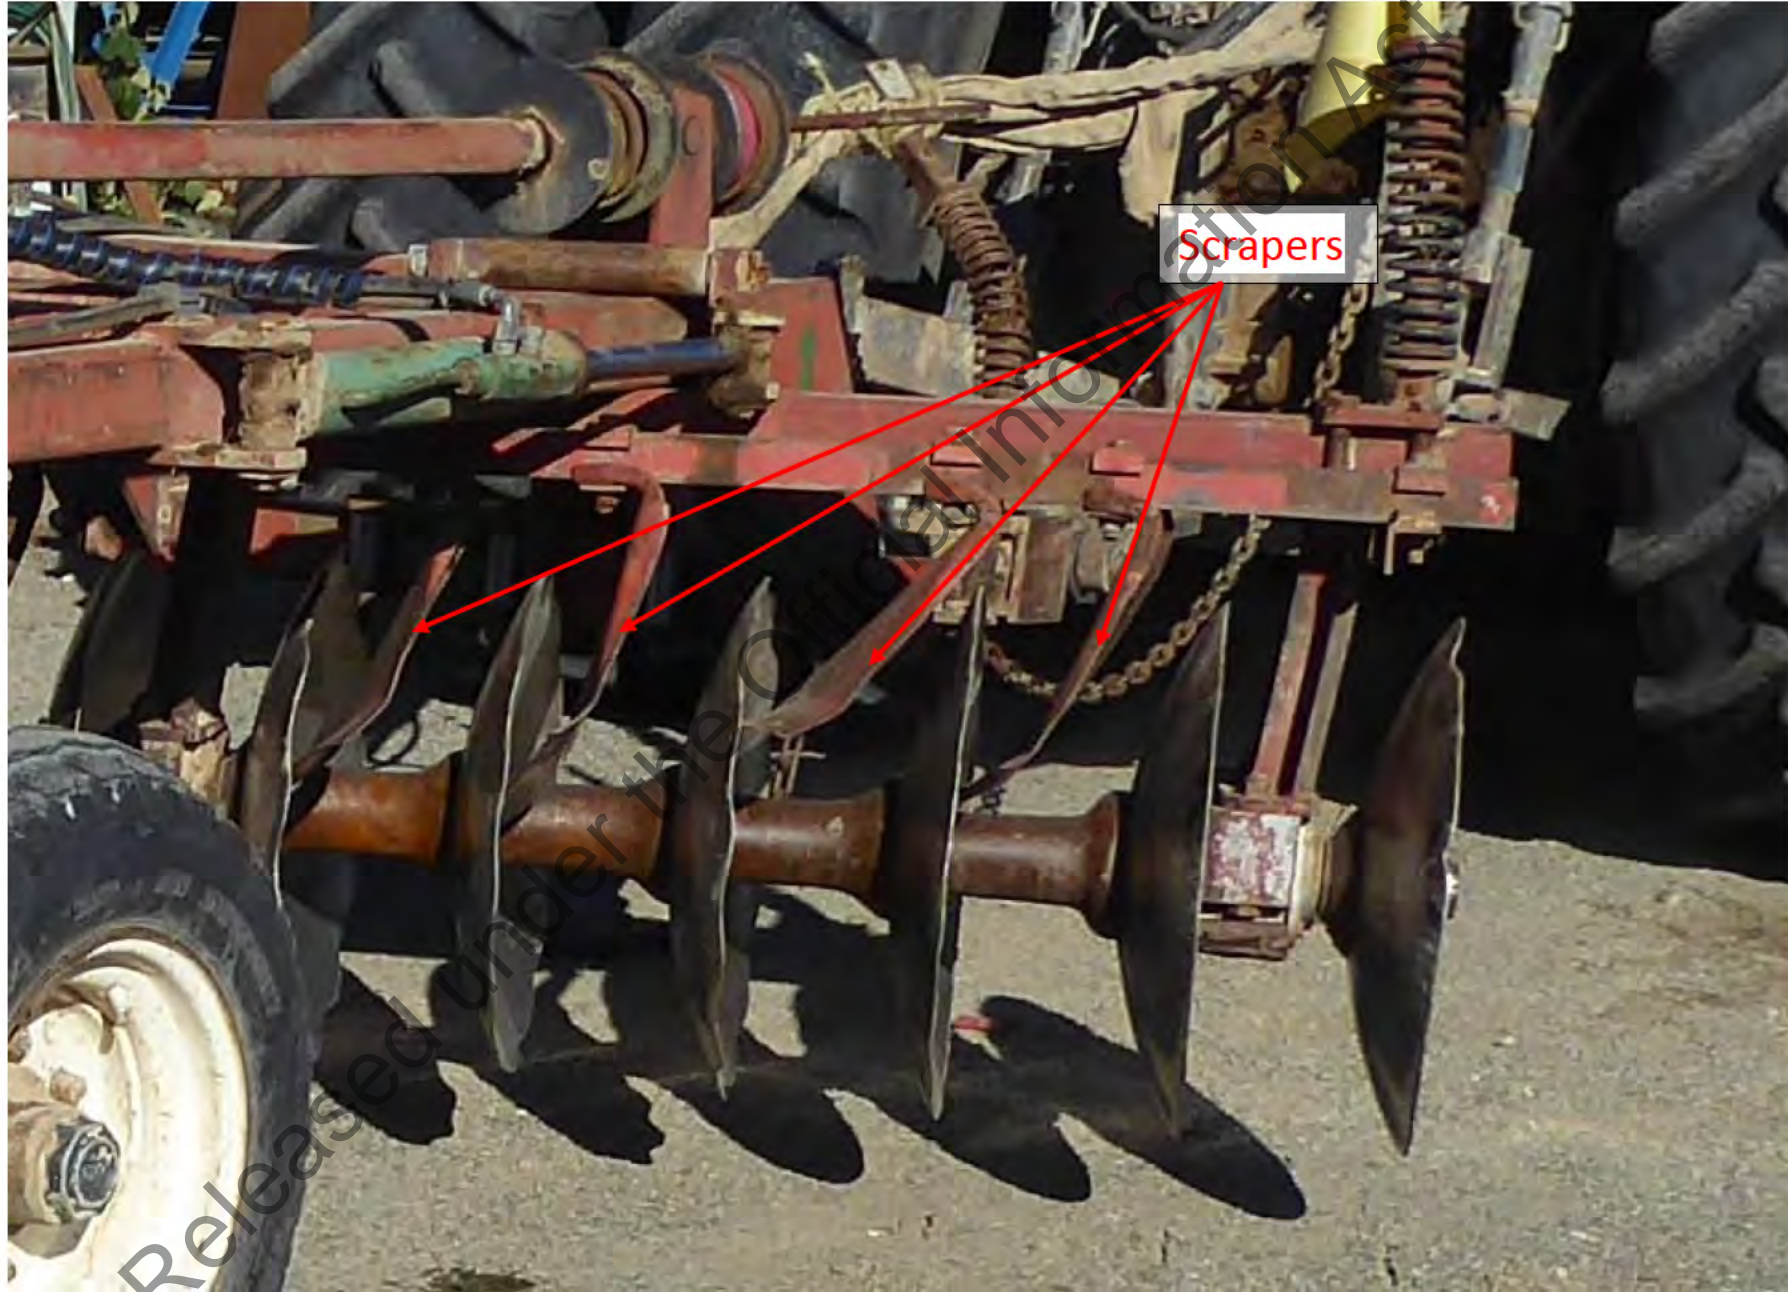
8, Photo 795. Close up of discs and scrapers. (Note scrapers are bent and out of alignment, this shows the wear and tear on scrapers as part of normal operations.)

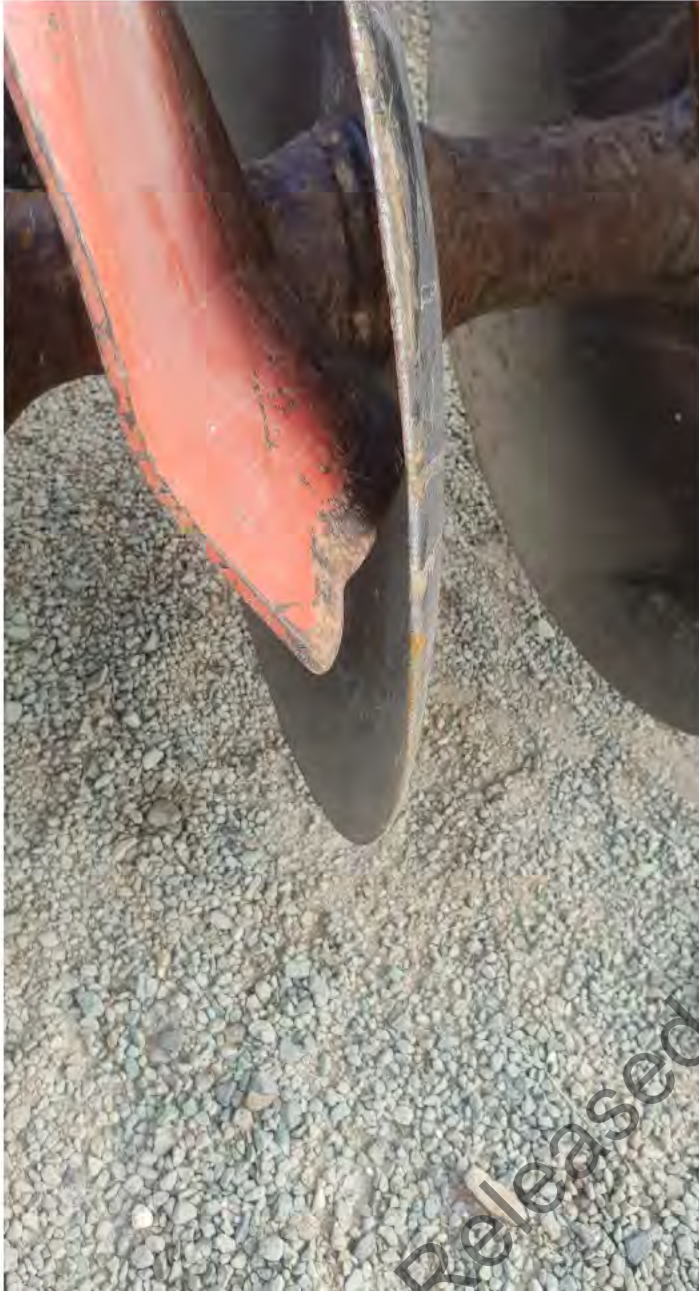
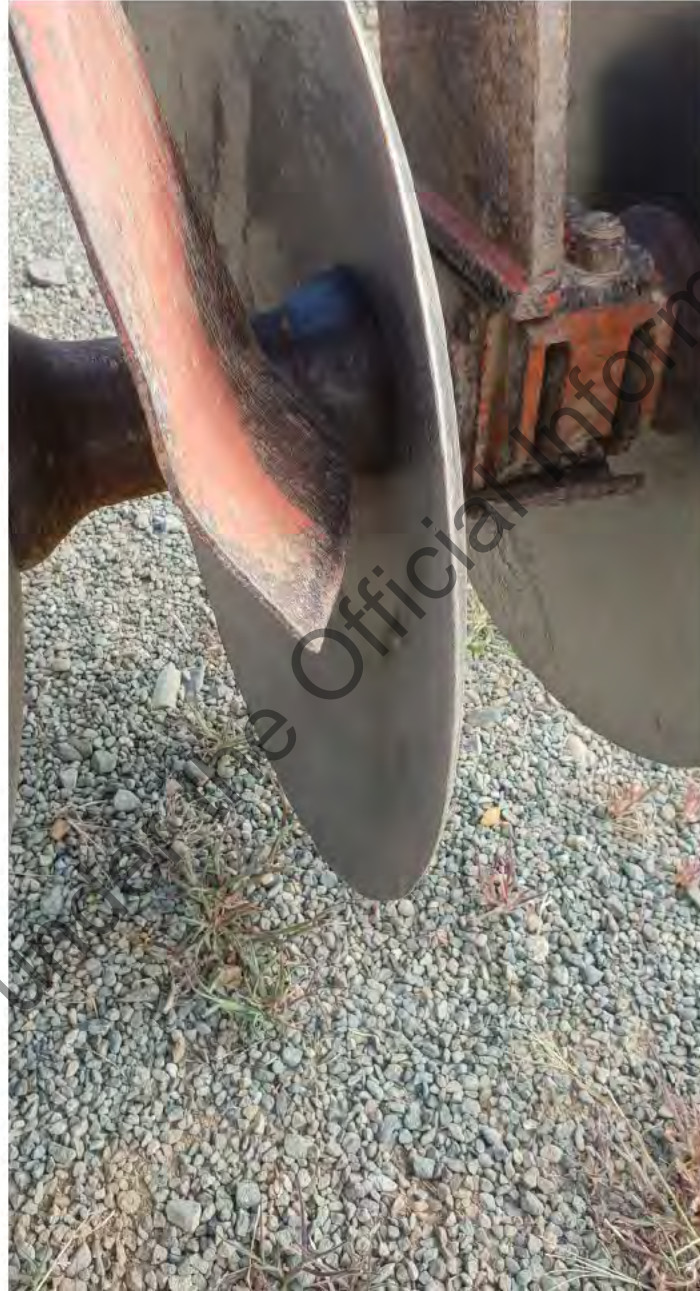
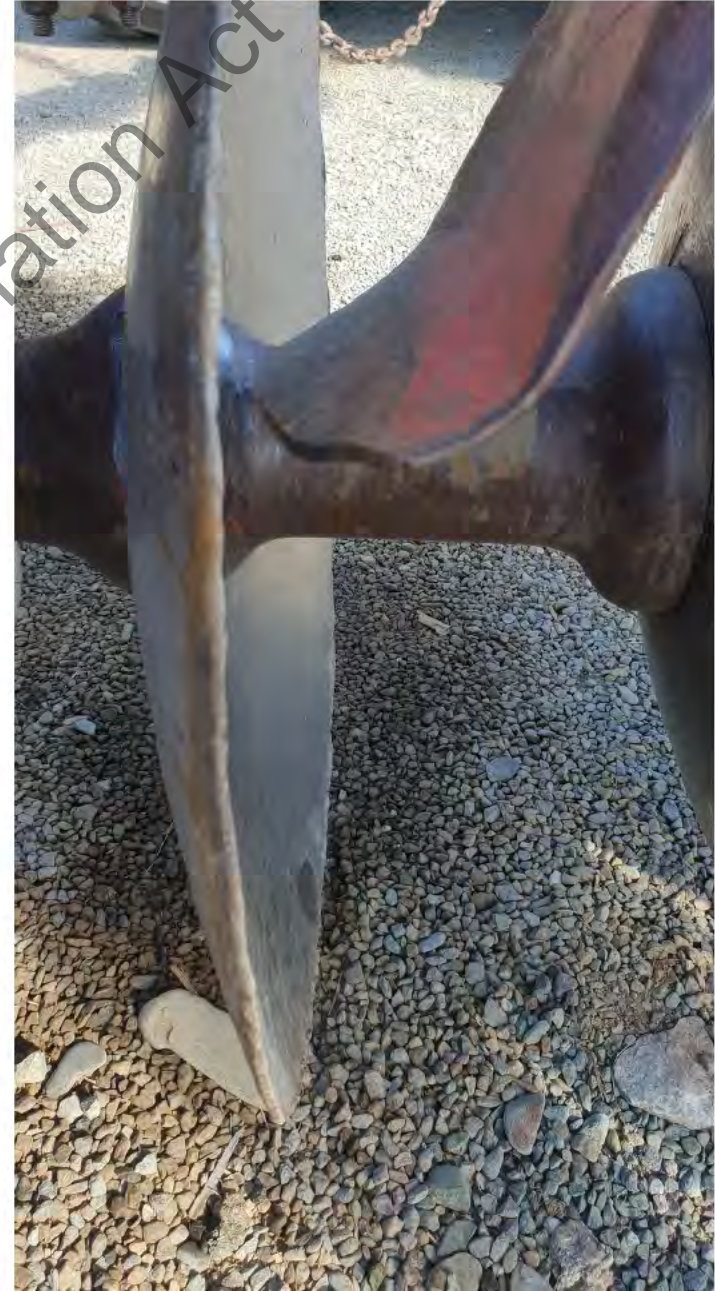
9, Photos 20190214-091241,-091301,-094037. Close up of discs and scrapers. (Note scrapers are at different distances from discs and in some cases very close.)
