FIRE INVESTIGATION REPORT

This vegetation fire, which occurred opposite [REDACTED] Pigeon Valley Road, Nelson, New Zealand, was ignited on 5 February 2019. It destroyed or damaged around 2000 hectares of pine forest, destroyed one home, multiple outbuildings, fences, shelter belts and pastures, and caused the evacuation of around 2500 people. This report covers the investigation process into the fire's origin and cause.

Pigeon Valley Fire, F2704034

Opposite [REDACTED] Pigeon Valley Road, Nelson, NZ

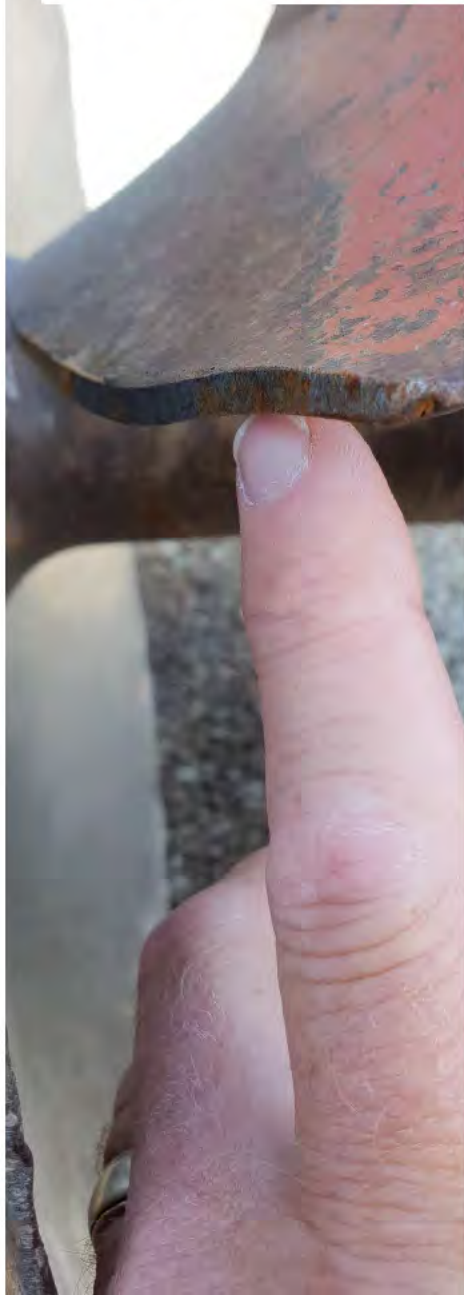
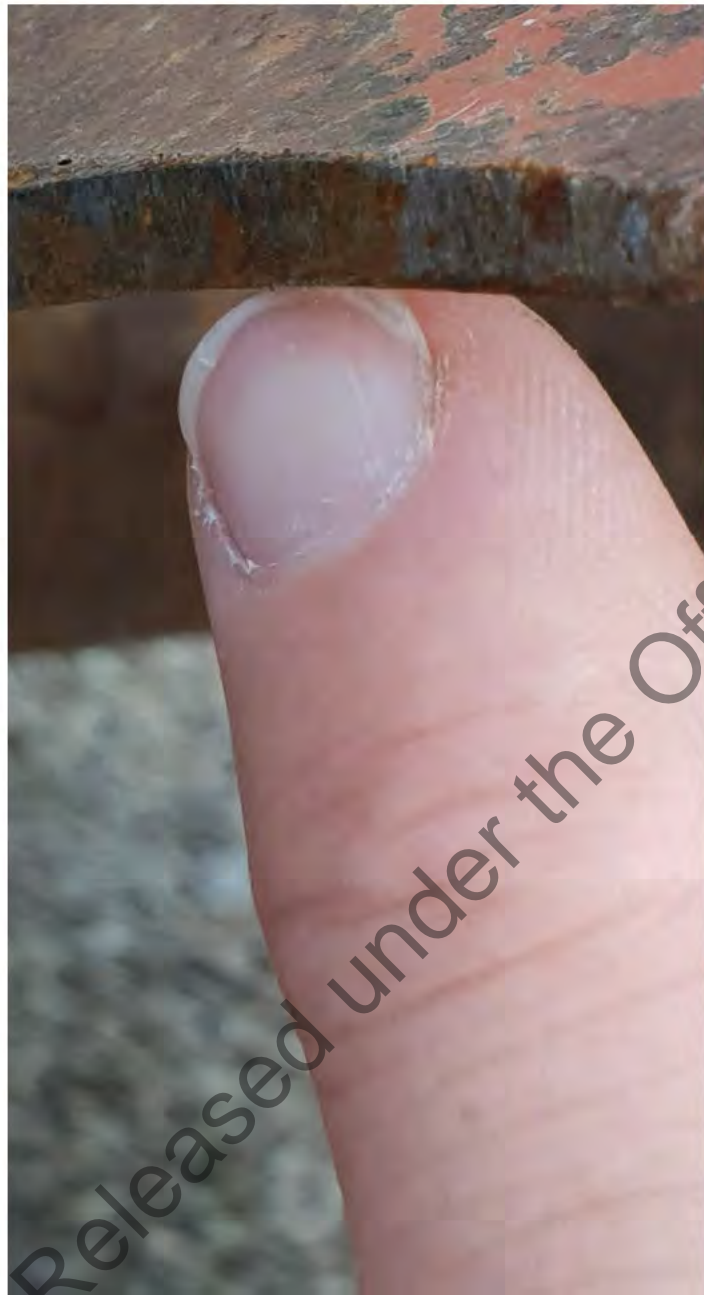
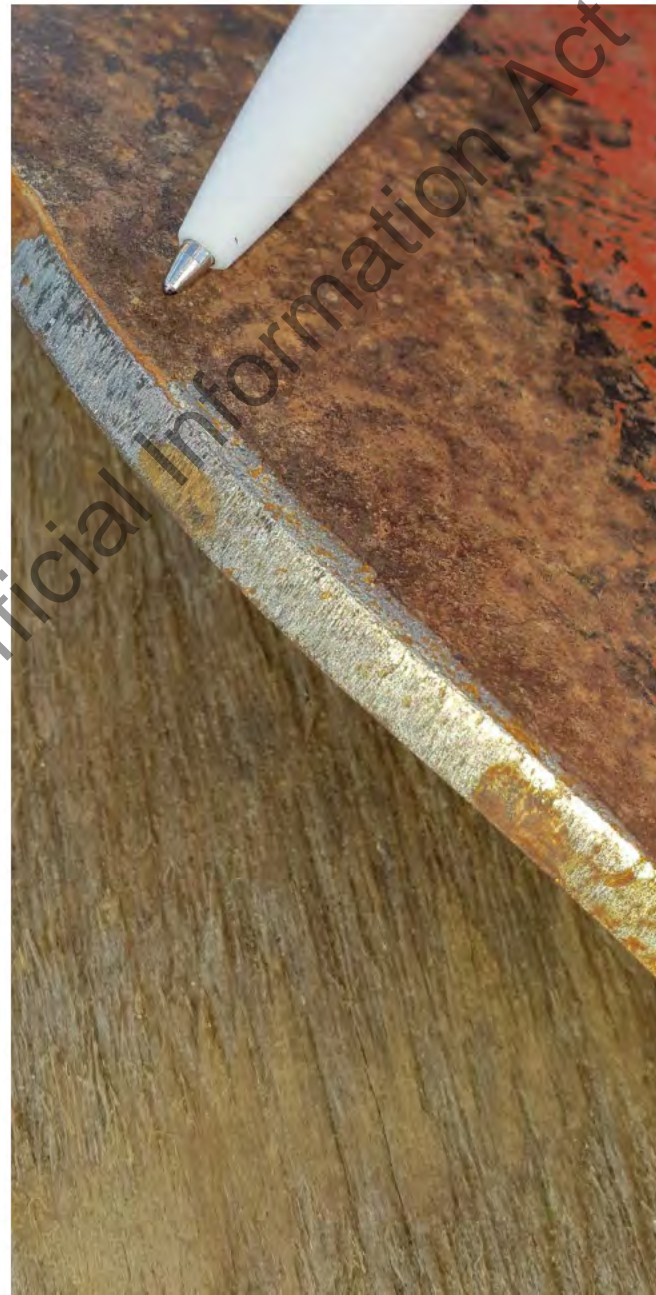
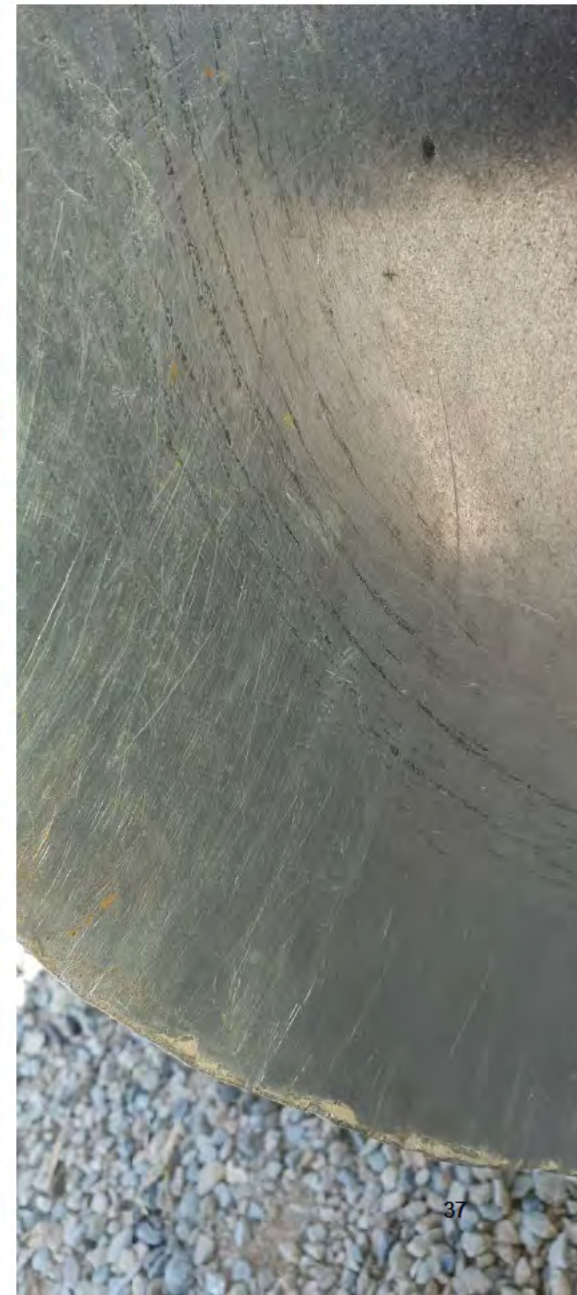
- 4.1.1.10.6 Some rub marks showing that at least one of the scrapers (metal blades that keeps the discs free of debris) has come in contact with a disc during operations. This has the potential to cause a hot surface and/or sparks. (Photo Log, 10.)

10, Photos 20190214-094156,-094208,-104817,-102140. Close up of fresh abrasion to scraper and corresponding scratches in disc. (3rd disc and scraper set in from front right gang)

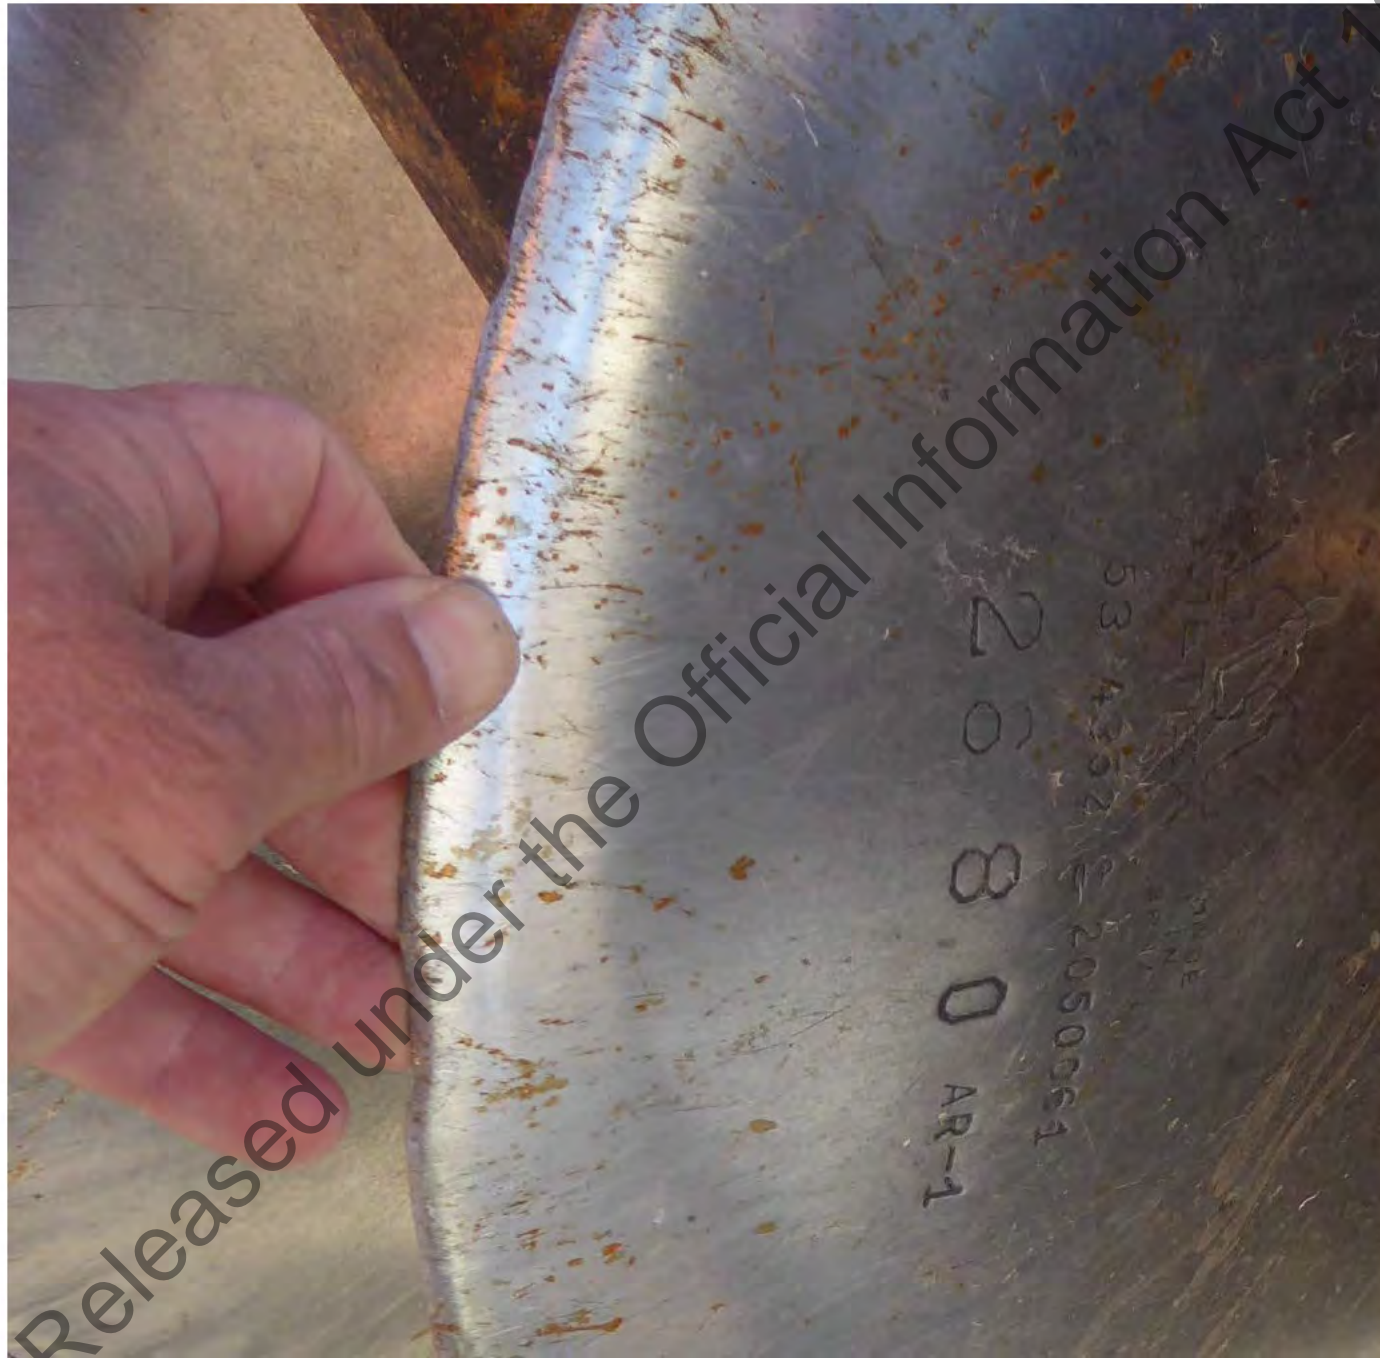
11, Photo 797. Close up of discs showing wear and tear on cutting edge.

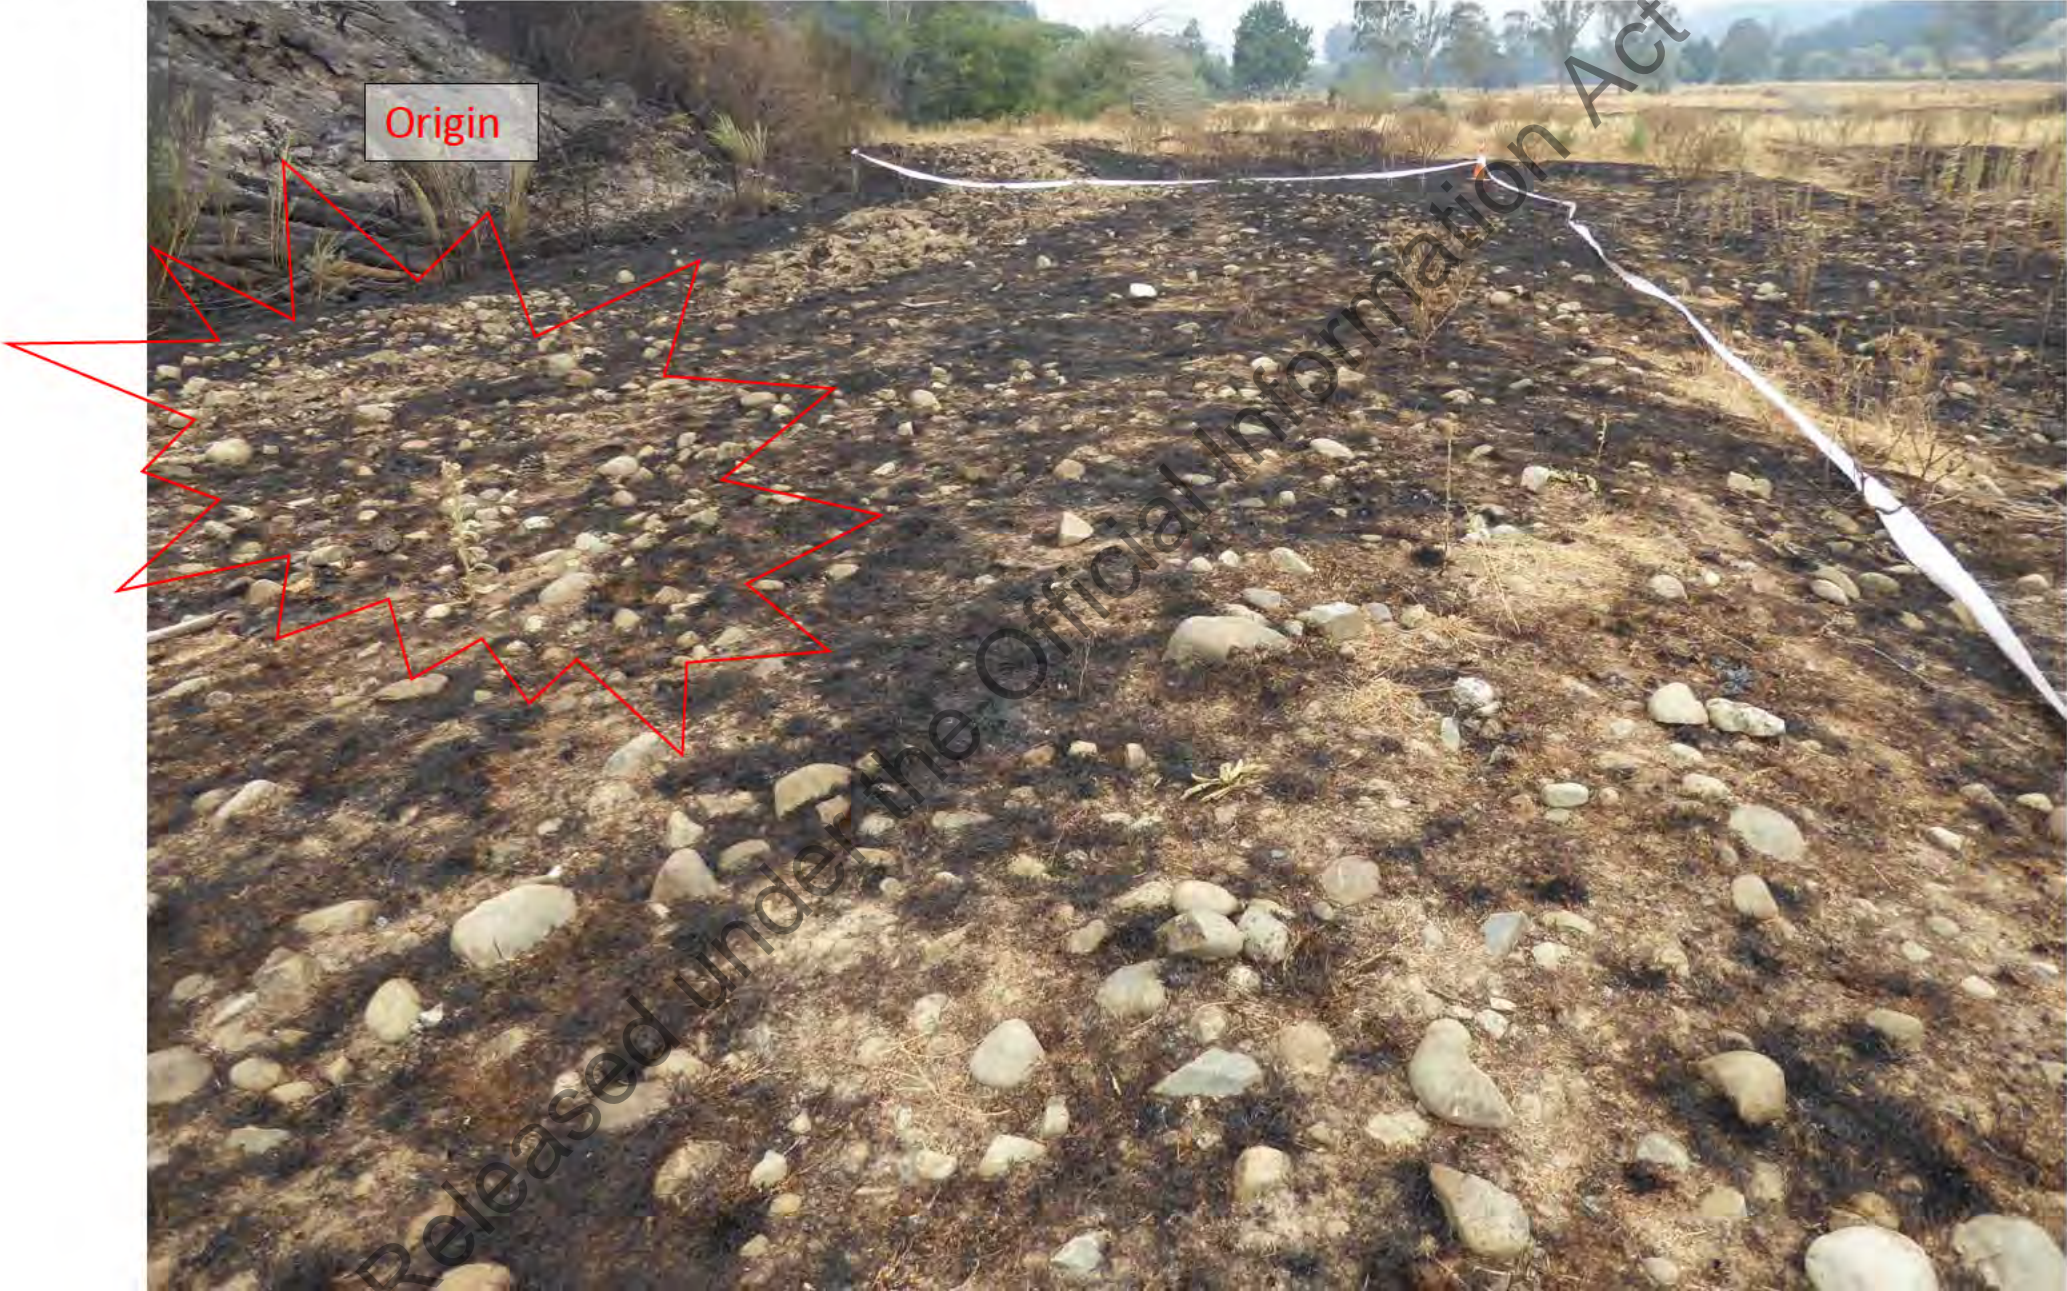
12, Photo 762. Note the very rocky nature of the area being disced. The origin is the rockiest area disced along the eastern edge of this block.
