Fire Research & Investigation Unit

Heads Up

This edition summarises a fire that occurred in a small residential care facility. At the time of this fire the building was occupied by two residents and one care assistant. Due to the nature of their disabilities the residents required constant monitoring.

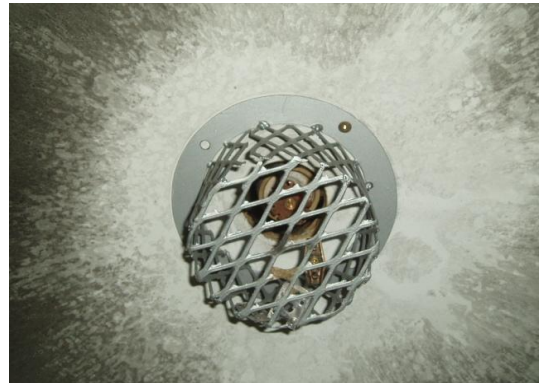
Issues were also discovered with the installation of unapproved sprinkler guards which would have effected water discharge patterns. Some recessed heads would not operate effectively as they could not drop down far enough due to misalignment during installation or due to the covers being fitted with adhesives affecting their operation.

Guard fitted to sprinkler head in room of fire origin

The report strongly recommended that independent surveys take place in similar properties to ensure that the installations correctly meet the requirements of the relevant standard.

It also recommended that regular testing and maintenance routines be established for these systems and that a manual should be on the premises that includes as built drawings, commissioning data, and records of testing.

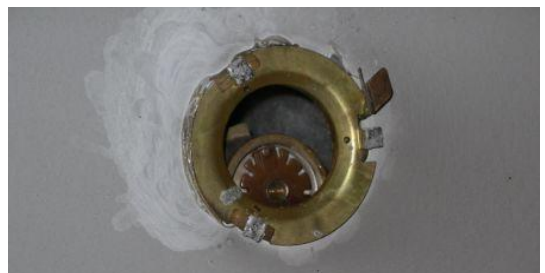
Recessed sprinkler head in hallway unable to drop down
