## Fire Research & Investigation Unit

# Heads Up

### BACKGROUND

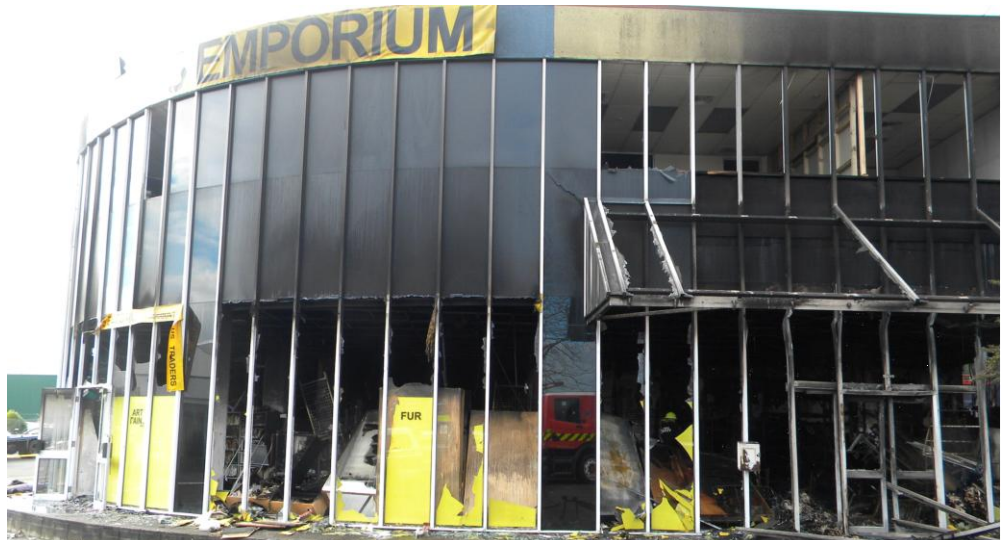
Fire damage was limited to the ground floor retail business that represented the room of fire origin, however smoke spread to other tenancies in the building.

The worst effected was the other ground floor tenancy which was a Medical Centre with expensive electronic equipment.

*Emporium involved in fire occupied ground floor along with Medical Centre.*

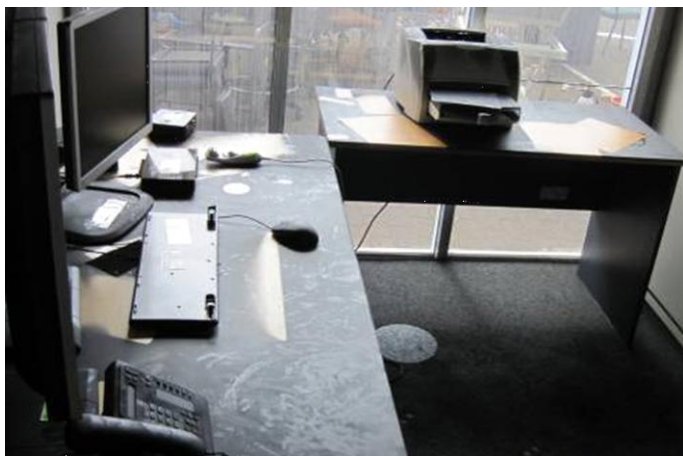
Smoke travel was not however controlled and this alone did considerable damage in the neighbouring tenancy making this a high loss multi-million dollar fire.

Due to the temperature differences, 200-300°C for the smoke layer and only 4°C to 6°C in the neighbouring tenancy, as the smoke entered the cold atmosphere it immediately lost its buoyancy and travelled down vertically leaving thick deposits on all horizontal surfaces. This resulted in extensive damage to critical health monitoring and screening equipment in the Medical Centre.

*Example of smoke damage in neighbouring tenancy.*

- Procedures for seeking consent for change of use of buildings should be followed as this may trigger the requirement to upgrade buildings to meet modern day building standards.
- While not mandatory, regular reviews and recommendations of specific improvements due to age, lack of protection systems, or obsolete technology in buildings will help reduce fire risk and avoid potential significant business interruption.
- Owners and insurers should be made aware of the possible implications of not having suitable construction to limit smoke and fire spread between tenancies.
- Legislative change should be considered making it a requirement that there should be protection against smoke and fire spread between tenancies within a building.

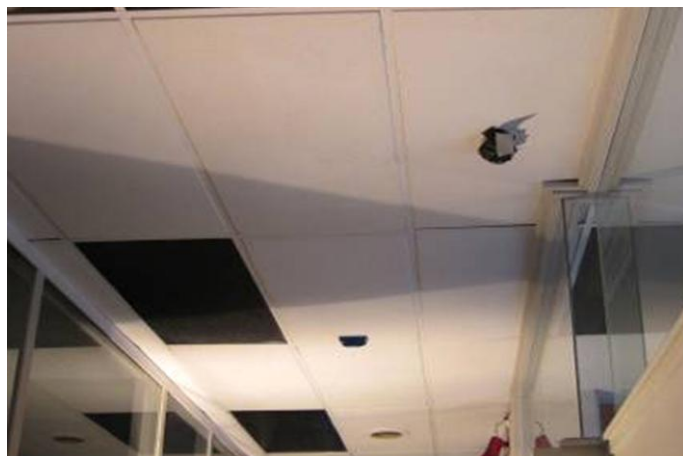
There was no separation in the ceiling area between tenancies due to this area being used to circulate air as an active part of a plenum air-conditioning system. A plenum system uses the ceiling space to commute air flow rather than ducting.

While there was some smoke travel through air conditioning extraction grills and other small openings, the main avenue of smoke travel was through fluorescent light units. These units had two slots open directly between the ceiling void and tenancy spaces for ventilation purposes during normal use. As there was no separation between tenancies in the ceiling space smoke was able to travel freely from one to the other.

*Fluorescent light units and other openings allowing smoke travel.*
