## Fire Research & Investigation Unit

# Heads Up

### BACKGROUND

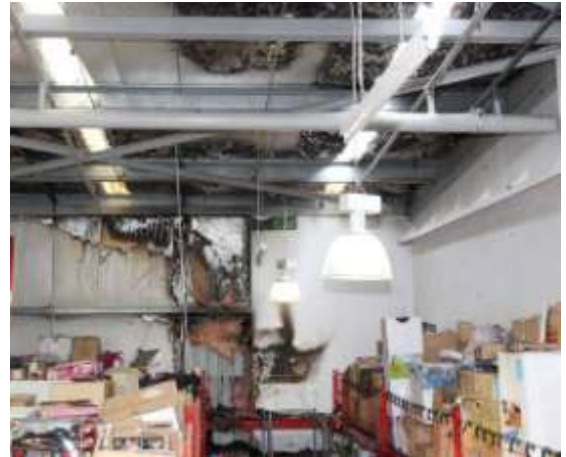
A deliberately lit fire was started against the external wall of a large warehouse which quickly spread to the internal surface linings of the building travelling up the wall and across the ceiling. Flaming pieces of building paper began to drop down onto stock below starting multiple fires within the building.

The post fire investigation examined why the fire spread so quickly when it involved building products that should have been fire retardant.

*Above: the rapid fire spread was promoted by flammable surface linings*

**Advice to builders and compliance officers** - ensure the product being used for linings is fire retardant as specified in the building consent documents.

**Advice to building owners** - to avoid potential loss and to protect business continuity, owners should ensure their building's interior surface linings meet the requirements of the Building Code. A simple indicative test can be to remove a small strip sample of surface lining (e.g. 500 mm x 50 mm) to a safe place and apply a small flame while the sample is held vertically. A product that meets the current code requirements (has a FI value less than 5) should not allow a flame to spread more than 100 mm upwards from the bottom edge within 160 seconds.

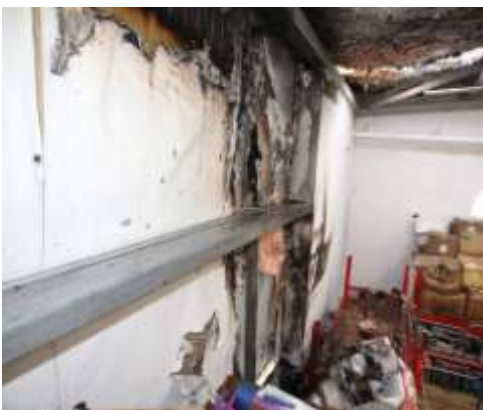
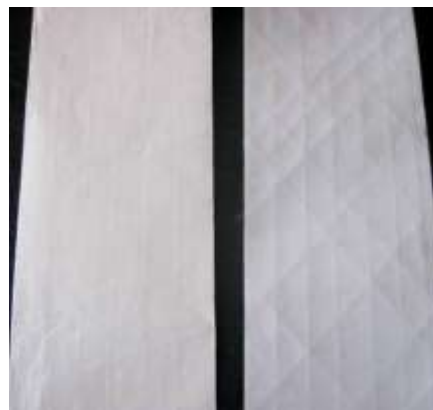
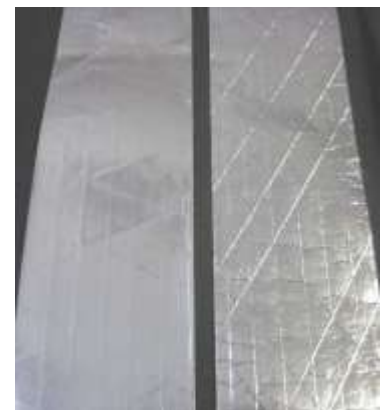
These underlays typically have a silver foil surface on one side and a white light reflecting surface on the other side. Once installed, building lining papers are not easily distinguishable between those that are fire retardant and those that freely support fire as they are not required to be marked or labelled. It is likely that builders and compliance officers would be unable to determine by visual inspection whether a product is flammable or if it meets the Flammability Index (FI) requirements of C/AS1 Table 6.2.

*Above: visual comparison of products with a C/AS1 compliant product on the right hand side of each photo.*

**Advice to manufacturers/suppliers** - it would be helpful to builders and certifiers if product identification could be discretely marked (e.g. on leading edges) for easy identification of the product.

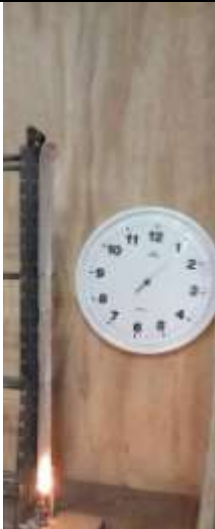
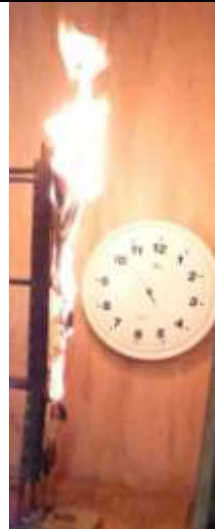
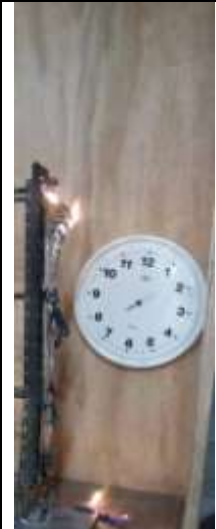
Sample of Product Installed	5 Secs	52 Secs	67 Secs

### Test 1 - product sample taken from building

Flame quickly spread the full length of the sample. Flaming material can be seen on the final photo falling from the sample as occurred in the building fire.
