Fire Research & Investigation Unit

Heads Up

BACKGROUND

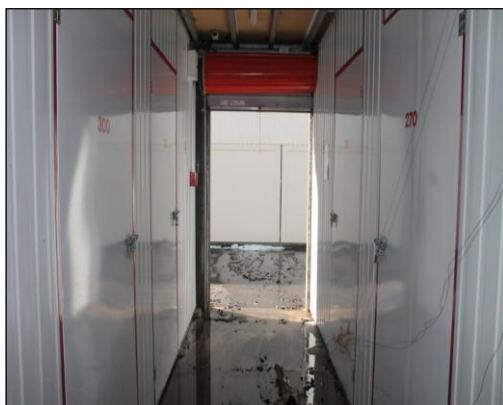
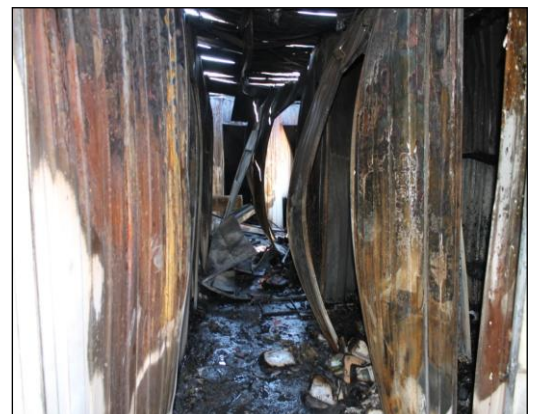
Left photo shows a view of a corridor in a relatively undamaged part of the lower level.

Right photo shows a similar view in a fire-damaged area.

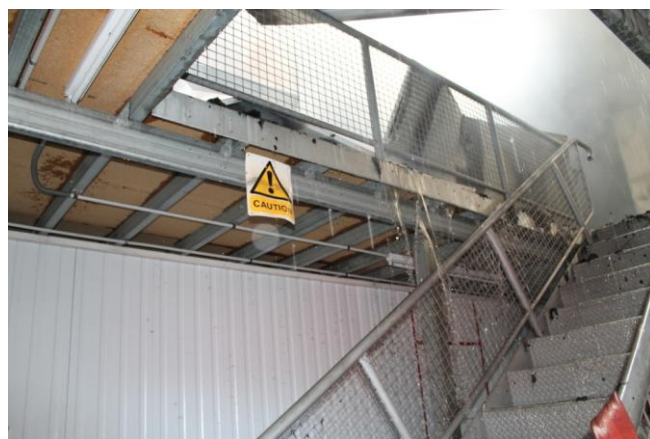
The design of the structure supporting the full-extent, intermediate floor allowed for structural stability of only 4 minutes (see picture right). This was based on the estimated time it would take for occupants to evacuate in an emergency.

- The prescriptive acceptable solution required the intermediate floor to have a structural stability rating of at least 15 minutes. For this building the fire engineer adopted a performance based approach and estimated the structural integrity time of four minutes based only for egress of occupants when a fire is first detected and ignored the safety of fire-fighters. Because they weren't aware of the design, fire-fighters investigating the fire were present inside the building more than four minutes after the fire was detected. Had the fire been on the lower level, any collapse could have trapped or injured those fire-fighters. The structural stability of the building is important for firefighter safety and designs only allowing for evacuation of occupants places firefighters in danger.
