Fire Research & Investigation Unit

Heads Up

A fire occurred in the CBS Canterbury Arena. This is a purpose built multipurpose arena of approximately 9,000 square metres with an internal height of approximately 26m high. The arena has a sprinkler system, with smoke detection in the air handling ducts.

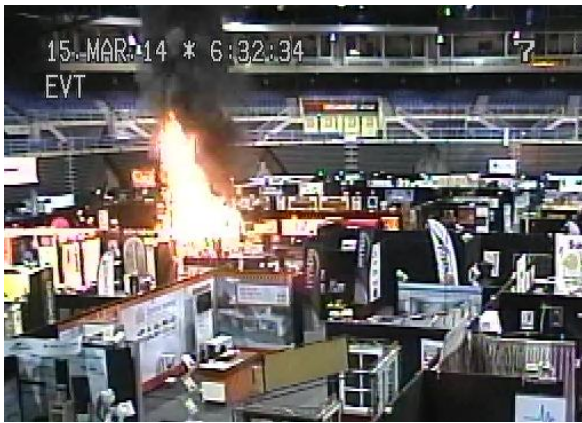
The fire investigation determined the most likely cause was the extension cable leading to the multibox by the spa pool stand, or the multibox itself.

Above: the developing fire prior to sprinkler activation.

1. Due to the high roof within the main arena the fire had grown to a significant size prior to activation of the sprinkler system.
2. The sprinkler activation had cooled the smoke resulting in significant low level smoke logging.

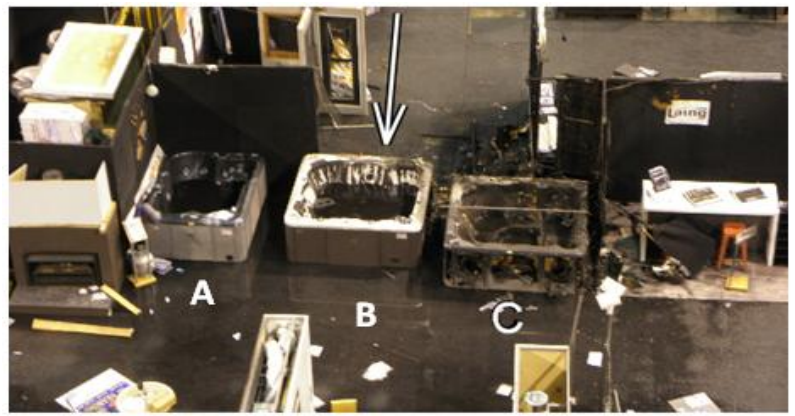
Attending crews were faced with smoke logged conditions and a sprinkler activation that had occurred which contained a fire at the spa pool stand. A firefighting crew was required to extinguish the fire as the spa pool was shielding the fire from the sprinkler discharge. Two spa pools were significantly fire damaged with a small amount of damage caused to a third spa pool (pool A in the photo over page). As the fire occurred the day before the show's opening, the remedial work to mitigate the effects of the extensive smoke logging and firefighting water led the organisers to cancel the show.

Elevated photo of the fire scene- Spa Pools annotated A, B and C. Arrow highlights direction of approach of fire crews.

3. The sprinkler system was effective in containing the fire but not in extinguishing it due to shielding by adjacent products. However this does demonstrate the value of sprinkler systems in detecting and suppressing or holding fires. This provides effective property protection and enhances business continuity after a fire.
