## Fire Research & Investigation Unit

# Heads Up

On the 24th of September 2014 a fire occurred on the second floor of a five storey administration building which forms part of a hospital. The building was fitted with a Type 7 automatic sprinkler system with smoke detection and manual call points.

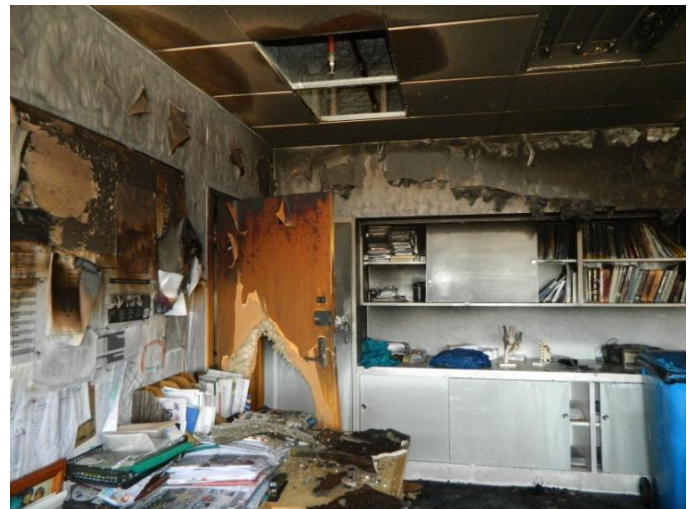
Figure 1: Room of origin of fire

The fire was caused by a faulty light fitting and discovered by staff. Subsequent attempts by several of the staff to alert Fire Service and building occupants to the fire were severely hindered by the failure of the manual call points and emergency telephones as these were all deactivated because of the works.

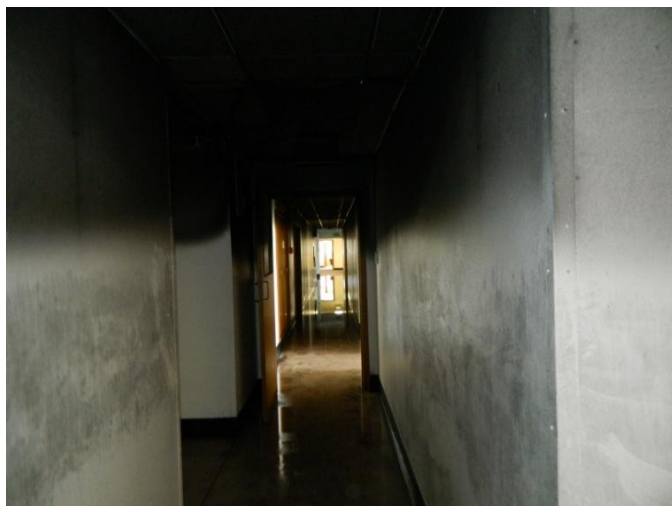
The isolation of the fire detection systems also directly compromised the passive fire protection of the building. As the fire alarm did not activate, hold-open devices did not release the fire and smoke doors, allowing smoke and heat to travel freely within the building.

The fire was extinguished when the attending Fire Service crews requested the reinstatement of the sprinkler system, but only after significant damage had already occurred in the room where the fire started. The rest of the floor suffered extensive smoke damage.

**Figure 2: Showing extensive smoke damage throughout building**
