## Fire Research & Investigation Unit

# Heads Up

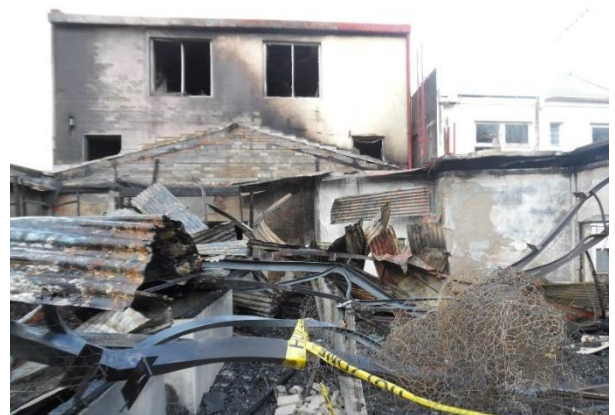
Figure 1 - Second Incident: Rear facade of commercial unit overlooking the burnt out workshop

In the second building, the upper level unit was not appropriately fire separated from either the ground floor commercial unit or the adjacent single-storey unit. In addition, automatic detection was only provided in the single storey unit. The Building Code would have required both adequate fire separation and automatic smoke detection to protect the sleeping risk.

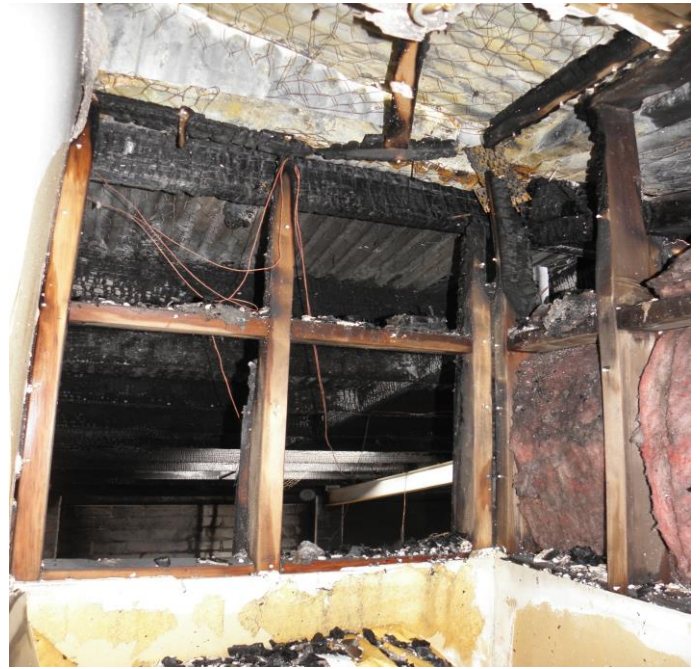
In the first building, the walls of the upper level unit were constructed with standard 12.5mm Gib board mechanically fixed to the timber frame. There were a number of penetrations through these walls which had not been fire stopped. Therefore the upper level unit containing the sleeping risk was not adequately fire separated from the ground floor spaces. The structural steel beam supporting the floor did not appear to have any fire protection. Finally, no automatic detection and alarm system was provided. All these features would have been required under the Building Code

Figure 2 - First Incident: remnants of the wall separating the kitchen of the residential unit from the workshop

- Adequate fire separation is also critical between sleeping areas and other parts of the building. Where existing partitions do not provide the required fire resistance, they should be replaced/upgraded as required.
