FIRE INVESTIGATION REPORT

Tiwai Point, Invercargill

Incident Information:
F4137934
Vegetation Fire
11:59 PM 29 January 2025

Report completed by:
Cameron, Scott, Fire Investigator
Fire and Emergency New Zealand, Te Kei

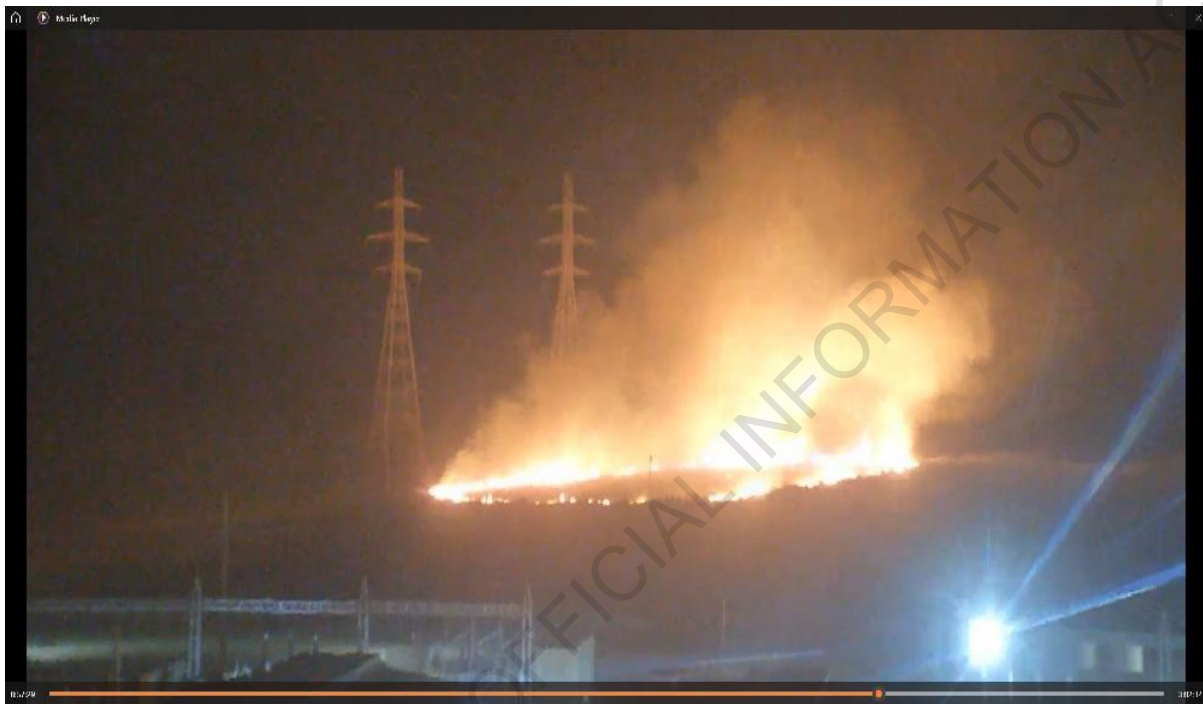
Image 3: State of fire about the time it was discovered on Tiwai CCTV.

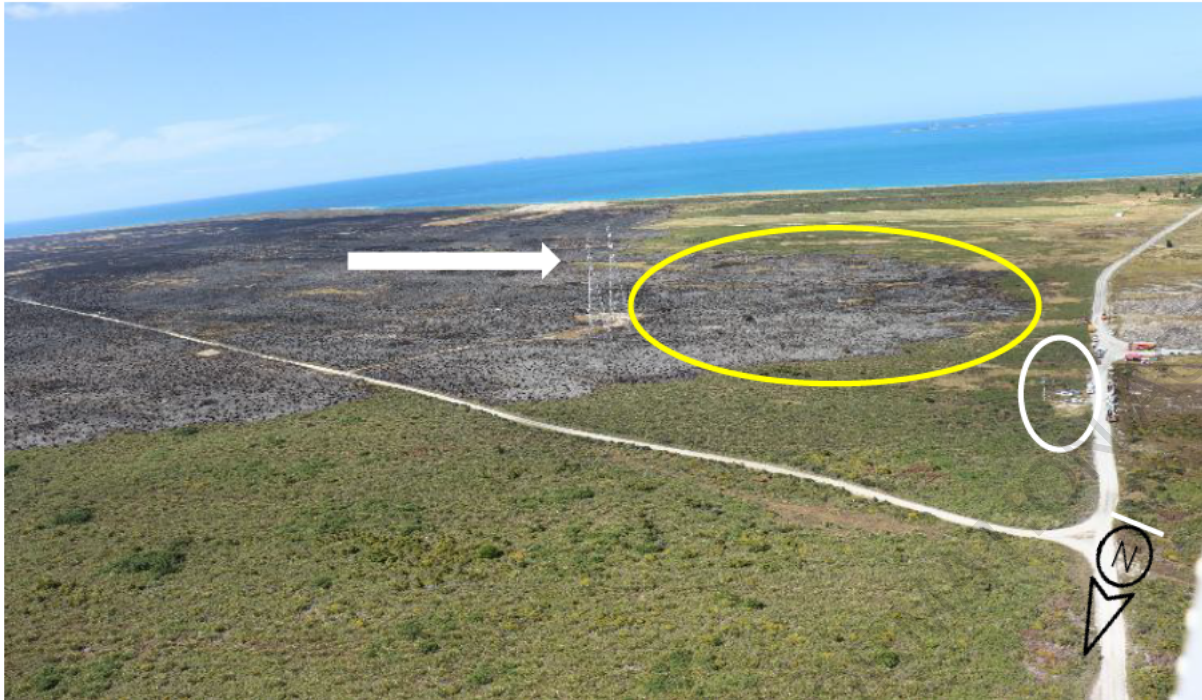
A location of approximately 3000m² was identified as the general area of origin. (*Refer to photos 1 and 2*).

Photo 1: Yellow circle indicates the general origin area. White arrow shows the second set of pylons, white circle shows where a 11kV distribution line starts.

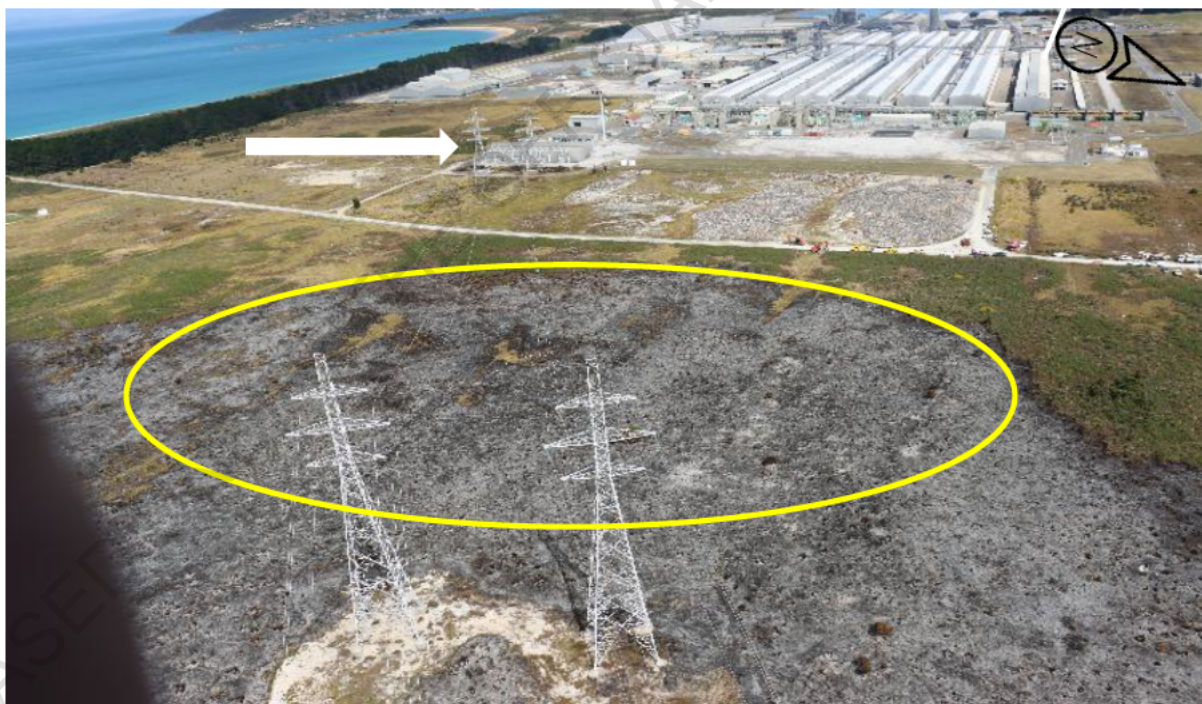
Photo 2: Yellow circle indicates the general origin area with Tiwai site in the background. White arrow shows the first set of pylons from the substation behind them.

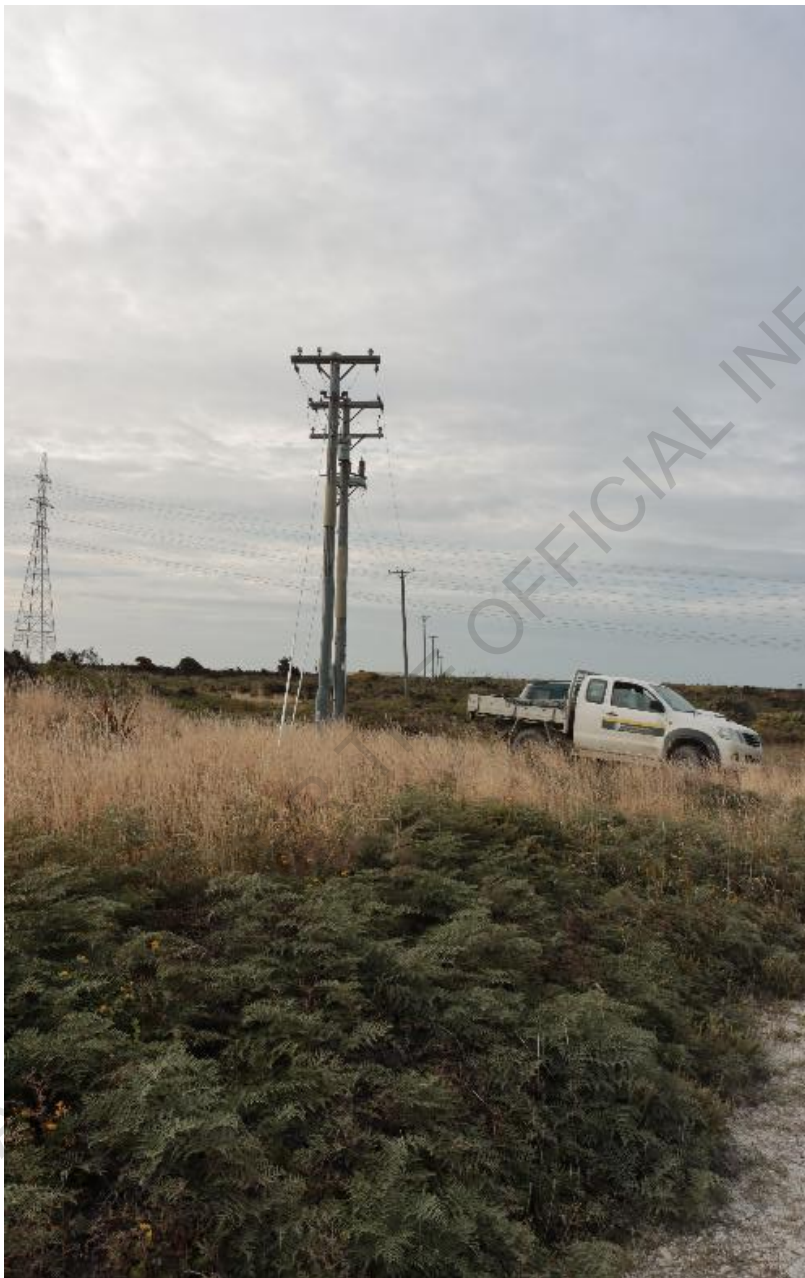
Photo 3: 11kv distribution line.

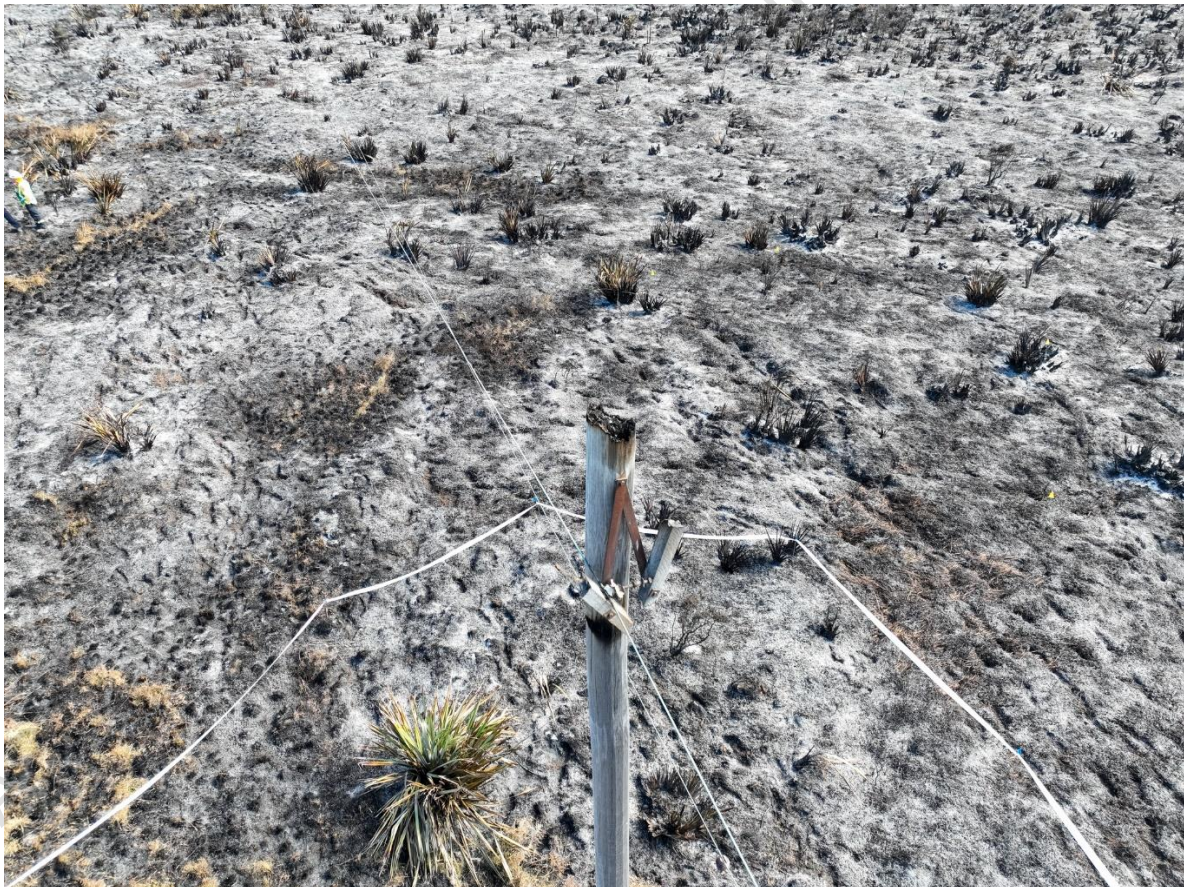
Pole 6 had a large section of the top of the pole missing with evidence of burning to the top of the pole and the crossarm. One of the 3 powerlines had broken and was on the ground. One was suspended in the air and the remaining line was the middle line was caught on the crossarm. The base of pole 6 did not receive any fire damage.

Photo 4: Fire damage to top of pole 6 and the crossarm.

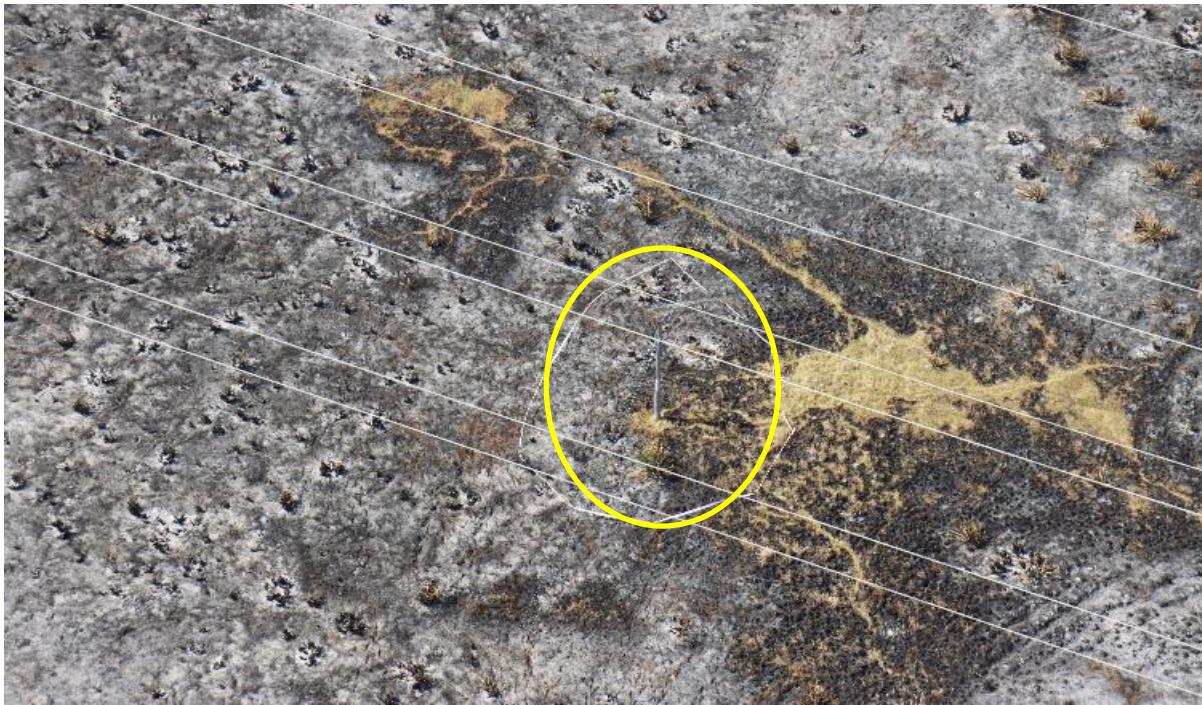
Photo 5: Specific area of origin around pole 6.

The specific origin area was reduced to about 10m².

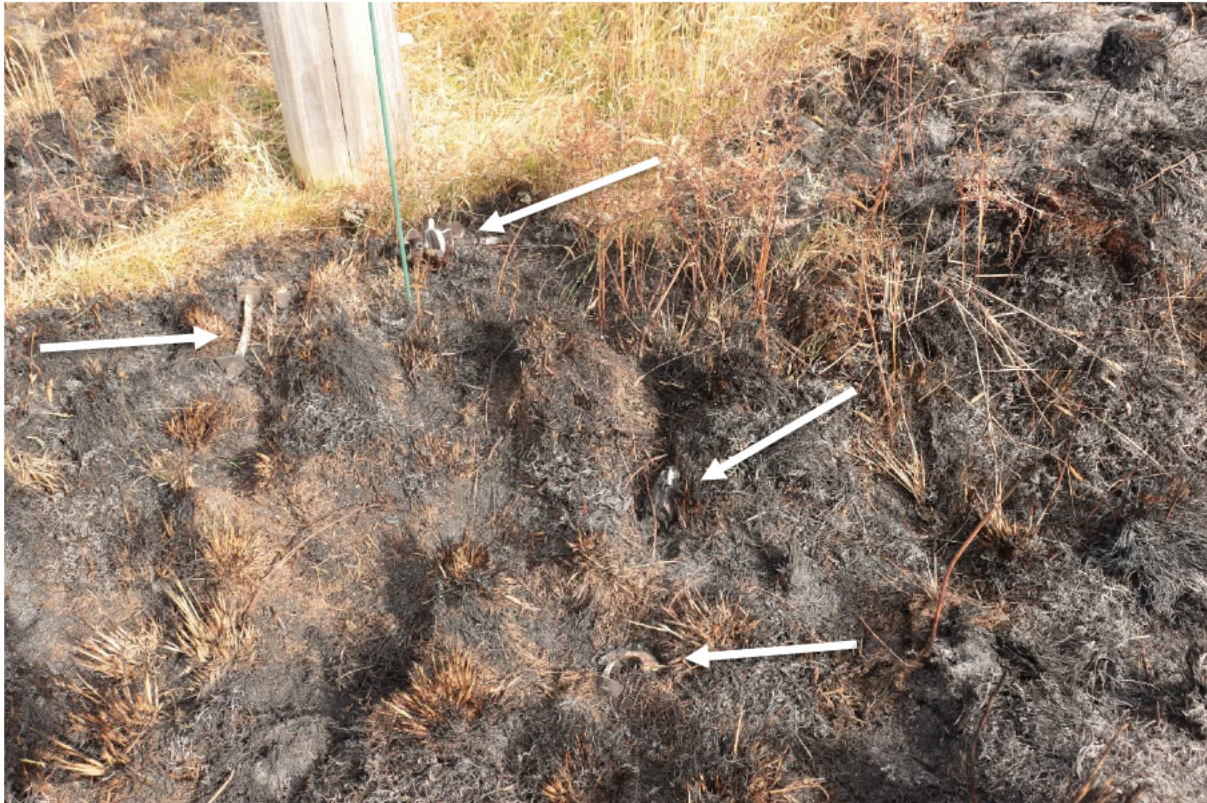
Flags were put out as items of interest were discovered. These included damaged wires, pole cap, damaged insulators, metal bolts, metal straps, nails, chunks of burnt wood from the crossarm and/or power pole. (Refer to photos 6 7 and 8).

Photo 6: White arrows indicate items of interest at the base of pole 6.

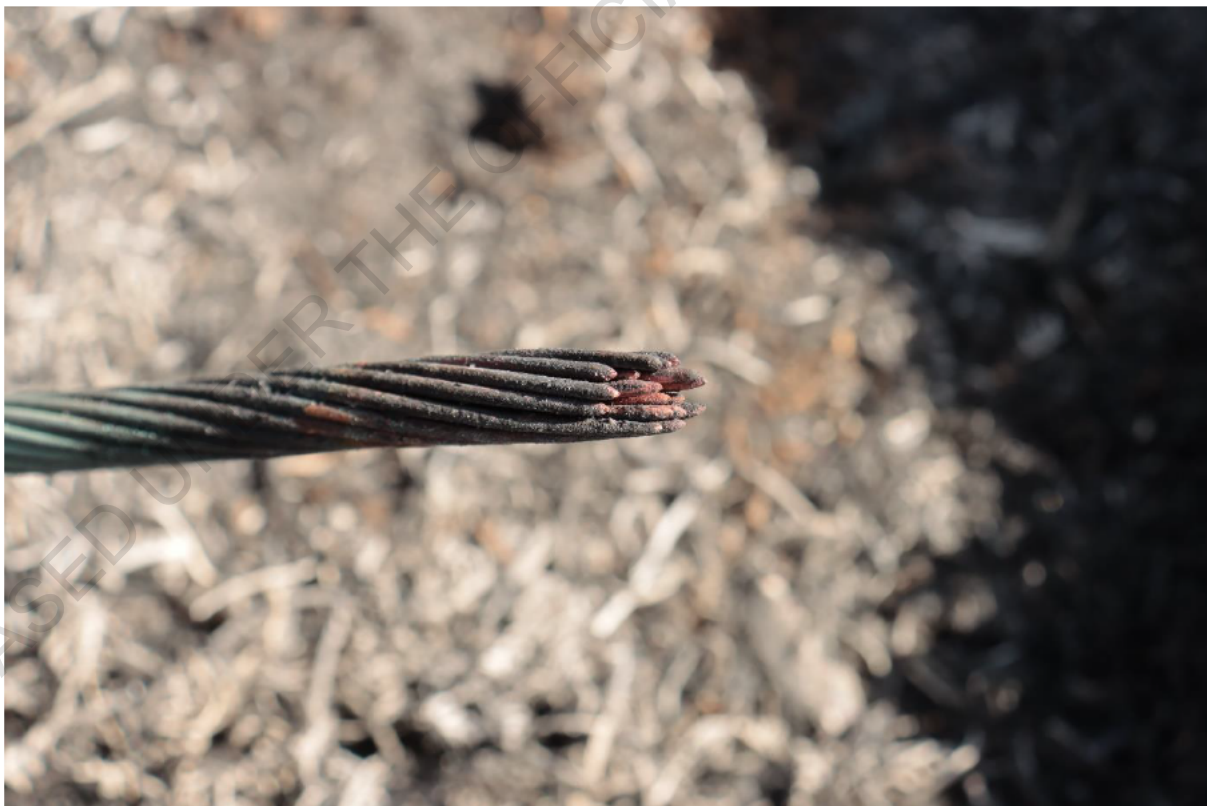
Photo 7: Powerline at the point it broke. End from the power feed supply.

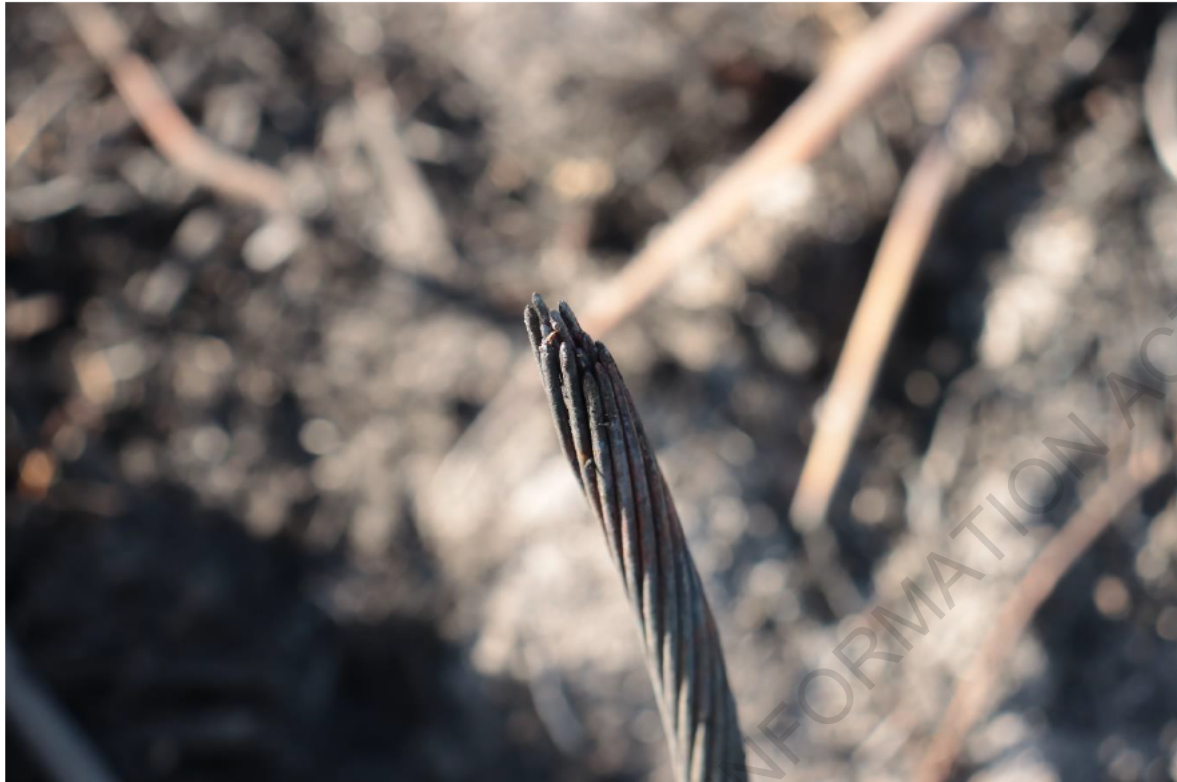
Photo 8: The other end of the broken powerline.

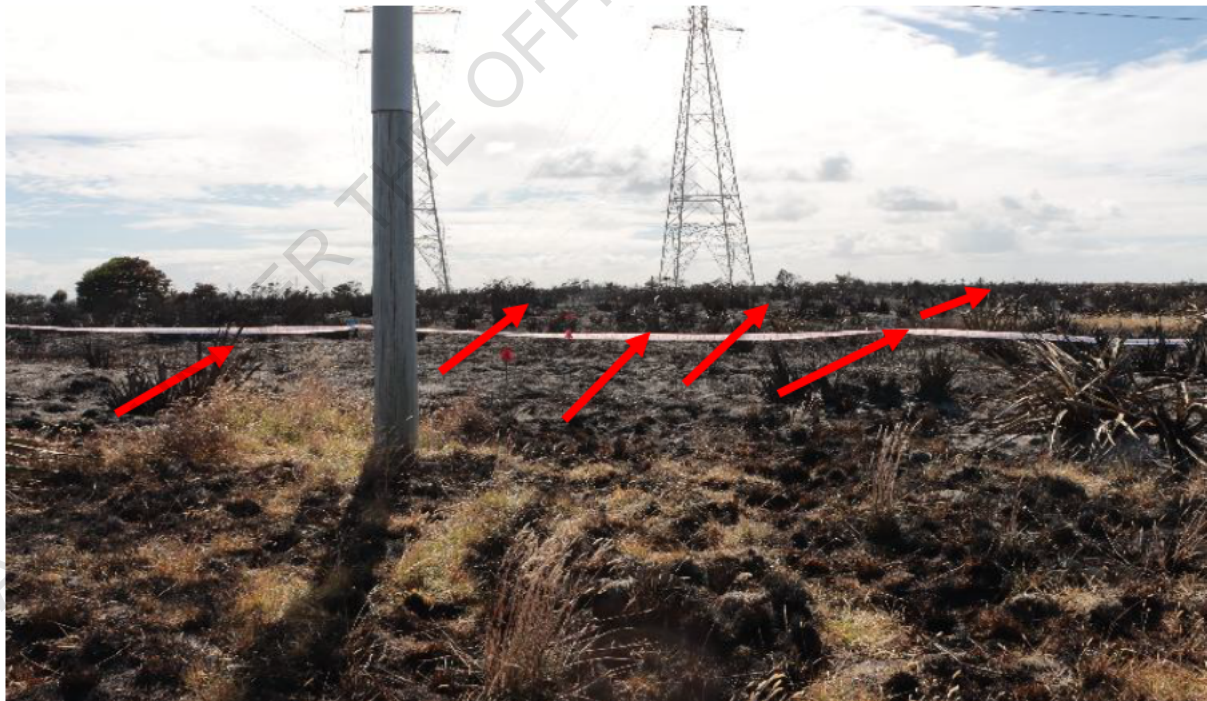
With several flags in the ground, it painted a clear picture of the fires progression as it spread from the specific origin area in a southeast direction away from power pole 6. (Refer to photos 9 and 10).

Photo 9: Red arrows indicate fire direction away from pole 6.

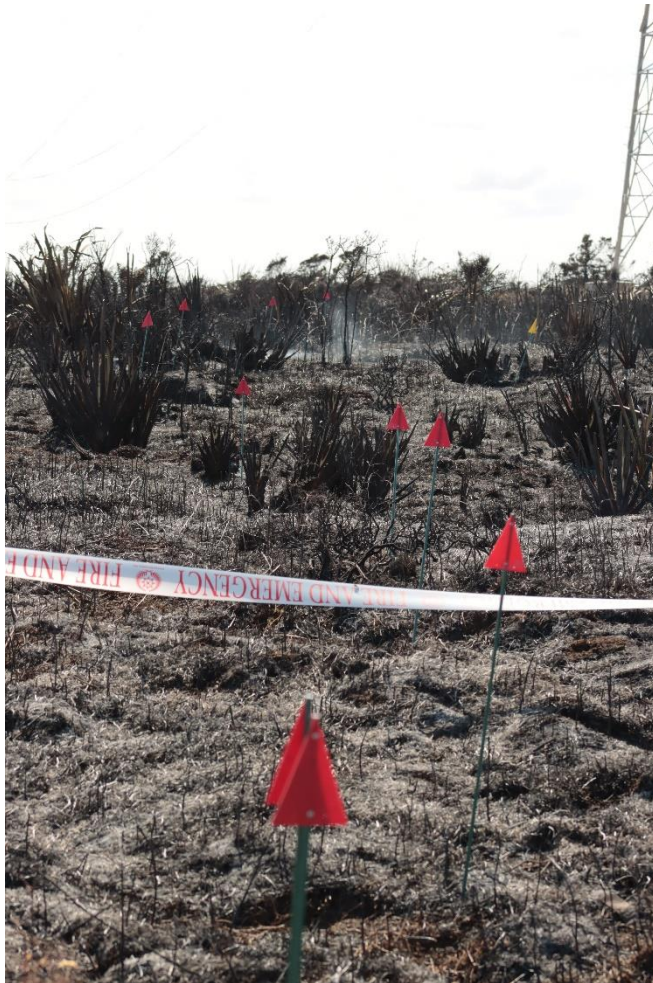
Photo 10: Red flags indicate fire direction away from pole 6.

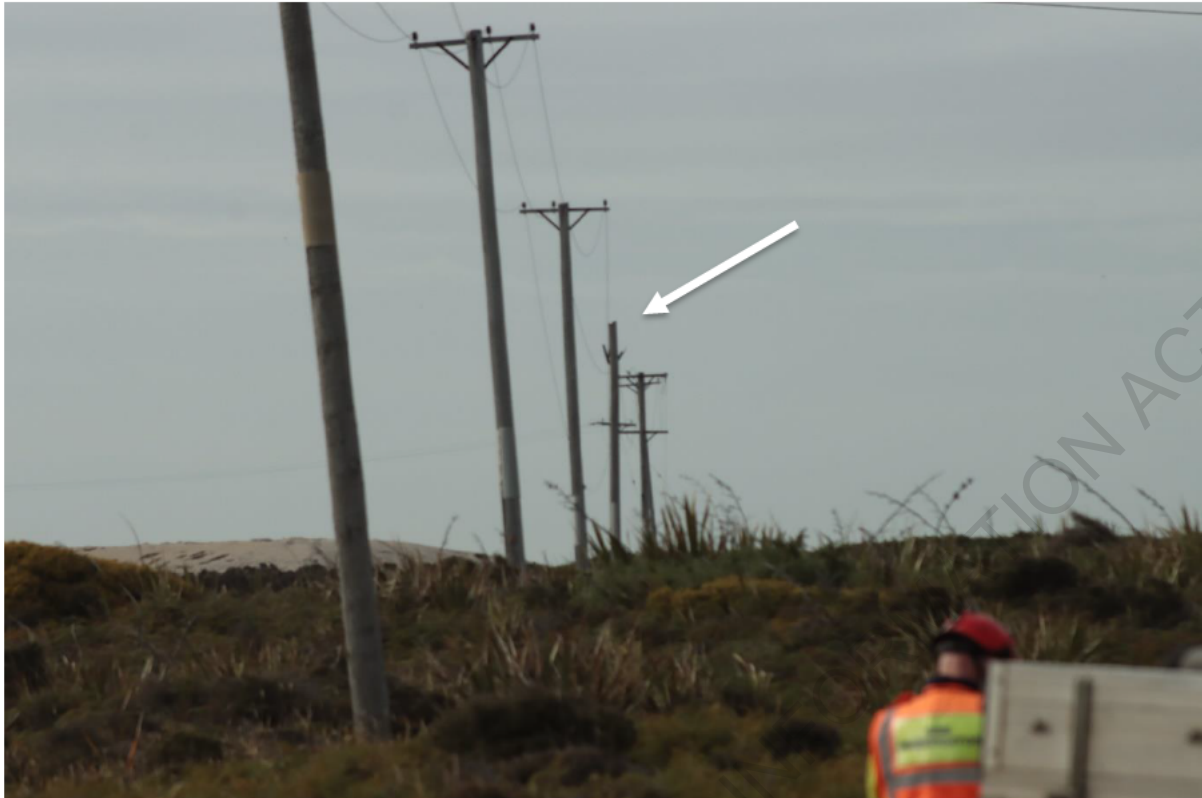
Photo 11 shows the path of the distribution line. The crossarms are visible to show the locations of the insulators. Damage is visible to pole 6.

Photo 11: Distribution line to NZAS bores. White arrow indicates damaged pole 6.

Power Net replaced damaged poles and reconnected the western powerline on the 11kV distribution line to the bores.

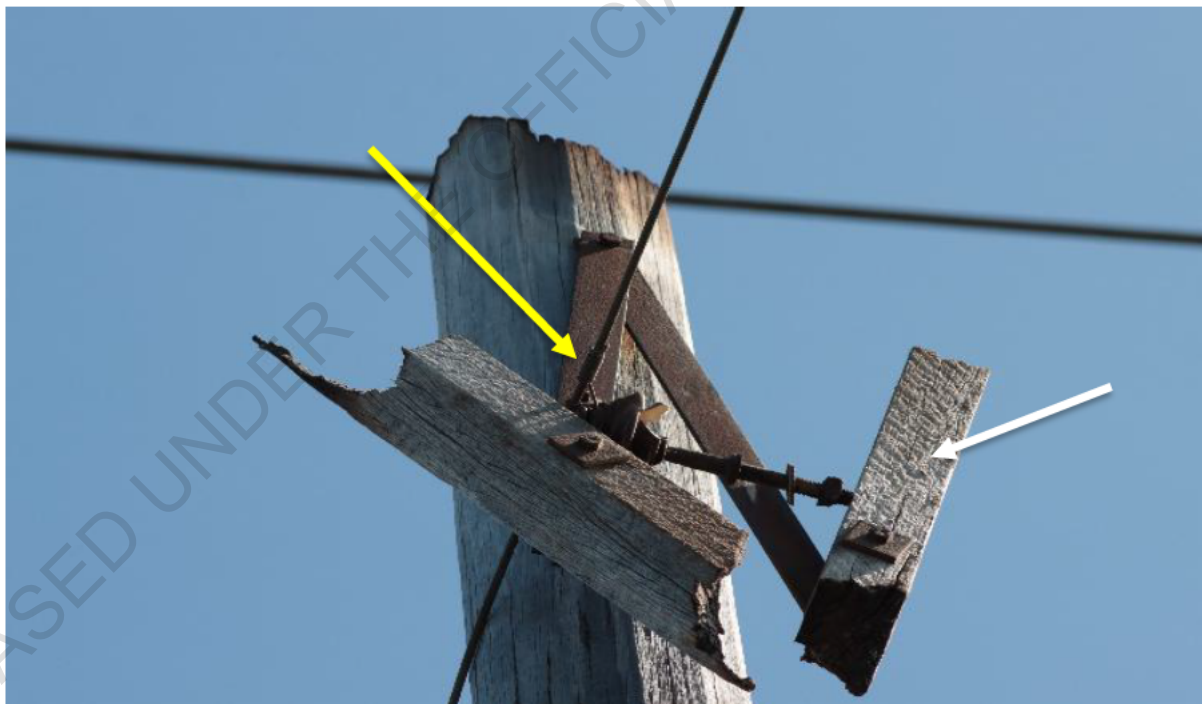
The crossarm had fire damage where it had burnt through the centre of the crossarm and dropped to the side of the pole. The western powerline and its insulator had broken away from the pole and was discovered on the ground. The middle powerline and its insulator remained in place. The east powerline still had the insulator attached but hanging in midair, supported by poles 5 and 7.

Photo 12: Fire damage to crossarm and top of pole. Yellow arrow indicates the middle powerline and insulator, white arrow indicated the damaged crossarm.

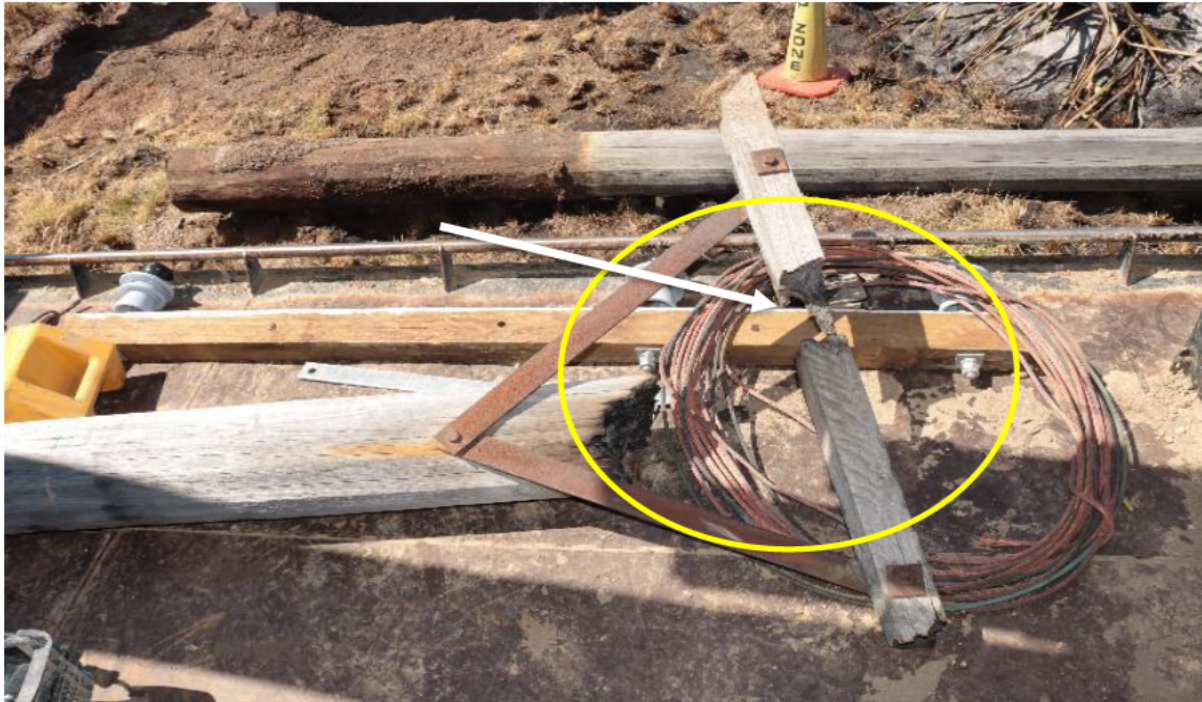
Photo 13: White arrow shows where the fire burnt through the crossarm, yellow circle indicates the burnt away section of the top of the pole.

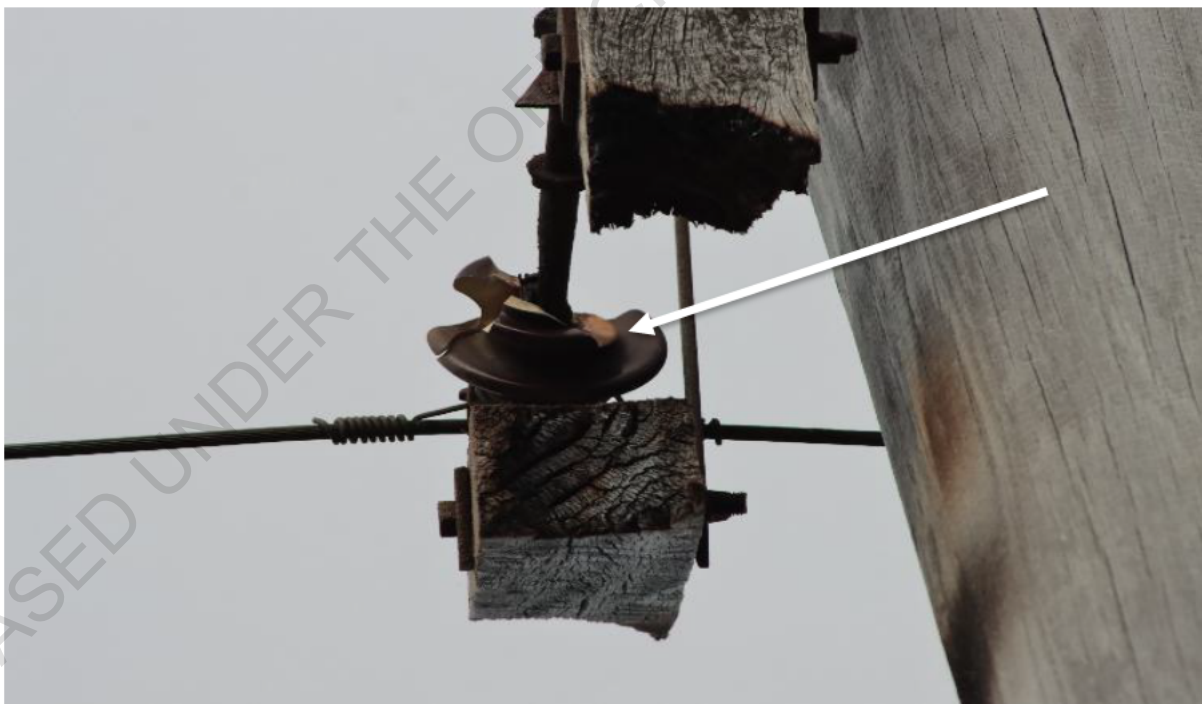
Photo 14: White arrow indicates a damaged insulator still on the powerline. Damaged insulator resulted in a phase to earth fault.

A cracked insulator mounted in the centre of the wooden cross arm has enabled the high voltage current to flow to earth through the pole causing a phase to earth fault, the high resistance of the wooden pole has produced extreme heat igniting the timber cross arm.

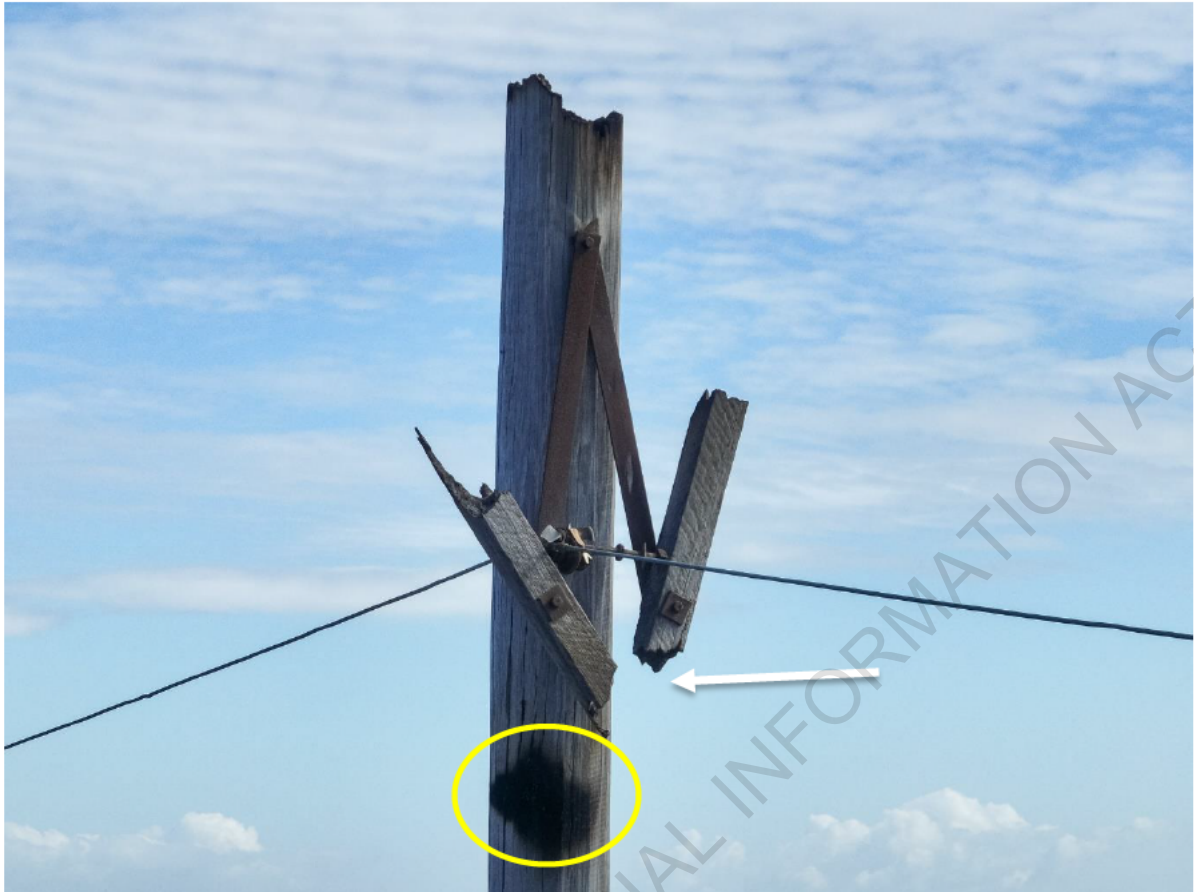
Photo 15: Yellow circle shows where a powerline was striking the power pole after the crossarm broke. White arrow shows burnt away tips of the crossarm.

Once the crossarm had burnt through it dropped allowing the live powerline to strike the pole and tips of the crossarm.

With the live line striking the pole, electricity has flowed to earth creating significant heat igniting the tips of the crossarm and burning the pole.

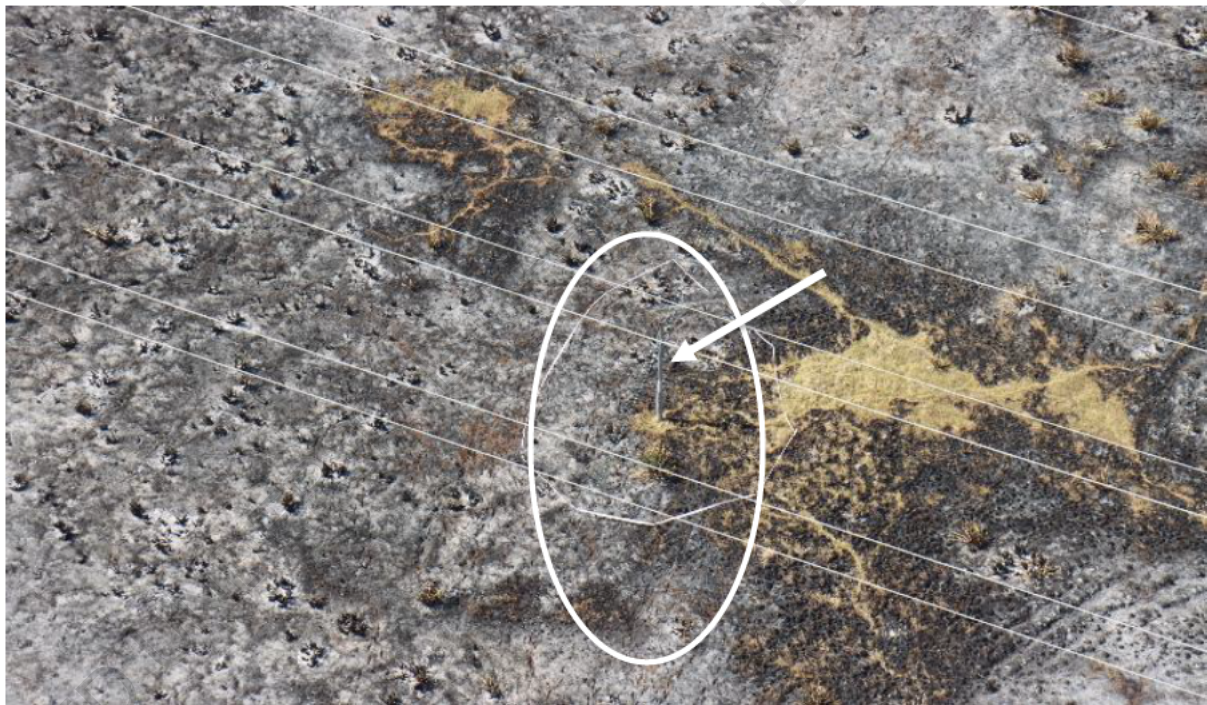
Investigators reduced the specific origin area down using fire directional indicators, supported by CCTV footage to identify the ignition area to be around pole 6. Fire damage to the top of pole 6 also support this being the ignition area.

Photo 16: White circle shows the ignition area, white arrow indicates pole 6.

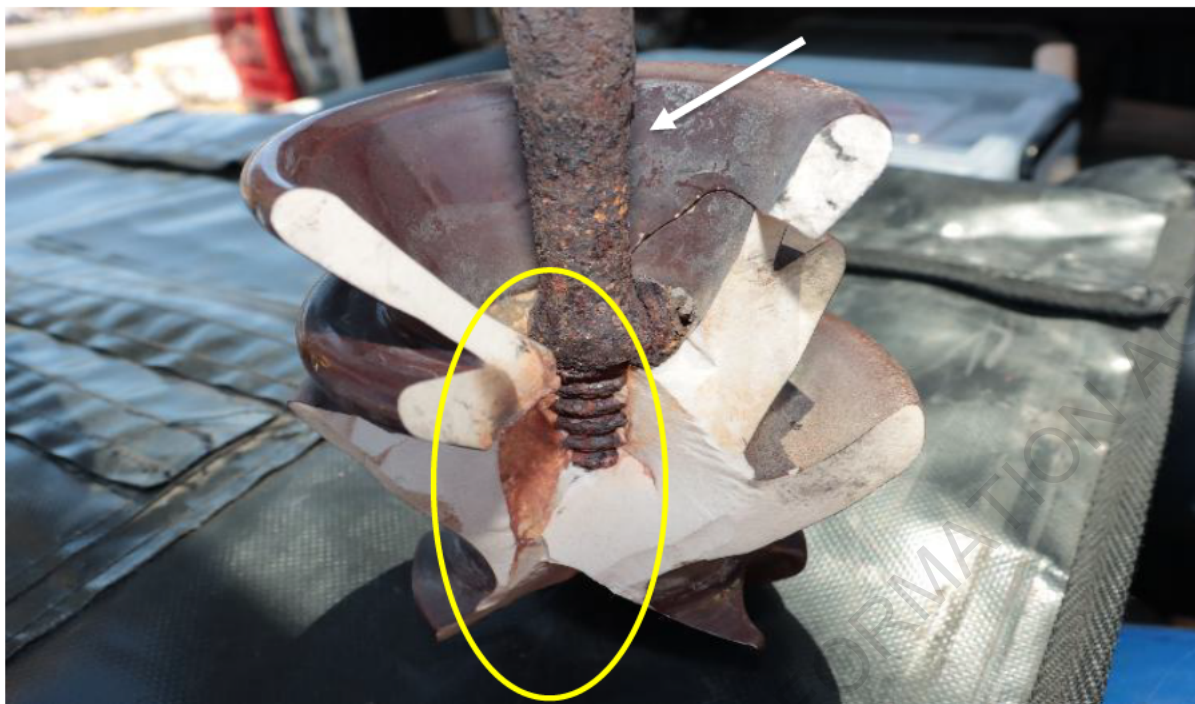
The initial ignition of the pole was caused by the phase to earth fault created by the cracked insulator allowing power from the 11kV line to flow to earth. Wooden poles are not very conductive so with electricity trying to flow to earth through the pole there is a very high resistance that creates substantial heat. With the area being close to the sea insulators can be covered in impurities such as dirt and salt.

With a high RH on the night these impurities would have become more conductive creating an easier path to earth, through the cross arm to the pole. The second ignition source was the electrical fault that occurred once the cross arm burned through allowing a live line to contact the pole eventually breaking falling onto the ground. Two other phases remained in the air contacting each other causing an electrical arc spraying out hot molten metal.

Photo 17: Damaged insulator, white arrow indicates the degraded steel pin, yellow circle shows the staining to the ceramic insulator indicating electrical leakage.
