FIRE INVESTIGATION REPORT

2 College Hill, Freemans Bay, Auckland, 1011

F4235145

Melville, Colin, Fire Investigator

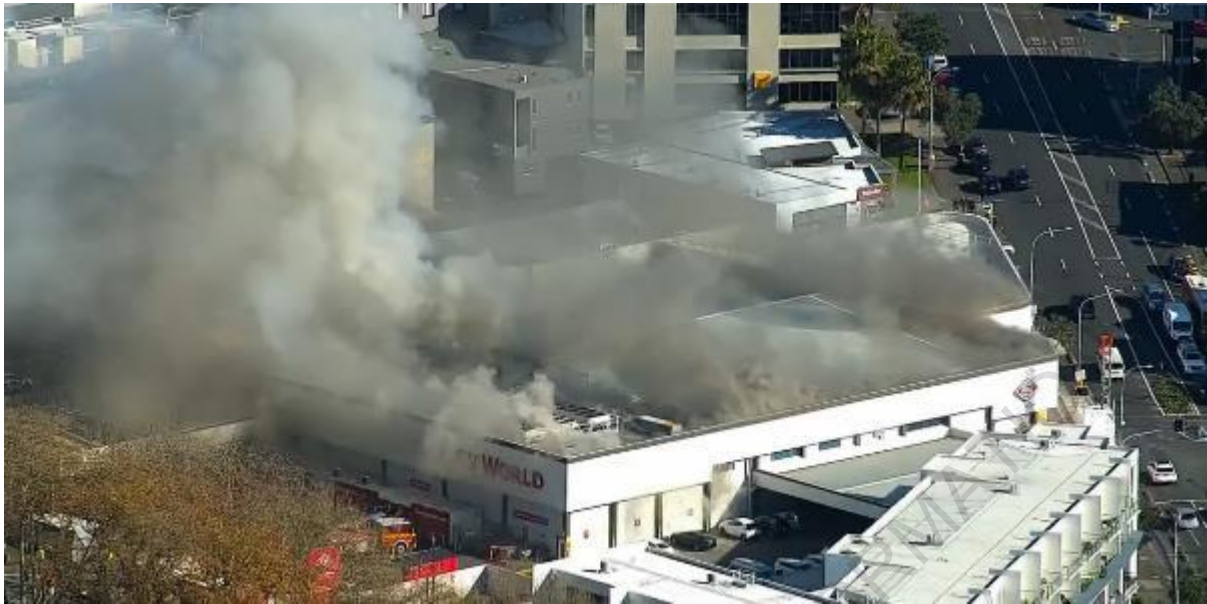
Image Number 4; (ATOC camera image). Upon arrival of the first fire appliance, (Auckland 207) at 11:23 a.m., the mezzanine floor and roof area of the supermarket were found to be well involved in fire.

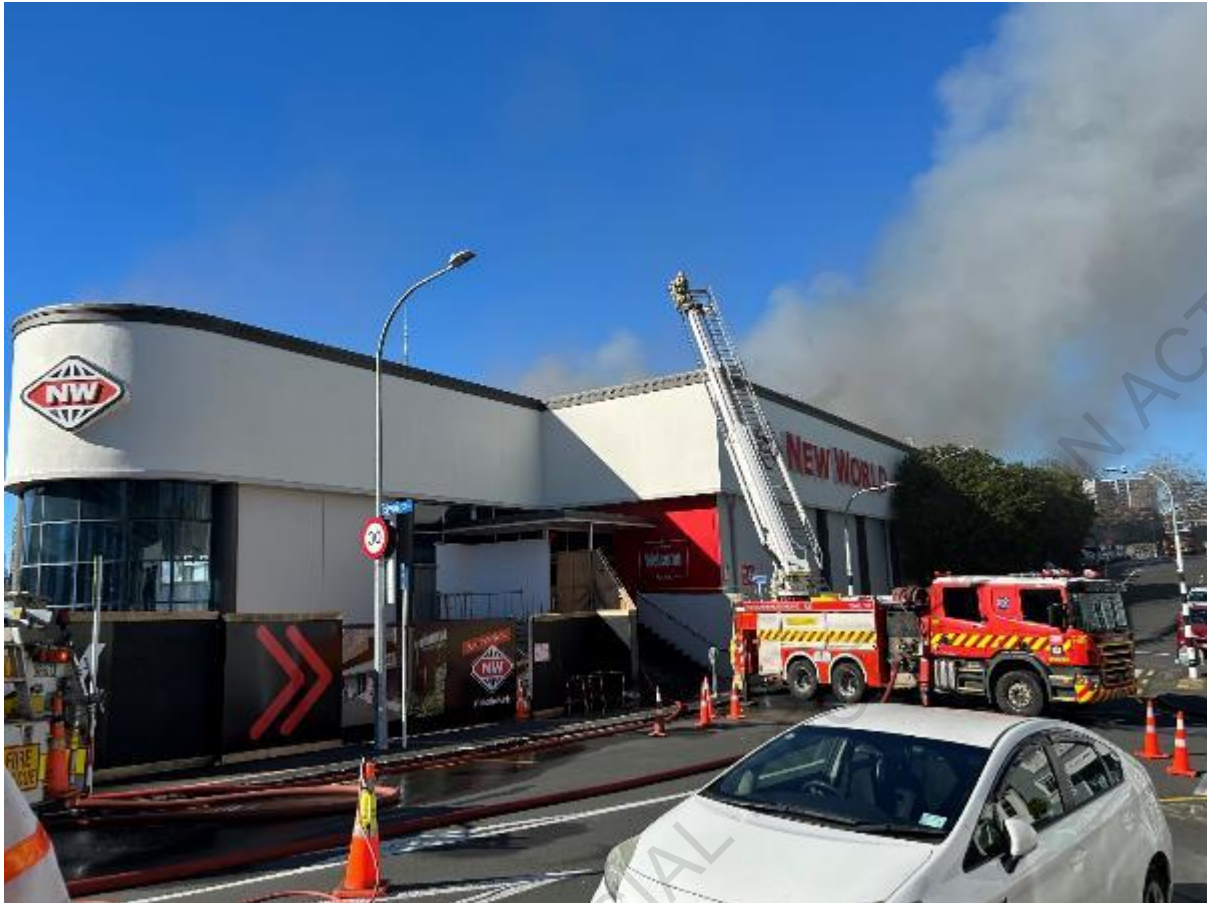
Photograph Number 5: West profile, (Scotland Street) side

The west profile, (Scotland Street) side had some smoke staining, however the exterior wall, glass within the windows and the doors leading into the supermarket's retail area had remained intact. The aluminium window and door frames were also undamaged.

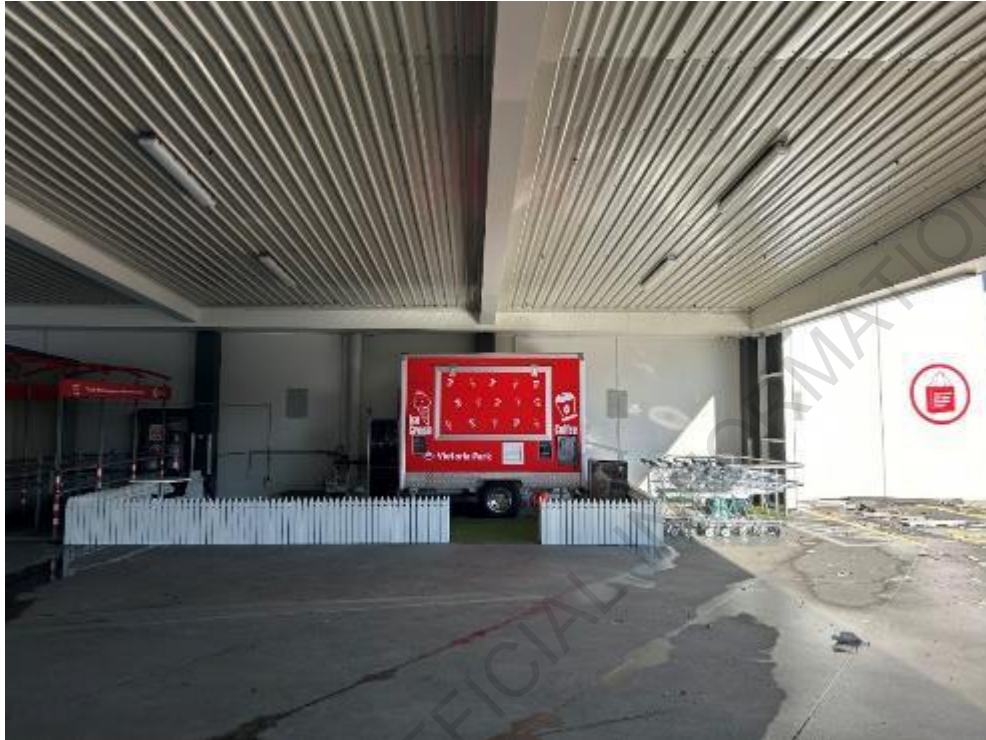
Photograph Number 10: Food caravan on the carpark level, north profile of the building undamaged by the fire.

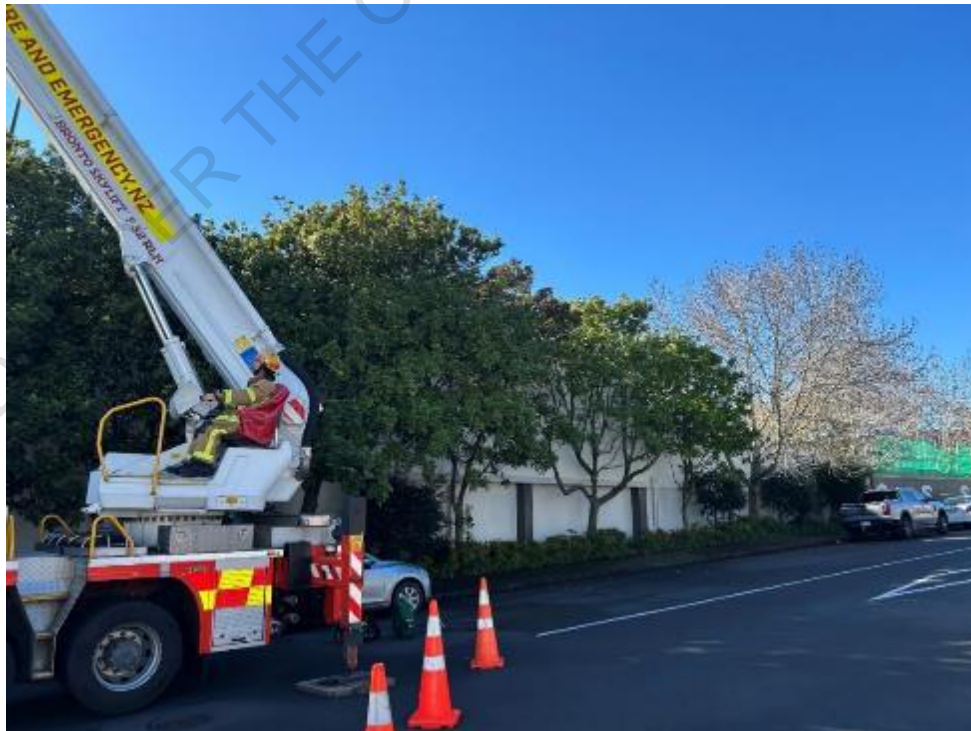
Photograph Number 15: The exterior, south profile.

The exterior, south profile of the building was undamaged by the fire.

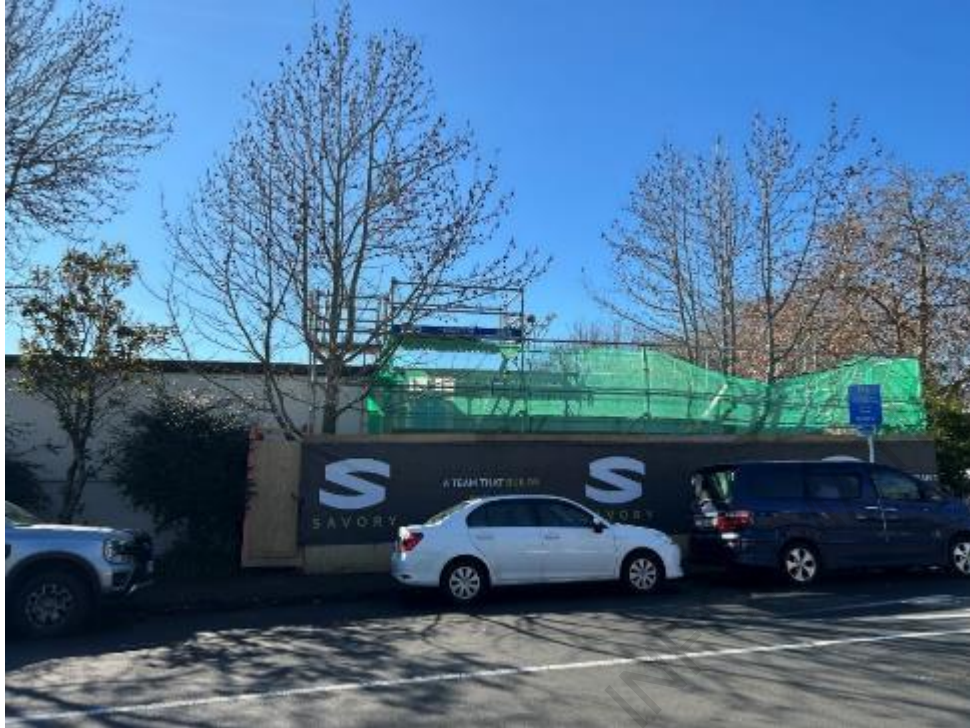
Photograph Number 16: The exterior, south profile of the building was undamaged by the fire.
