FIRE INVESTIGATION REPORT

87-93 Wellesley Street West, Auckland Central, Auckland

F2866954

Report completed by:

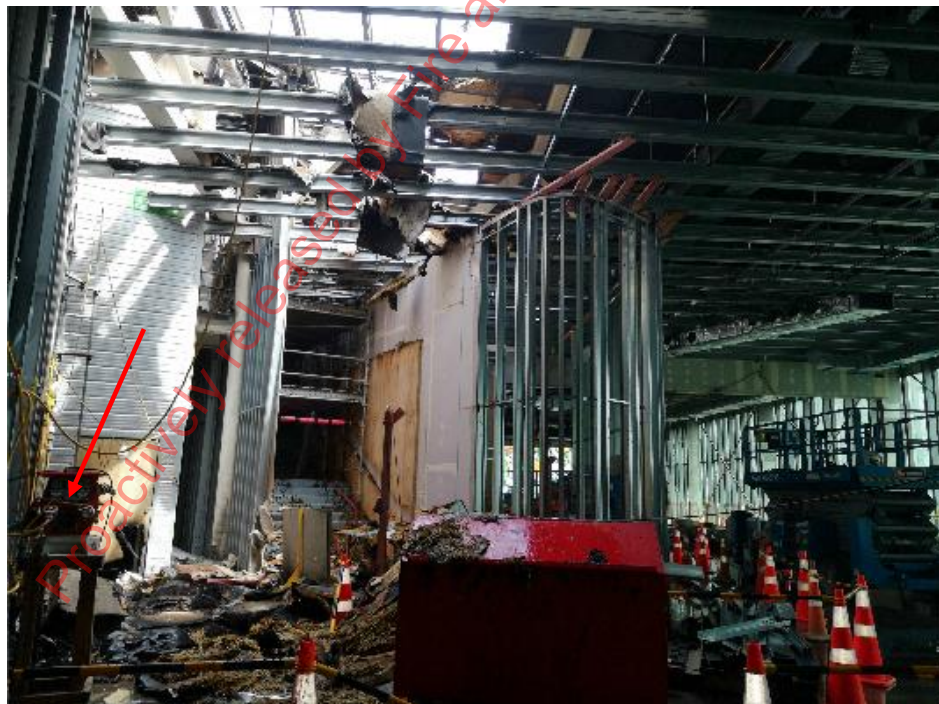
Examination of western side of Level 5 showed considerable fire damage in the ceiling and some fire damage from drop down⁹ burning as evidenced in Photo 4 below. The lack of combustible items in this area contributed to the limited fire development observed.

Photo 4: Western side of Level 5 showing limited fire damage at floor level other than from burning items dropping down. Largely unburnt remains of Durra Panels® can be seen amongst the floor debris. An electrical distribution box is visible to the left of the photo (red arrow).

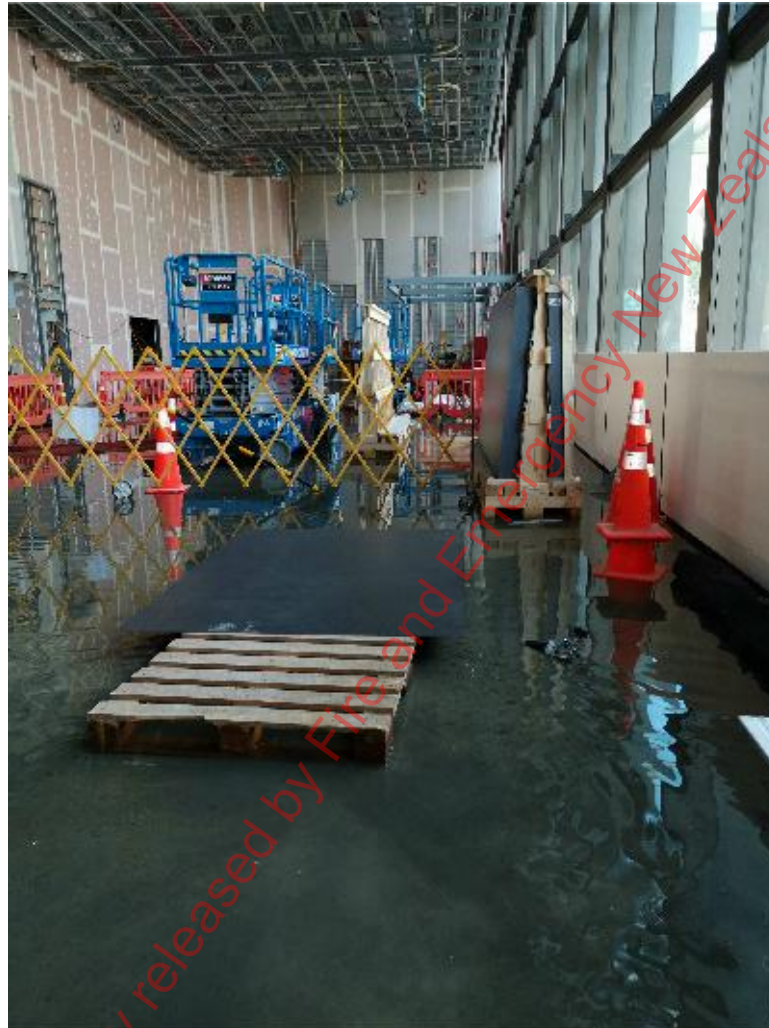
Photo 5: Level 5 south side with no visible fire damage.

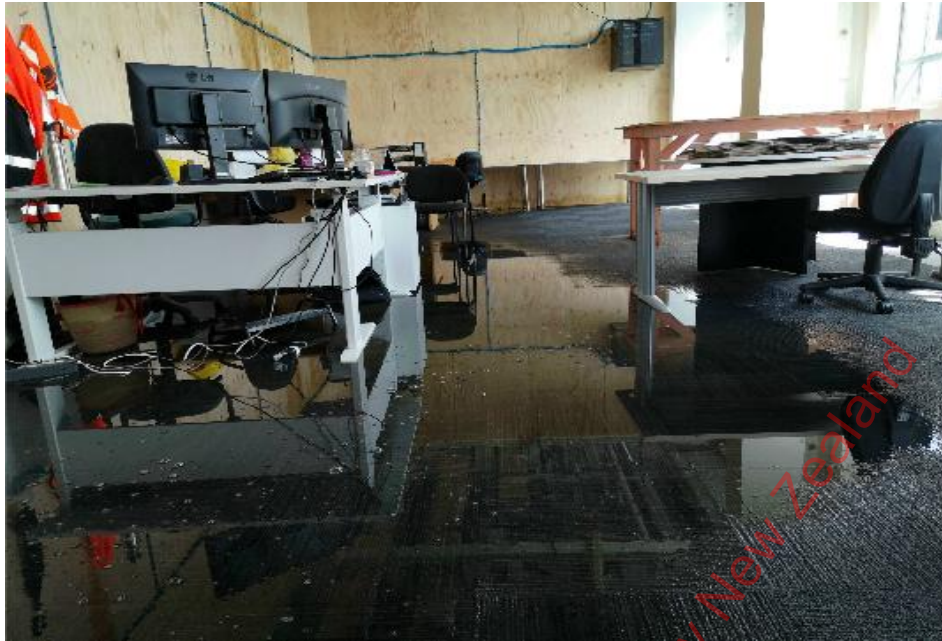
Level 4 and lower floors were examined to ascertain the extent of fire spread in the building. No thermal damage or fire products were observed to have penetrated the Level 5 floor and only firefighting water reached levels below Level 5.

Photo 6: Level 4 showing water damage.

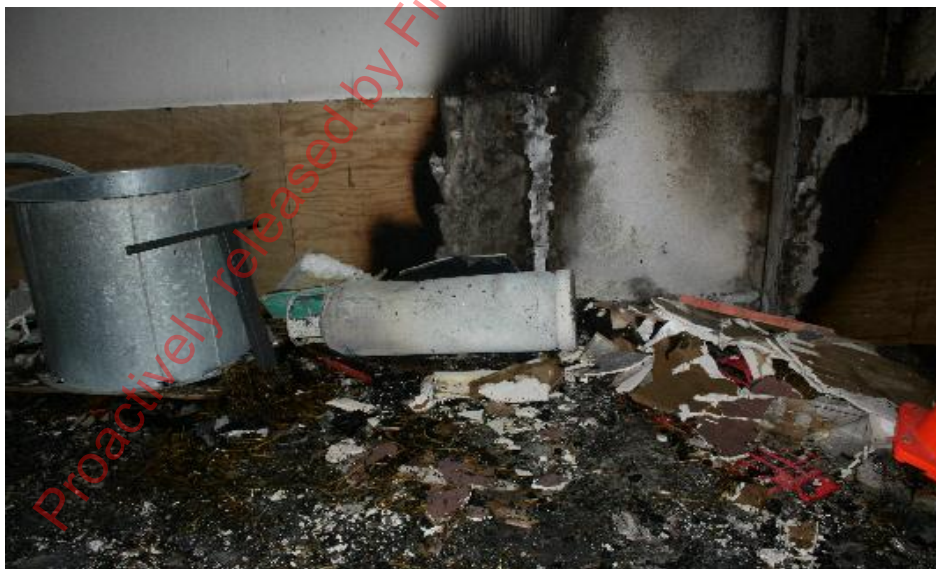
Photo 7: A gas cylinder which has fallen in a mezzanine floor with visible denting on the top side. Venting gas has ignited creating a clearly visible burn pattern on the rear wall.

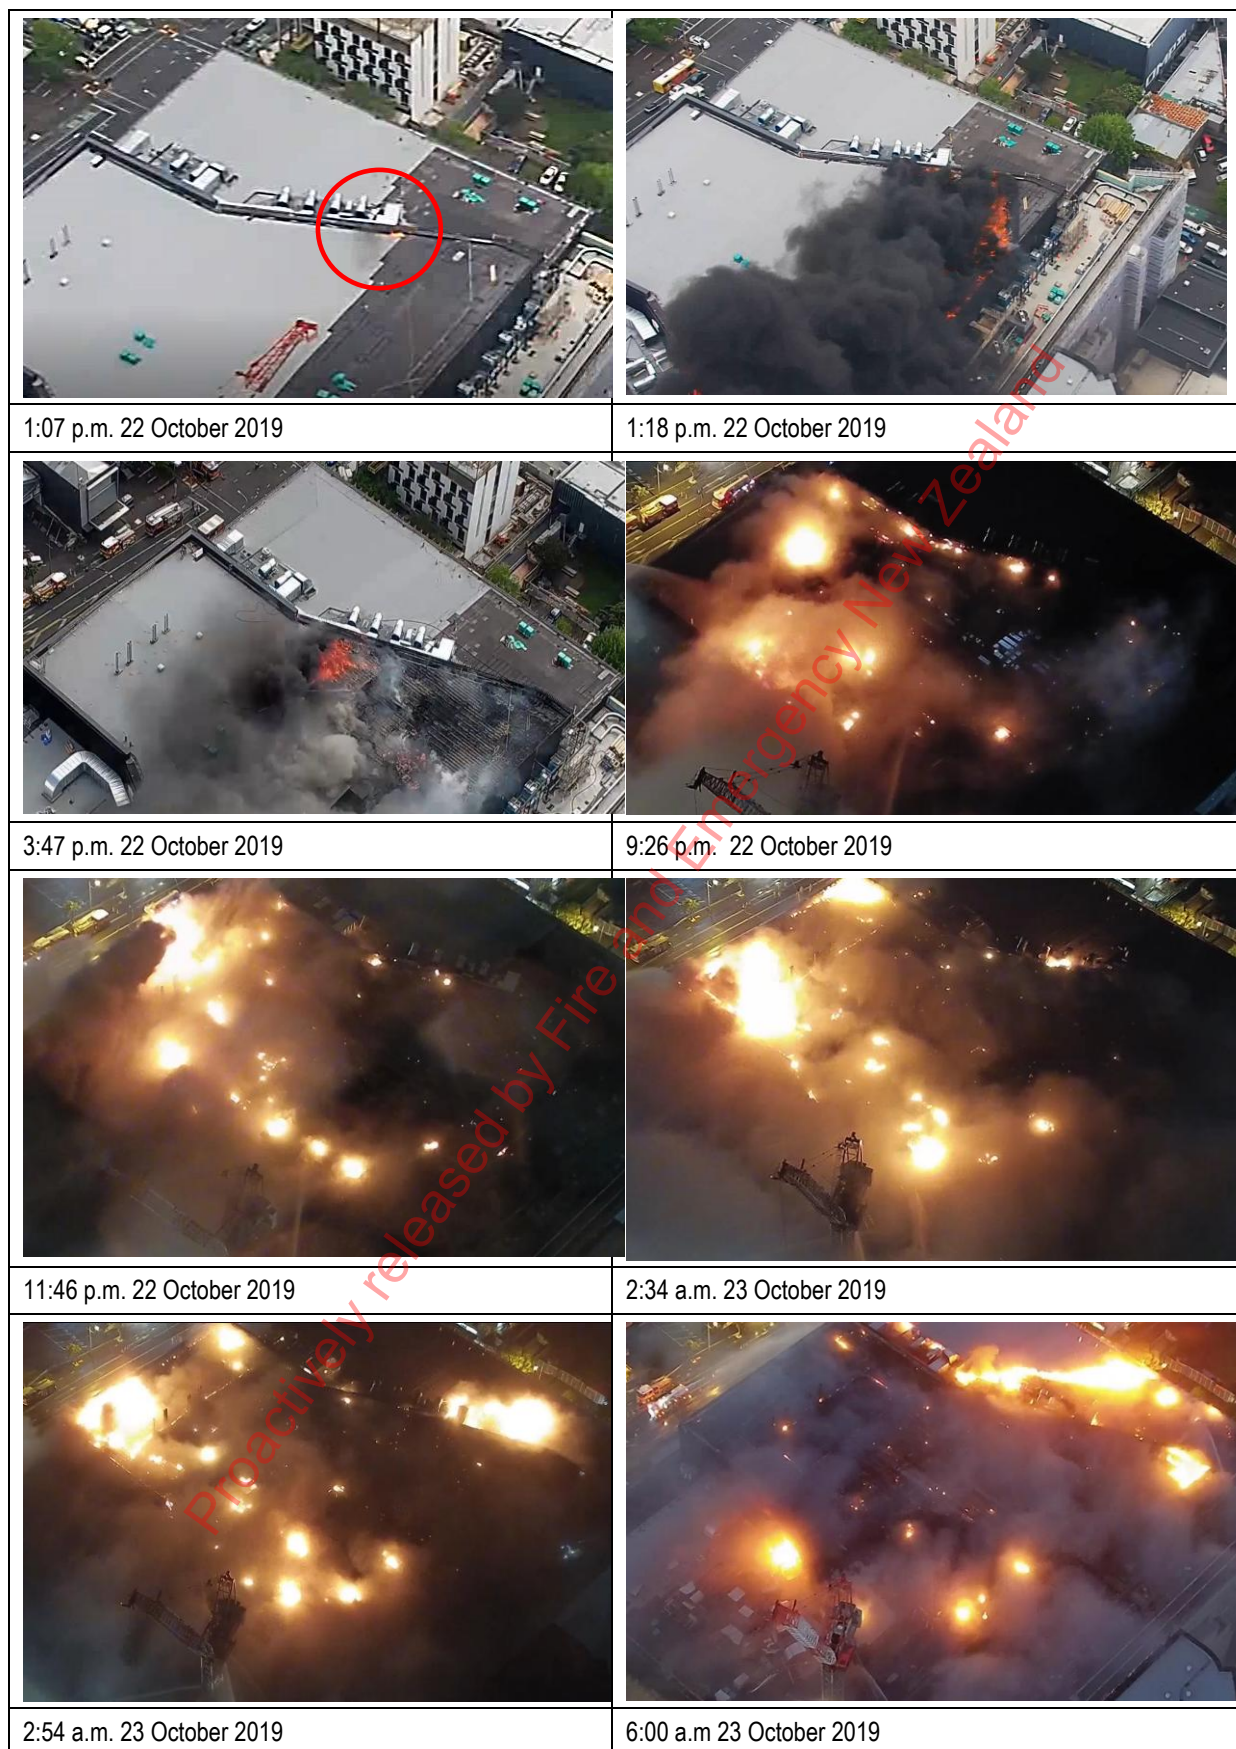
Study of continuous video from the time of discovery of the fire showed gradual progression of the fire towards the south face along the western guttering of Level 7. By 9:26 p.m. on 22 October 2019 fire had reached the southern face closest to Wellesley Street. At 11:46 p.m. on 22 October 2019 the first signs of fire breaking out on the western side of the building on Level 6 were visible, most likely a result of burning materials dropping down from Level 7 and heat transferring through openings in the wall. This wall was constructed of Speed Wall, a non-combustible product with a metal exterior filled and a concrete like centre. Openings in the wall for doorways, air conditioning and other services permitted fire transfer to other parts of the building, notably the plant room.

Photo 9: Progression of fire development. Images taken from video provided by Auckland Transport Operations Centre (ATOC).

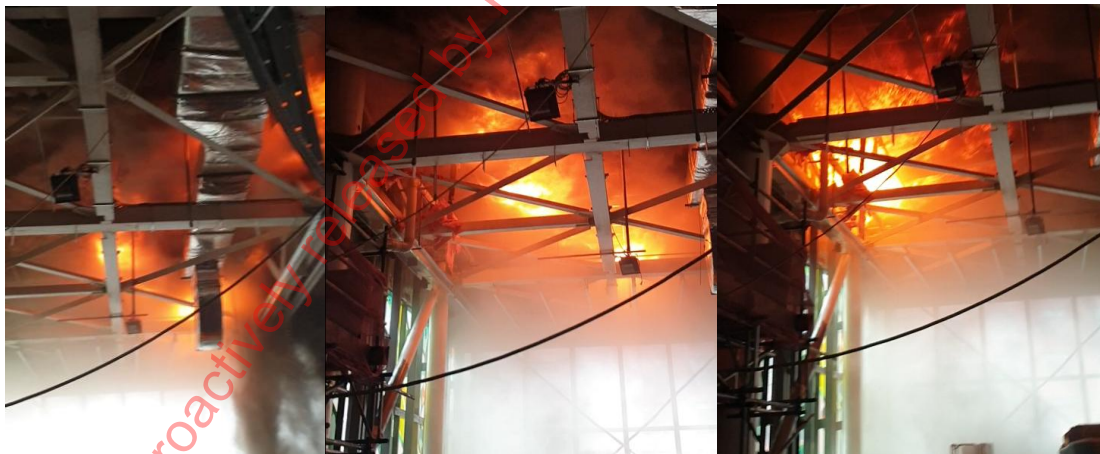
Photo 10: Shows ignition of smoke tracking across the ceiling within a period of 4 s and igniting combustibles several metres away adding to fire spread.

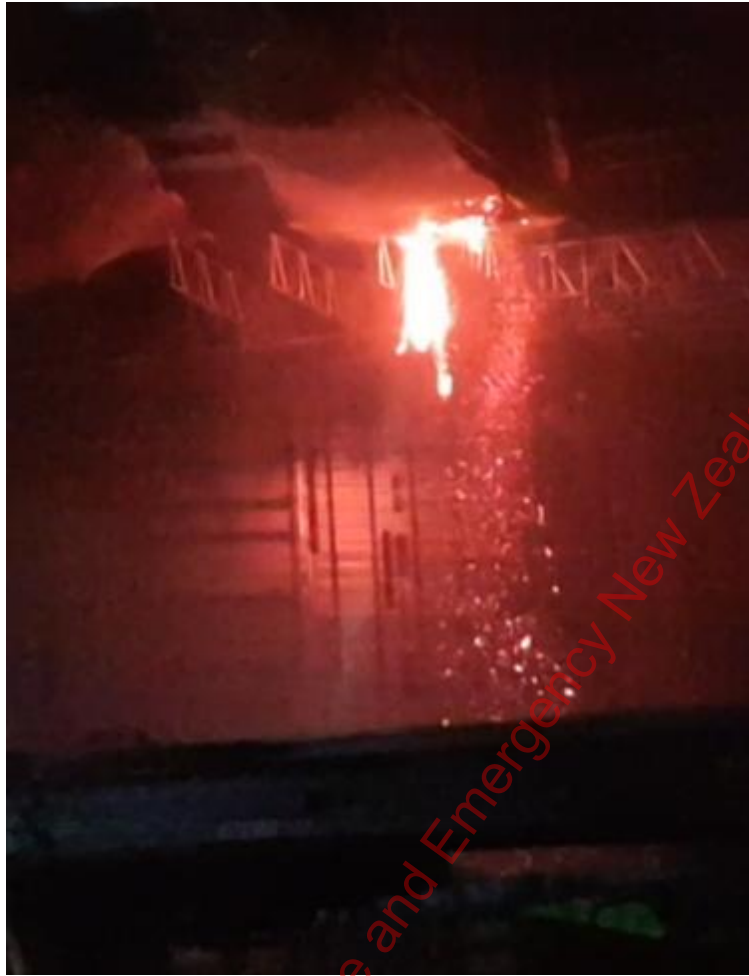
Photo 11: Burning elements within the ceiling construction collapsing on Day 2 providing a mechanism of fire spread to combustibles below.

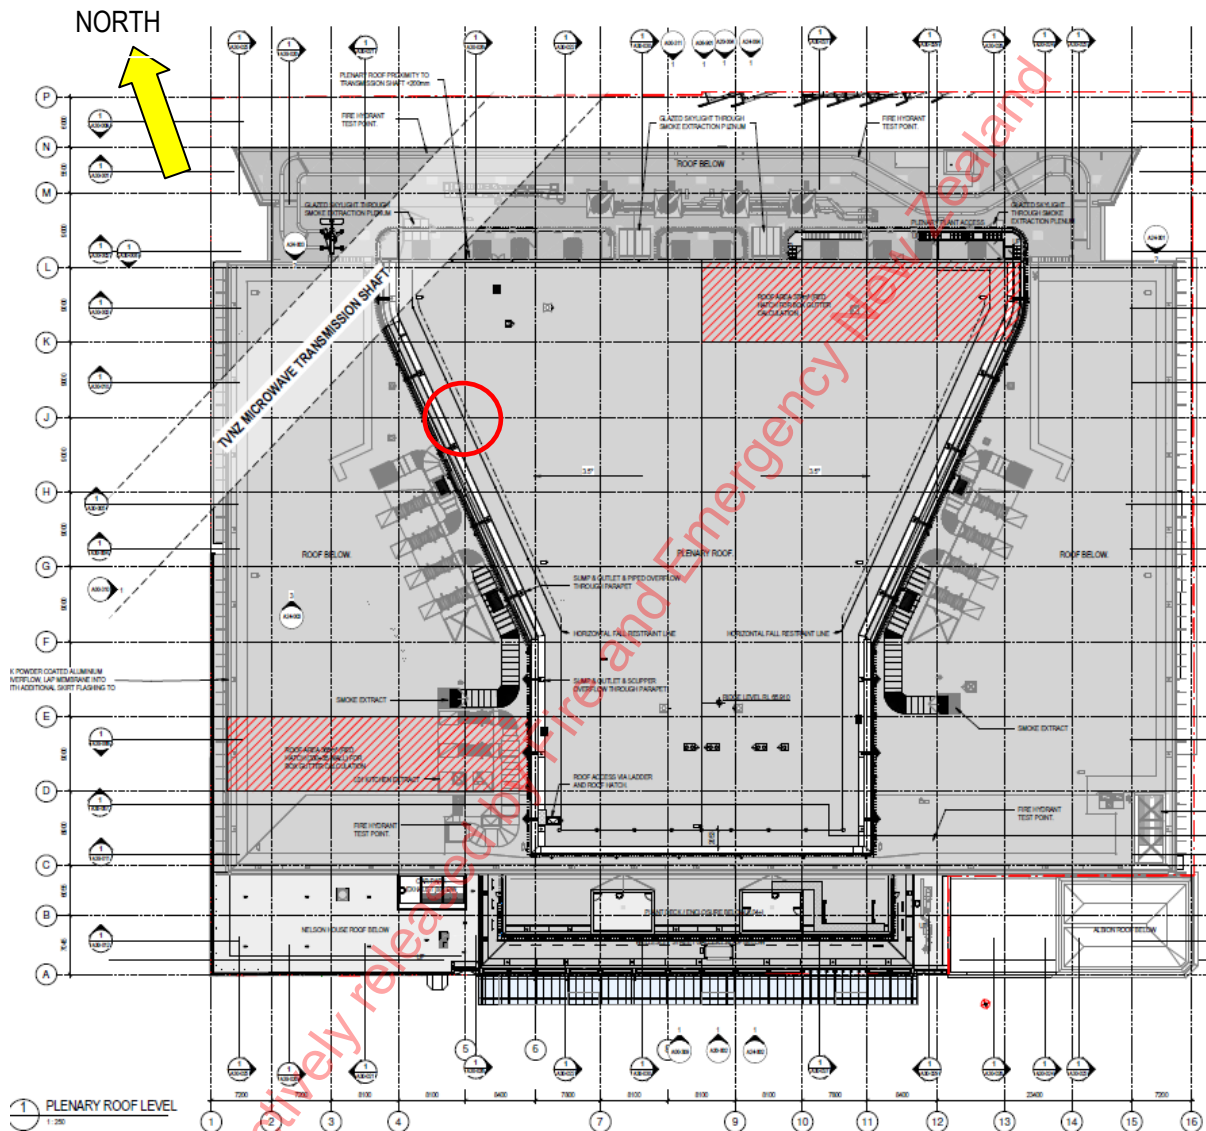
Video footage of the NZICC viewed from the Sky Tower showed the first wafts of visible white smoke appearing near the western edge of Level 7 roof (Grid J- 5) at about 1:03.38 p.m. on 22 October 2019 with intermittent flame visible less than 1 minute later.

Image 3: Approximate location of first visible smoke and flame (red circle).

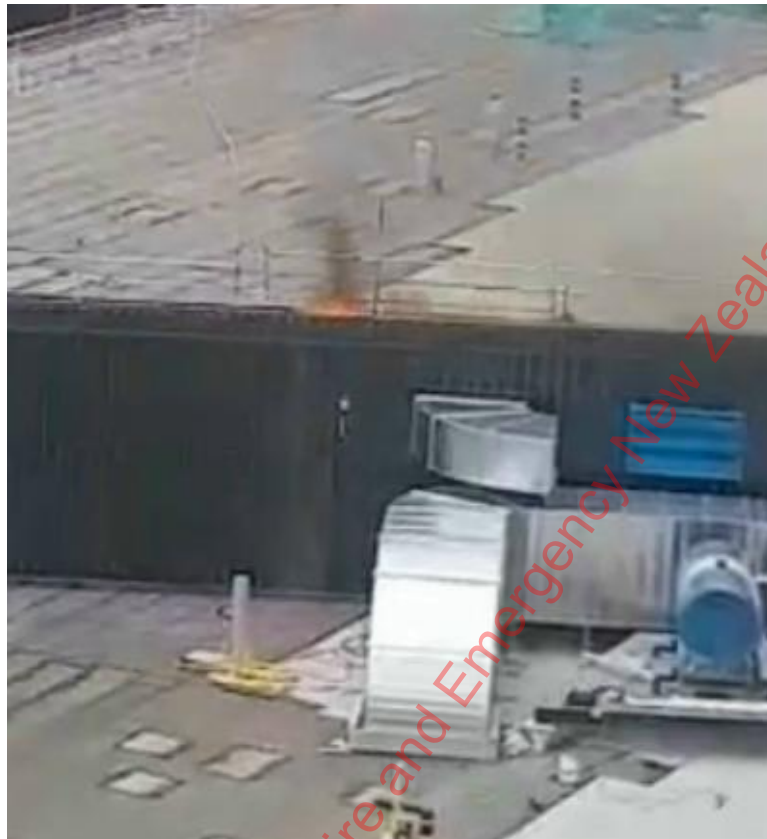
buffeting the flame and smoke, momentary lapses in gusts showed the location of the source of flame to be in the area of the guttering approximately 1-2 m to the left of the large air ducting penetrating the Level 7 western wall.

Photo 12: During a lull in wind gusts (indicated by the vertical smoke position) the flame was clearly visible from the crane located to the west at the Sudima hotel construction site. Photo from witness.

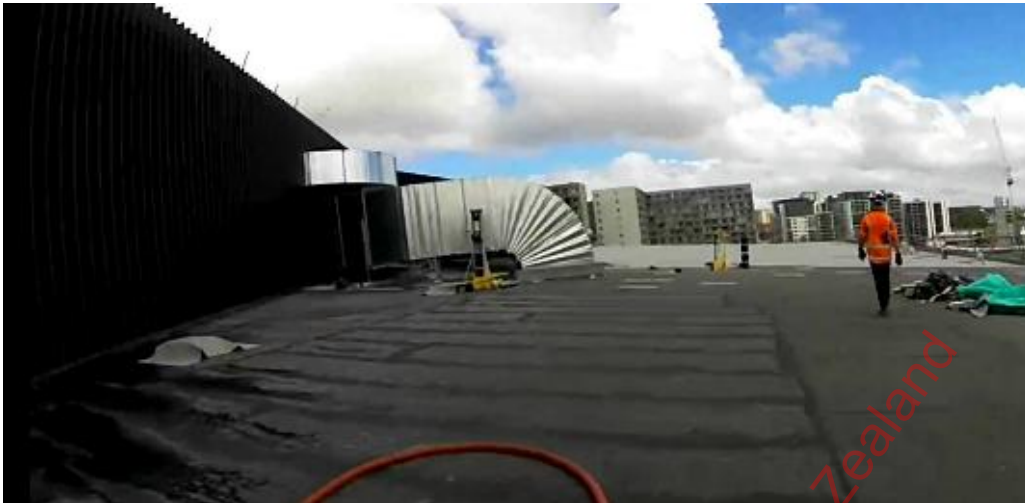
Examination of the Level 6 roof area immediately below where the flame was first observed showed the absence of any fuel packages¹⁴ that could have provided sufficient heat to transfer fire to the height of the Level 7 roof. A fire involving the membrane of Level 6 was ruled out as an initial fuel first ignited¹⁵ due to the absence of smoke or flame that would have been produced from a fire with sufficient thermal energy to transfer fire to the Level 7 roof, some 6 m above it. Video of this area, Photo 13, at 2:23 p.m. on 22 October 2019, 1 hour and 20 minutes after the fire started showed no visible sign of fire at this level.

Photo 13: Western side of Level 6 showing no signs of fire 1 hour and 20 minutes after the fire was first observed on Level 7.

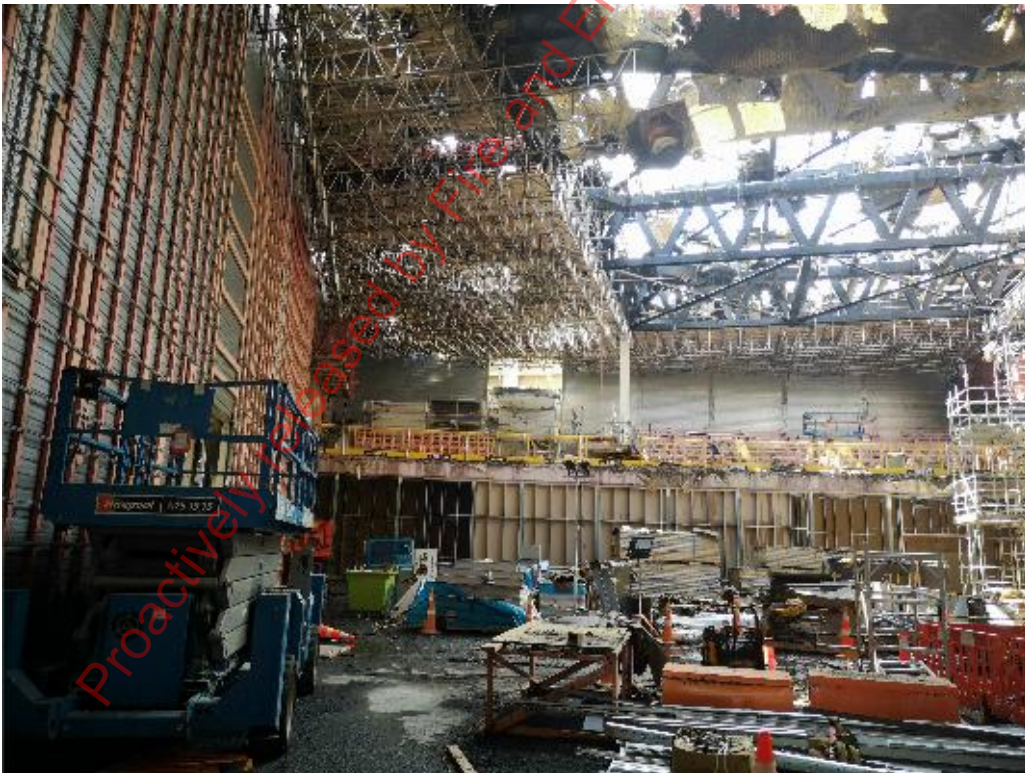
The inside of the Level 7 western wall descended from the Level 7 roof to the atrium floor of Level 5. This area was examined from Level 5 for indications of fire damage and potential for a fire start. Apart from some remote damage caused by drop down, the wall and the immediate adjacent areas were largely free of fire damage.

Photo 14: Level 5 western atrium wall (left) with minimal fire impact. The 'Birds Nest' scaffolding is visible top left under the ceiling.

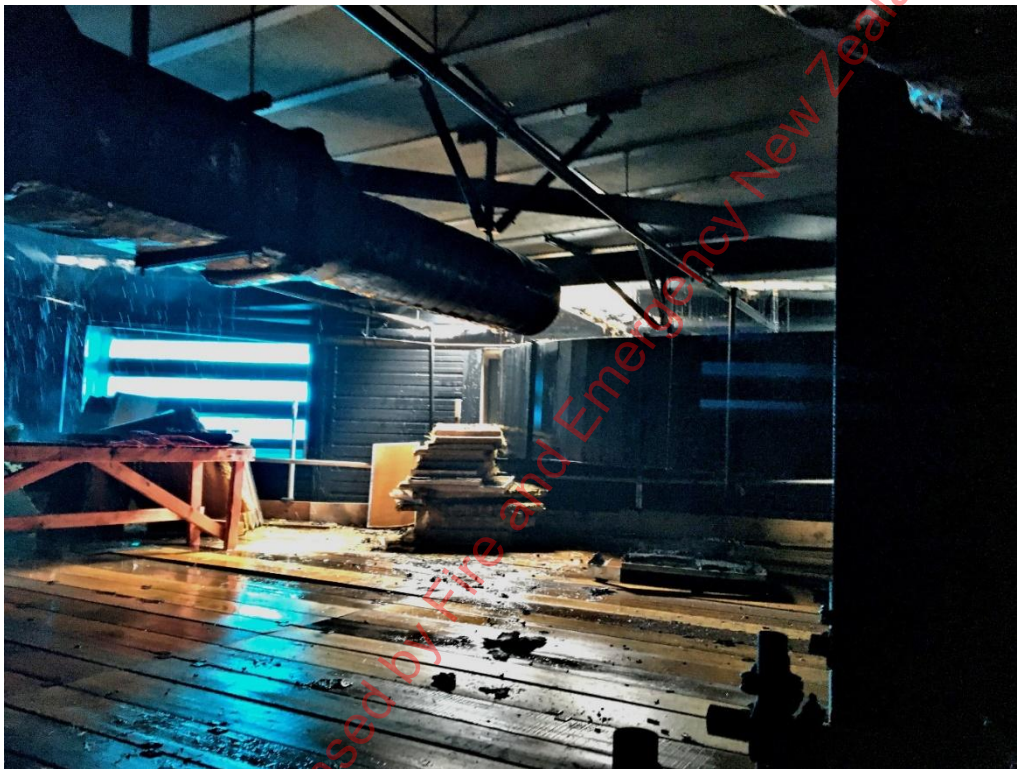
Photo 15: View across the Birds Nest taken approximately 30 minutes after the start of the fire. Visibility was clear and the only fire impact at this stage was from drop down from above. Photo provided by Fletcher Construction.

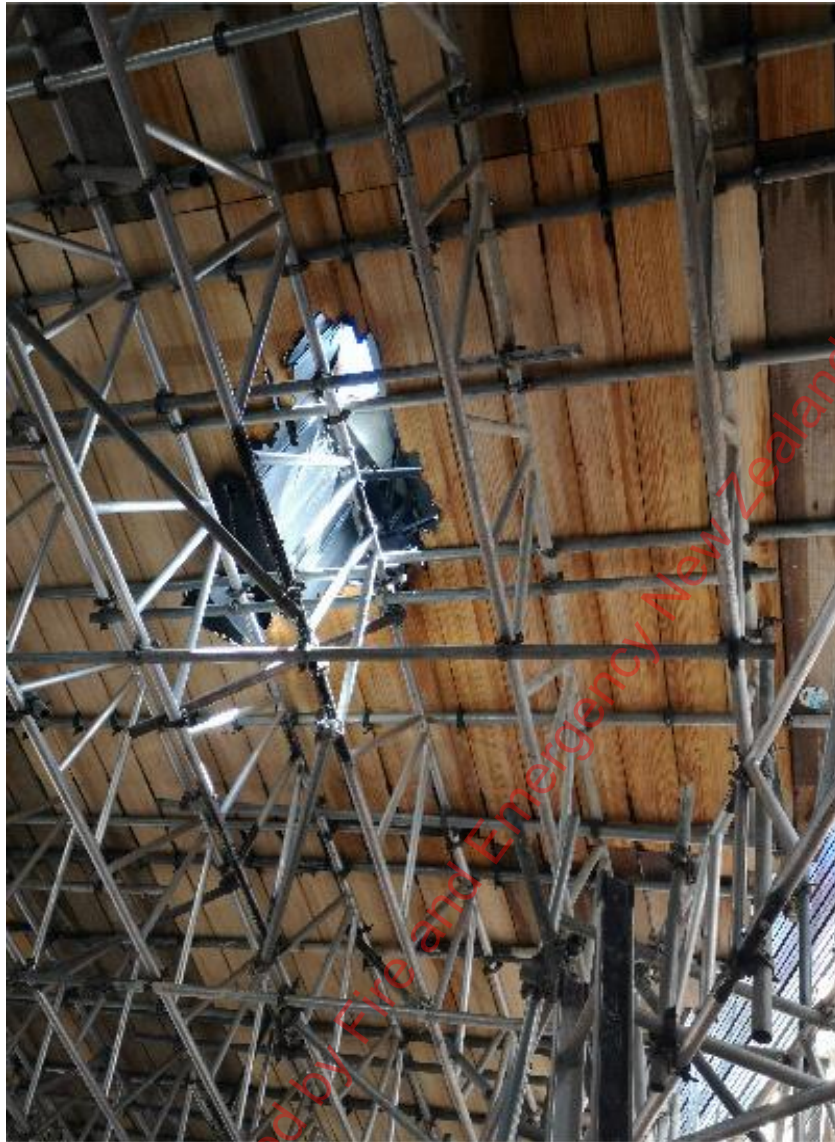
Photo 16: Burn damage to 'Birds Nest' floor caused from burning debris dropping from above the scaffolding floor.

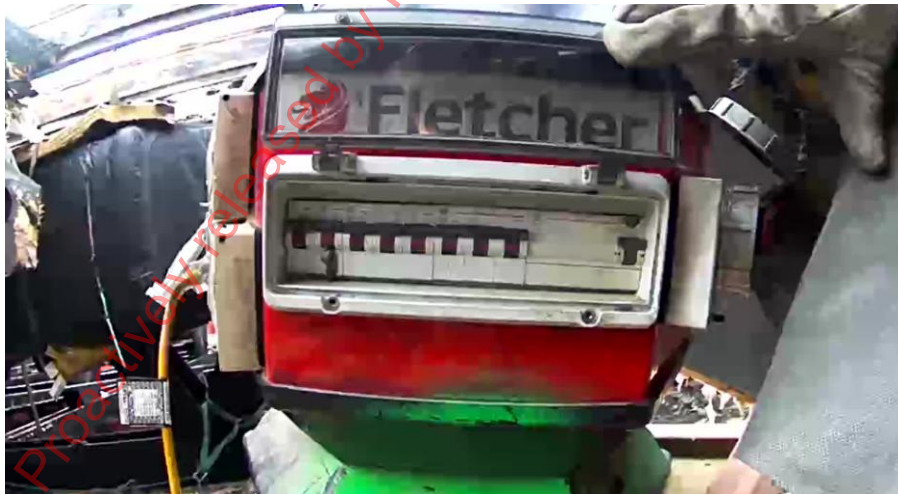
Photo 18: Power box with circuit breakers showing none had tripped.

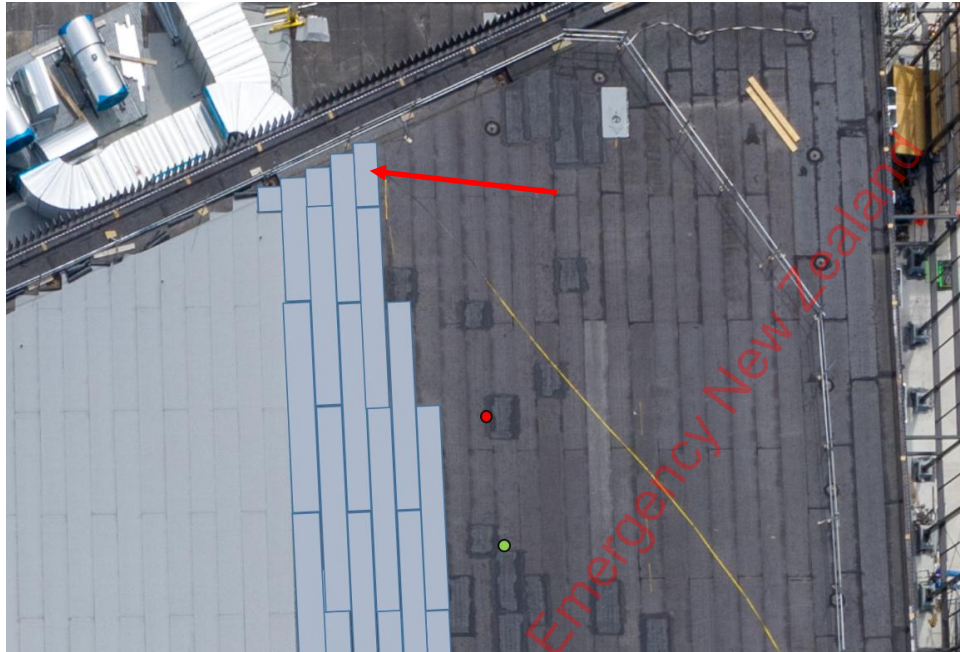
Photo 19: Shows position of the last short length of Cap Sheet laid to the gutter ~12:20 p.m. on 22 October 2019 (red arrow). Location of the 2 gas cylinders marked with red and green circles.
Photo supplied by Fletcher Construction – additions by Fire and Emergency.

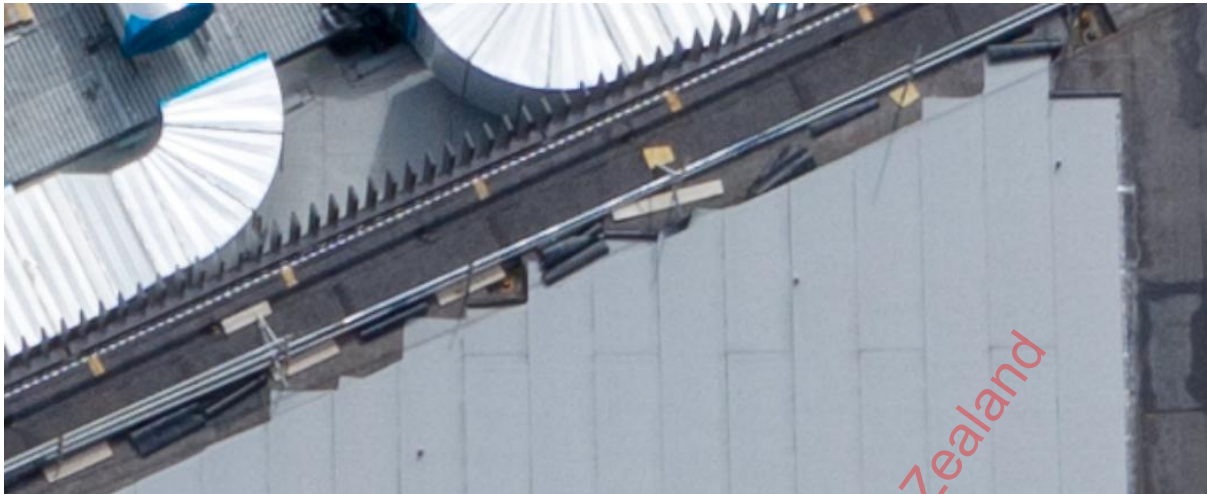
During the morning both workers on Level 7 were laying full lengths of Cap Sheet across the roof and spent various times in the gutter area where the fire was later first observed. As the line of the gutter on Level 7 was on a rake¹⁶ of approximately 30°, each run of Cap Sheet was progressively longer. Full rolls of Cap Sheet would therefore finish short of the gutter and required additional short sections to be installed. The workers could be seen interacting with the gas cylinders and retrieving rolls lying further along in the gutter, presumably the leftover of membrane rolls from earlier runs.

Photo 21: A photo taken 2 days before the fire shows the Cap Sheets laid to the edge of the gutter and residual rolls left lying in the gutter area. Photo supplied by Fletcher Construction.

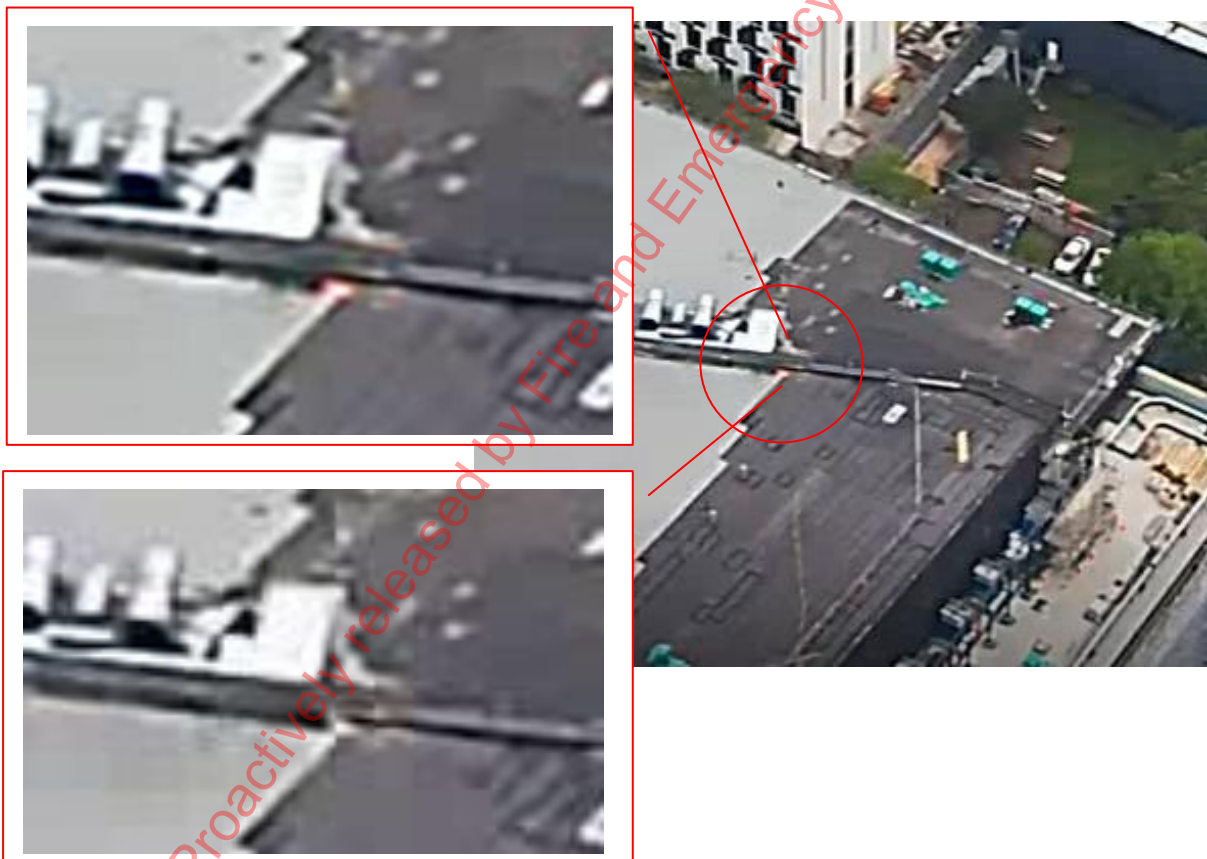
Photo 22: Left top and bottom images show early signs of the fire with a distinct gap between the flame and smoke and the parapet. The shadow of the parapet is visible behind the flame. This suggests the area of origin was in the gutter rather than the parapet area. Video images from ATOC.

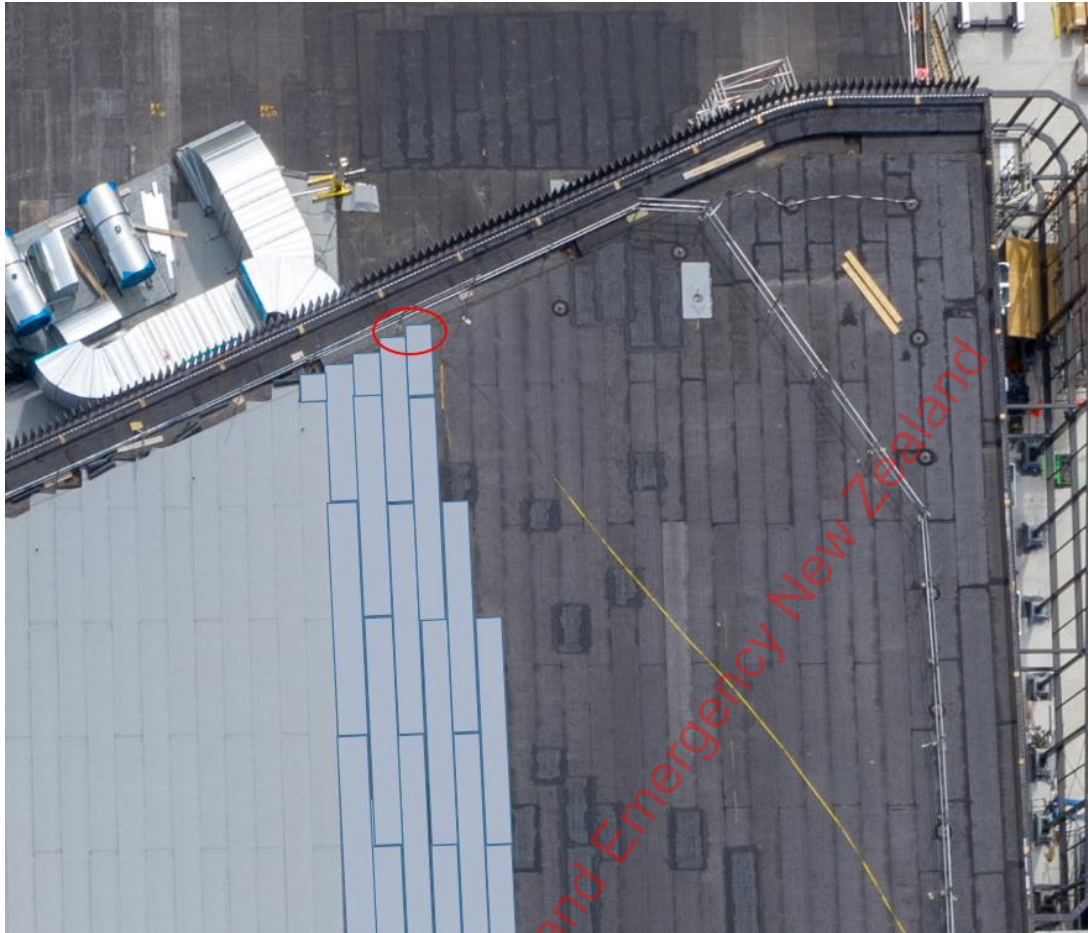
Photo 23: Showing area of origin (red circle). Photo supplied by Fletcher Construction.
Addition by Fire and Emergency.

Within the area of origin, examination of the video footage of the fire in its incipient stage, the fire patterns¹⁹ and thermal impact on the structure reveal the point of origin²⁰ as being in the gutter, about 1.8 m north of the large air conditioning ducting visible in Photo 23.

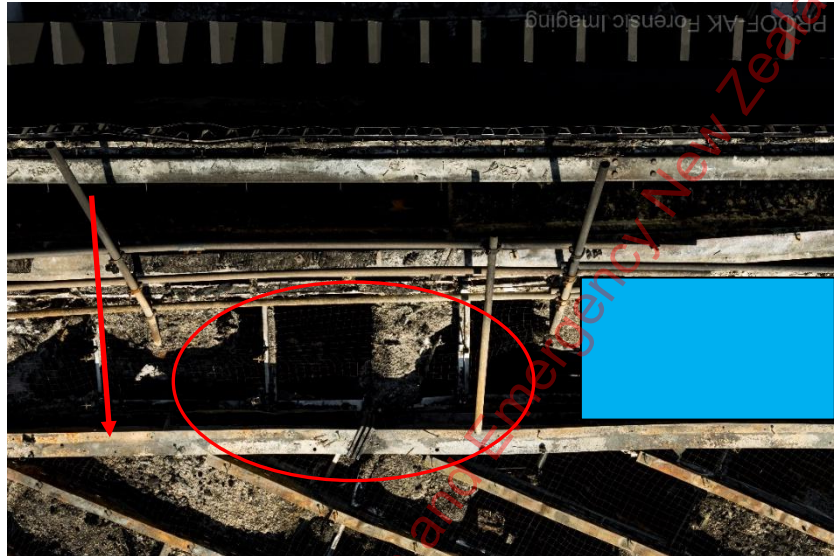
The point of origin is indicated by the red circle in Photo 24.

Photo 24: Photo taken from above. The red arrow points to the steel I beam that supported the eastern side of the guttering at the point of origin (red circle). The approximate position of guttering floor is indicated by blue rectangle.

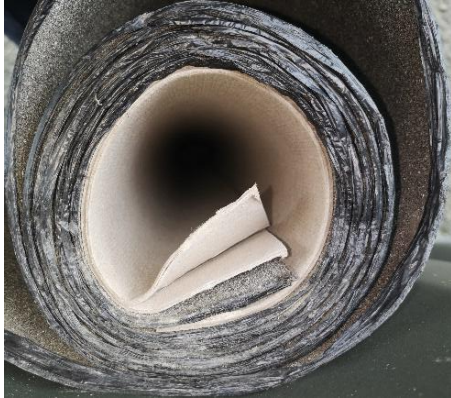
The probable cause³ of this fire is believed to be an inadvertent ignition of the cardboard centre of a roll of waterproofing membrane. The cardboard centre of the roll smouldered for a period of up to 38 minutes

Photo 26: Shows cardboard Centre inside Cap Sheet membrane roll.

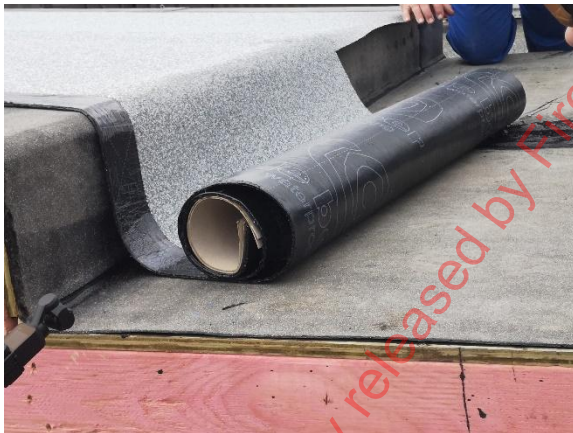
Photo 28: Cap Sheet torched on with residue roll left in gutter initially presenting little evidence of smouldering.

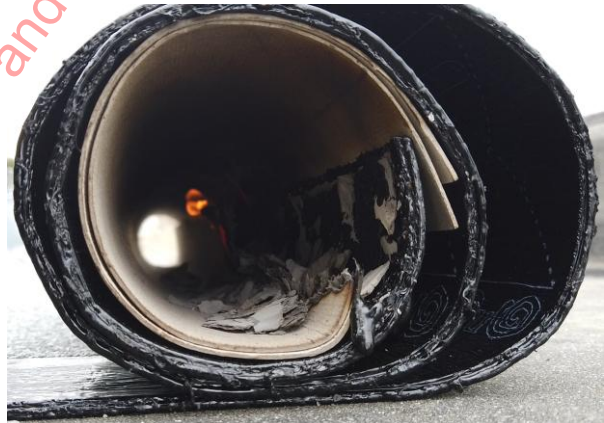
Photo 29: Gradual smouldering tracked inside the roll with occasional flickering flame returning to smouldering.

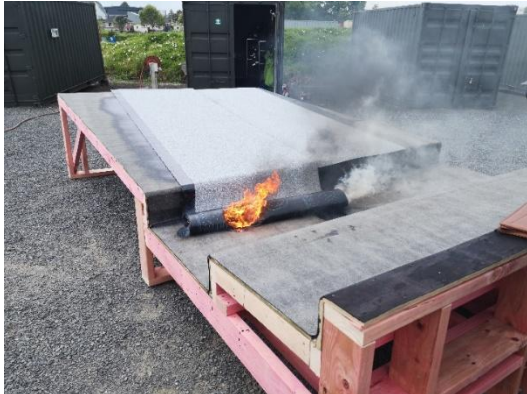
Photo 30: Flame penetrating through membrane on the roll. Notable is the white puffing smoke similar to that observed at the NZICC.

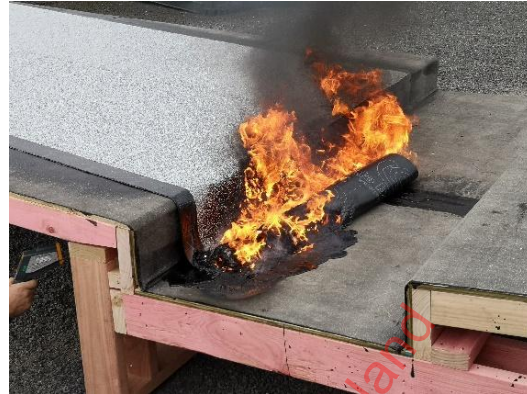
Photo 31: Fire developing beyond the roll to the vertical gutter surface and beginning to extend to the horizontally laid Cap Sheet representing the main roof surface. Smoke is becoming black.

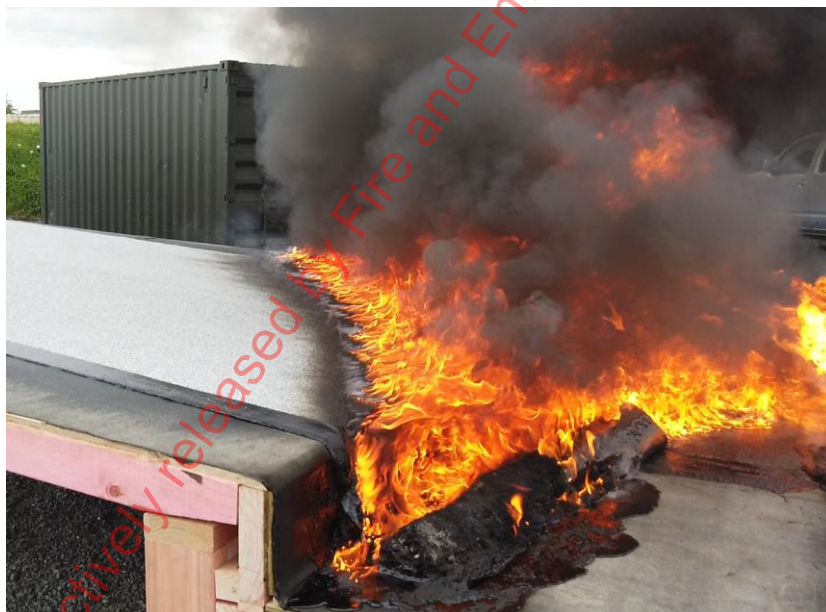
Photo 32: Fire development at 5 minutes 30 s from when only the roll was burning.

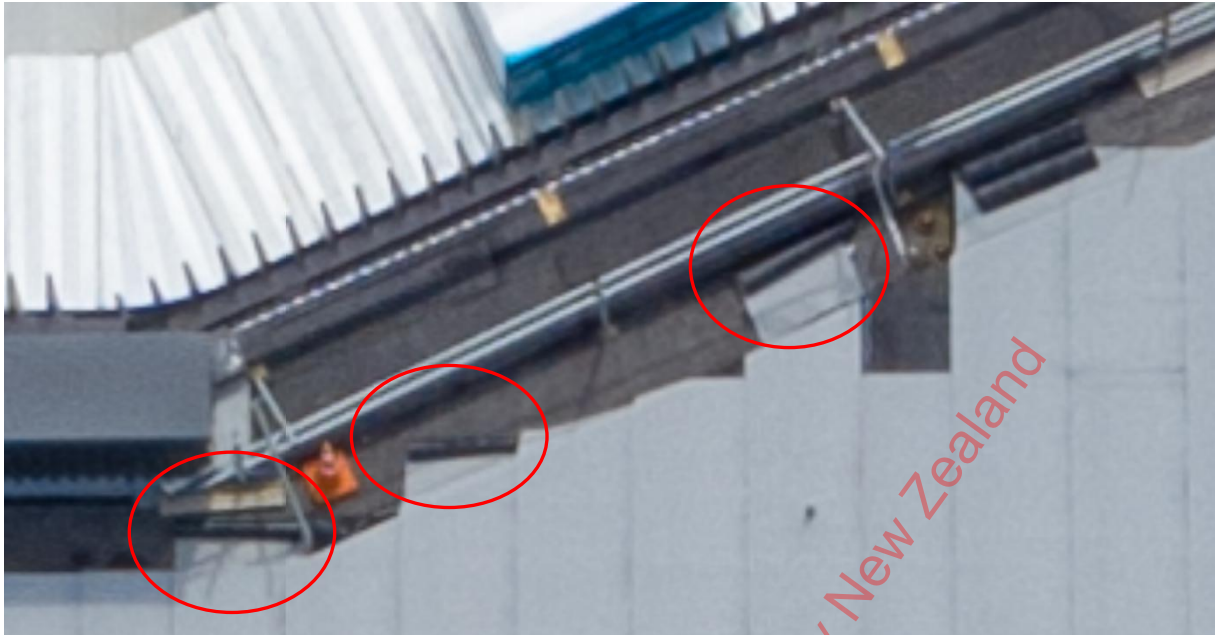
Photo 39: Three examples of residual rolls appearing to be still joined to laid Cap Sheet.

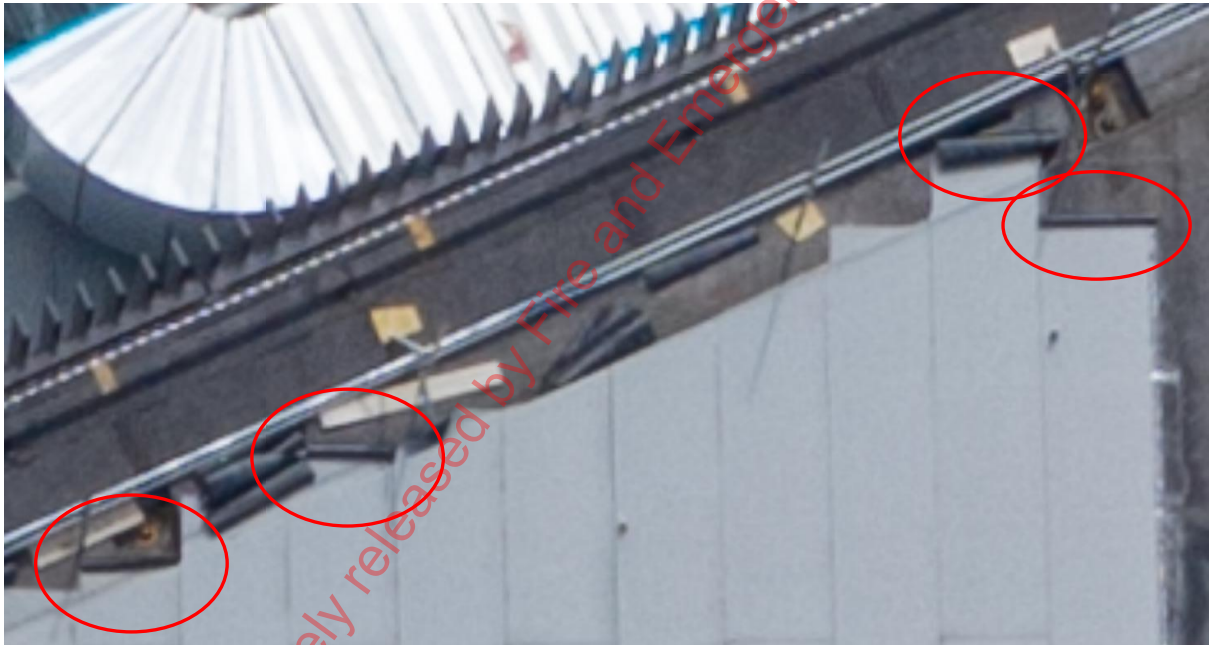
Photo 40: Four examples of residual rolls appearing to be still joined to laid Cap Sheet.

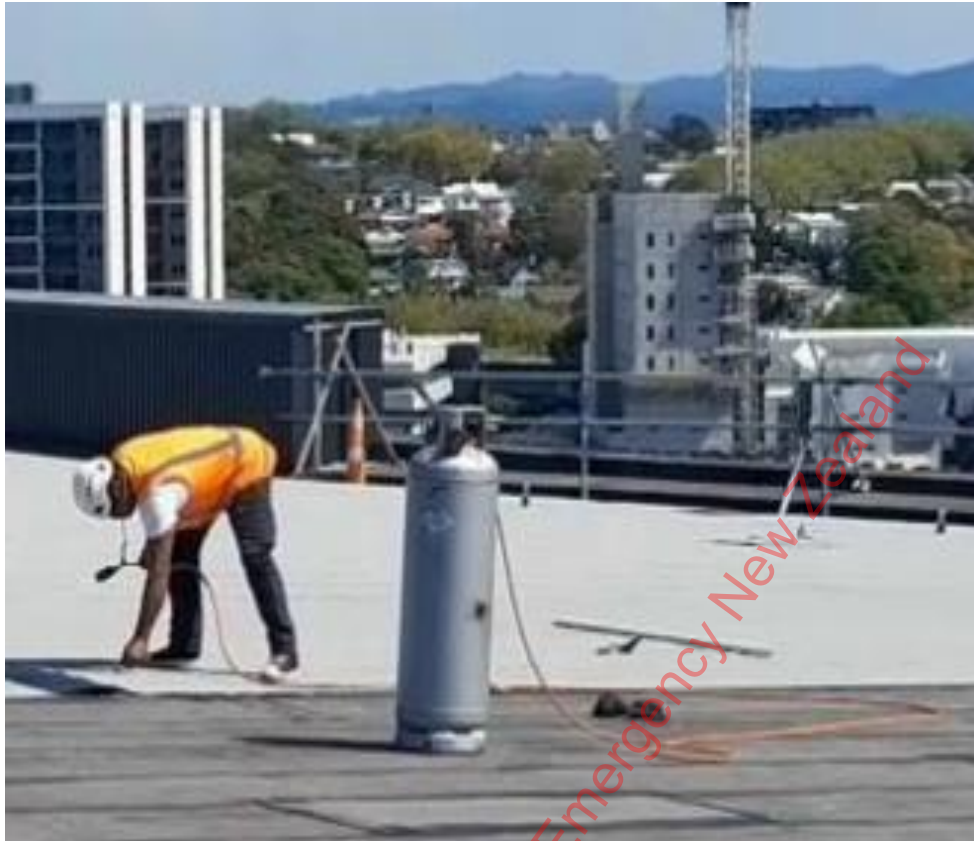
*Photo 45: Shows an un-tensioned gas hose falling slack beside
A gas cylinder and slack in the hose on the ground. Photo provided by Worksafe.*

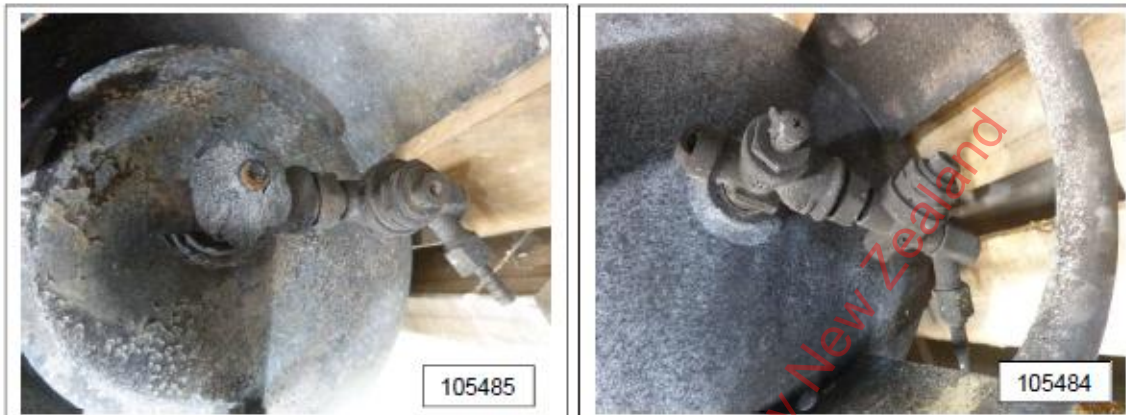
Figure 4: Valves of both cylinders in as found condition
