FIRE
EMERGENCY

The Lake Ōhau Fire

A Summary of Events

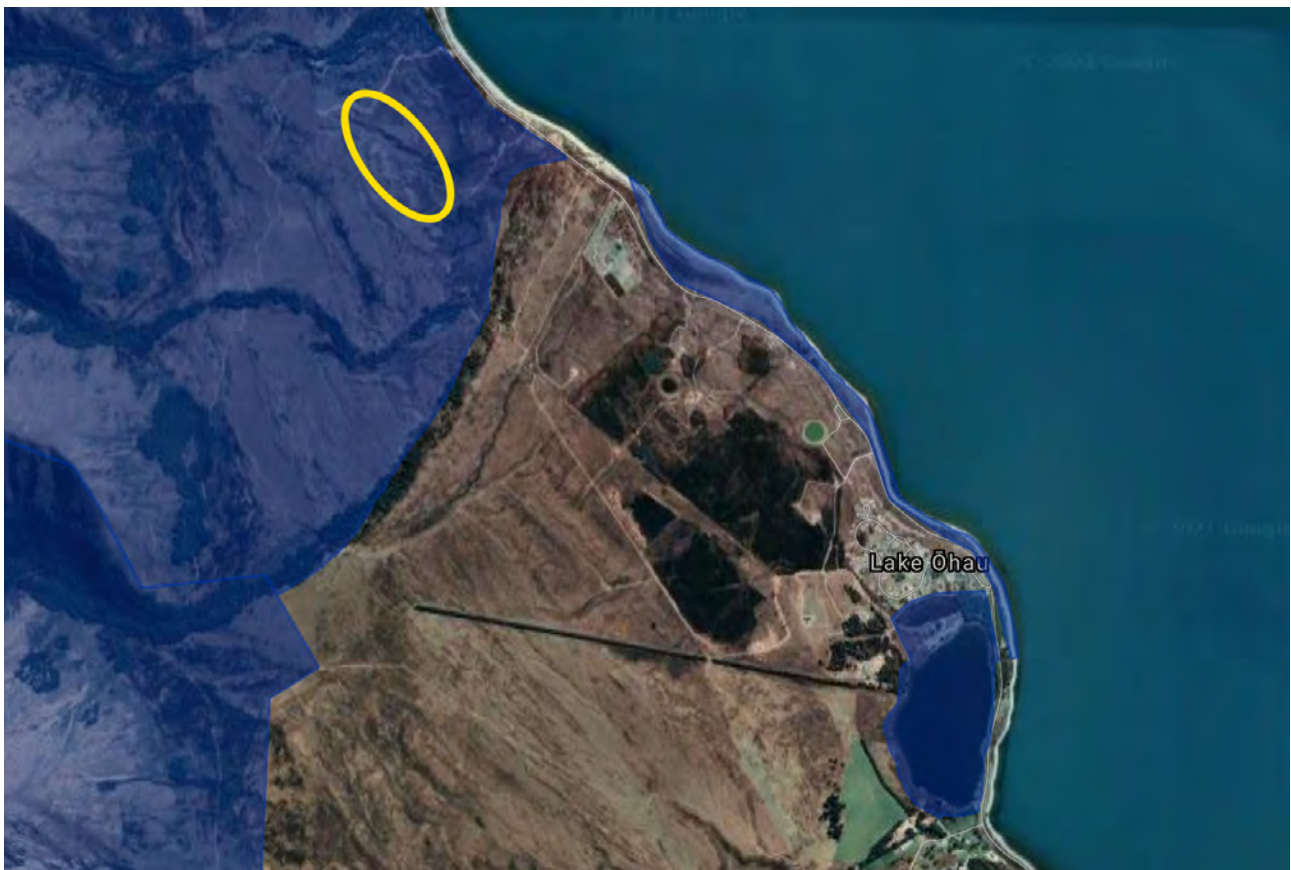
This map identifies Department of Conservation land in blue and the yellow ellipse is the approximate location of the general origin of the fire area.

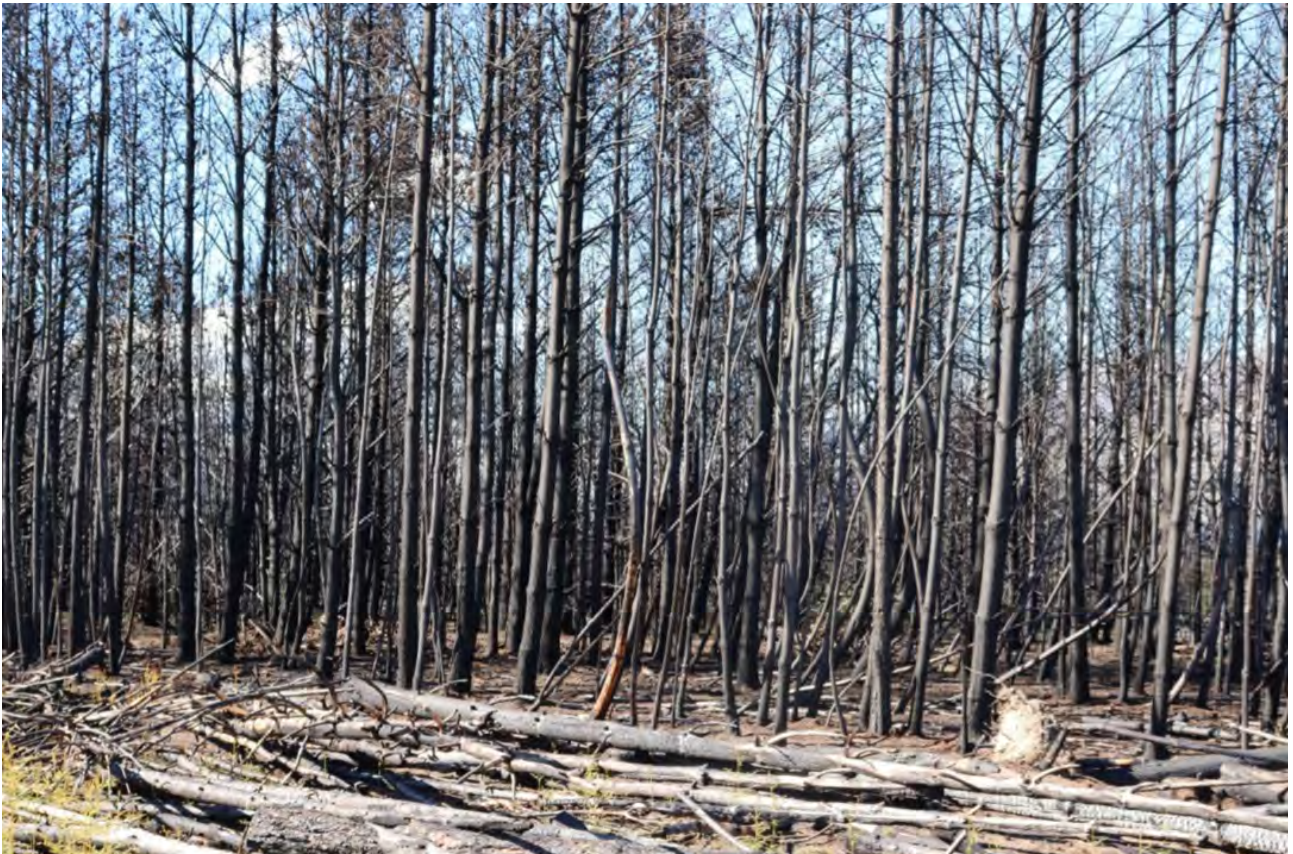
Once the fire reached the trees, the fire dynamics changed and the fire intensified. The fire crowned, meaning it burned through the tops of the trees, creating an ember storm. Areas of wilding pines increased the intensity of the fire. This is due to the small lower branches which naturally die off as the trees grow, leaving at least two metres of dry dead branches available to burn from the ground upwards.

The above photograph shows the dry dead branches within the wilding pines to the east north east of Lake Ōhau village.

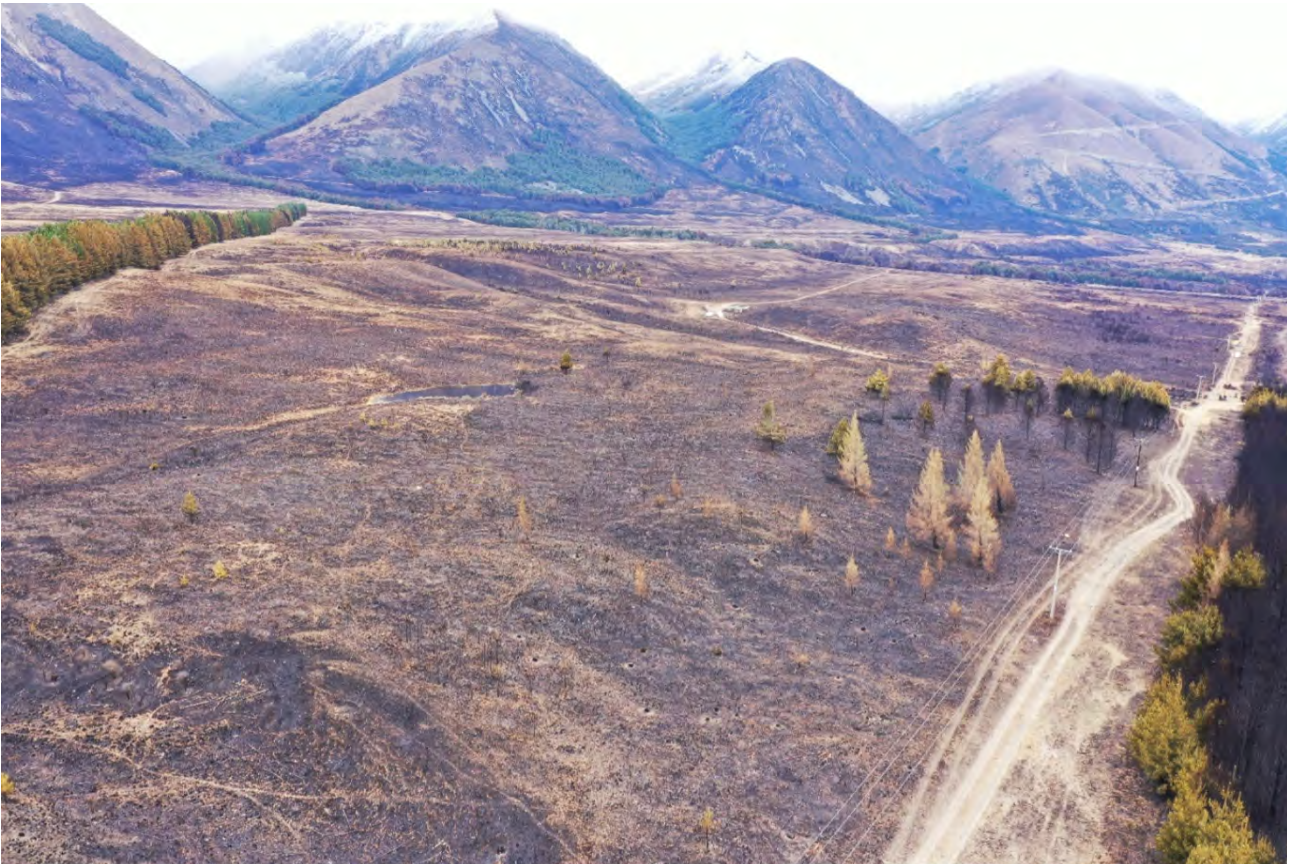
Looking northwest from the south side of Lake Ōhau village with the power line at bottom right

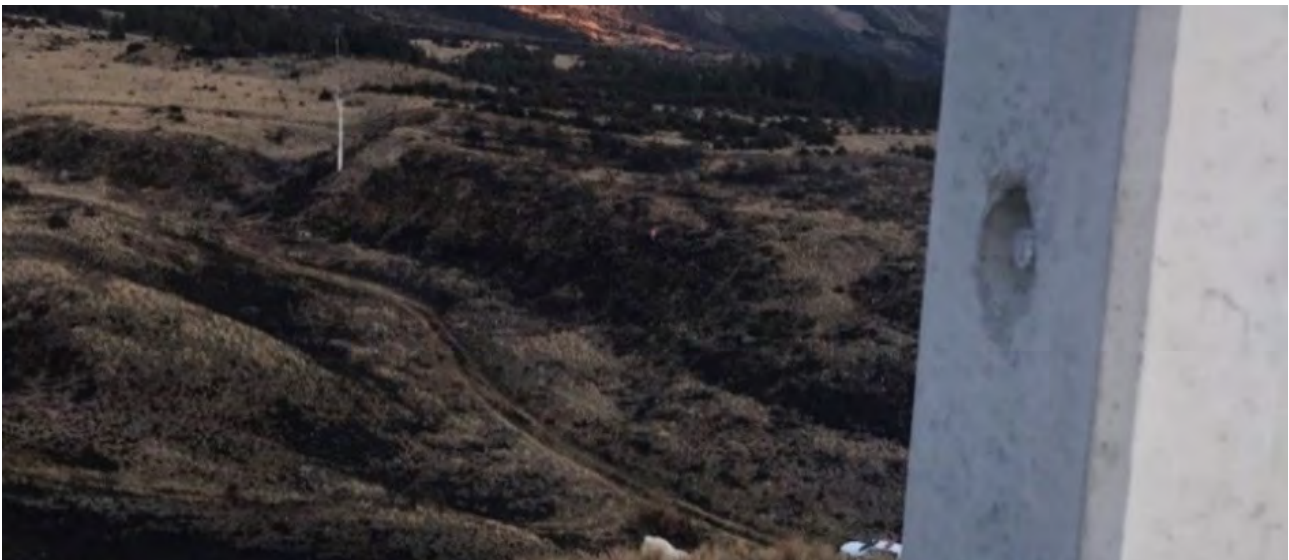
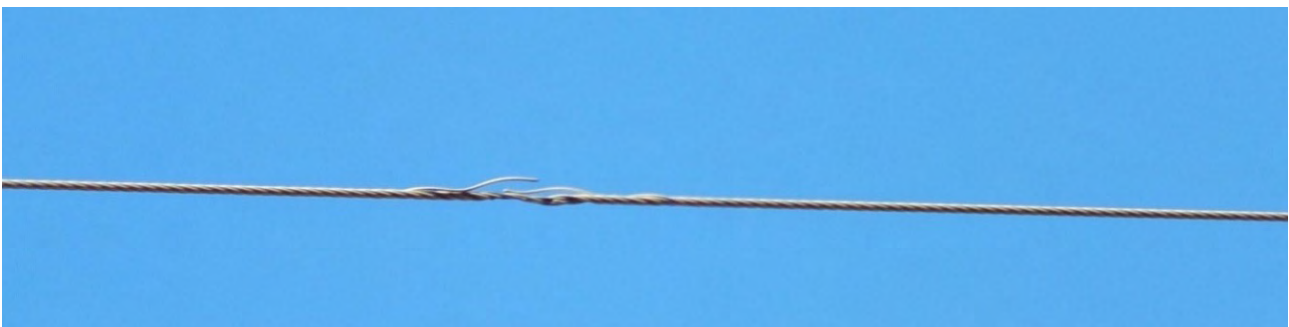
Span from Pole 870452 to Pole 821215 - 175m

Damage to two powerlines was identified on the span between two poles identified as pole 870452 and pole 821215.

These powerlines spanned a gully. Fire and Emergency secured the powerlines as exhibits. However, when compared against data showing faults on the lines on the night of the fire, there was no supporting data to suggest this damage could have created an ignition source.

Further, the investigators concluded the damage was an unlikely ignition source due to the height of the powerlines over the gully which meant molten aluminium globules would have cooled down before they hit the ground. Lastly, they concluded there was minimal back burning which they would have expected to see had the fire started in this location.

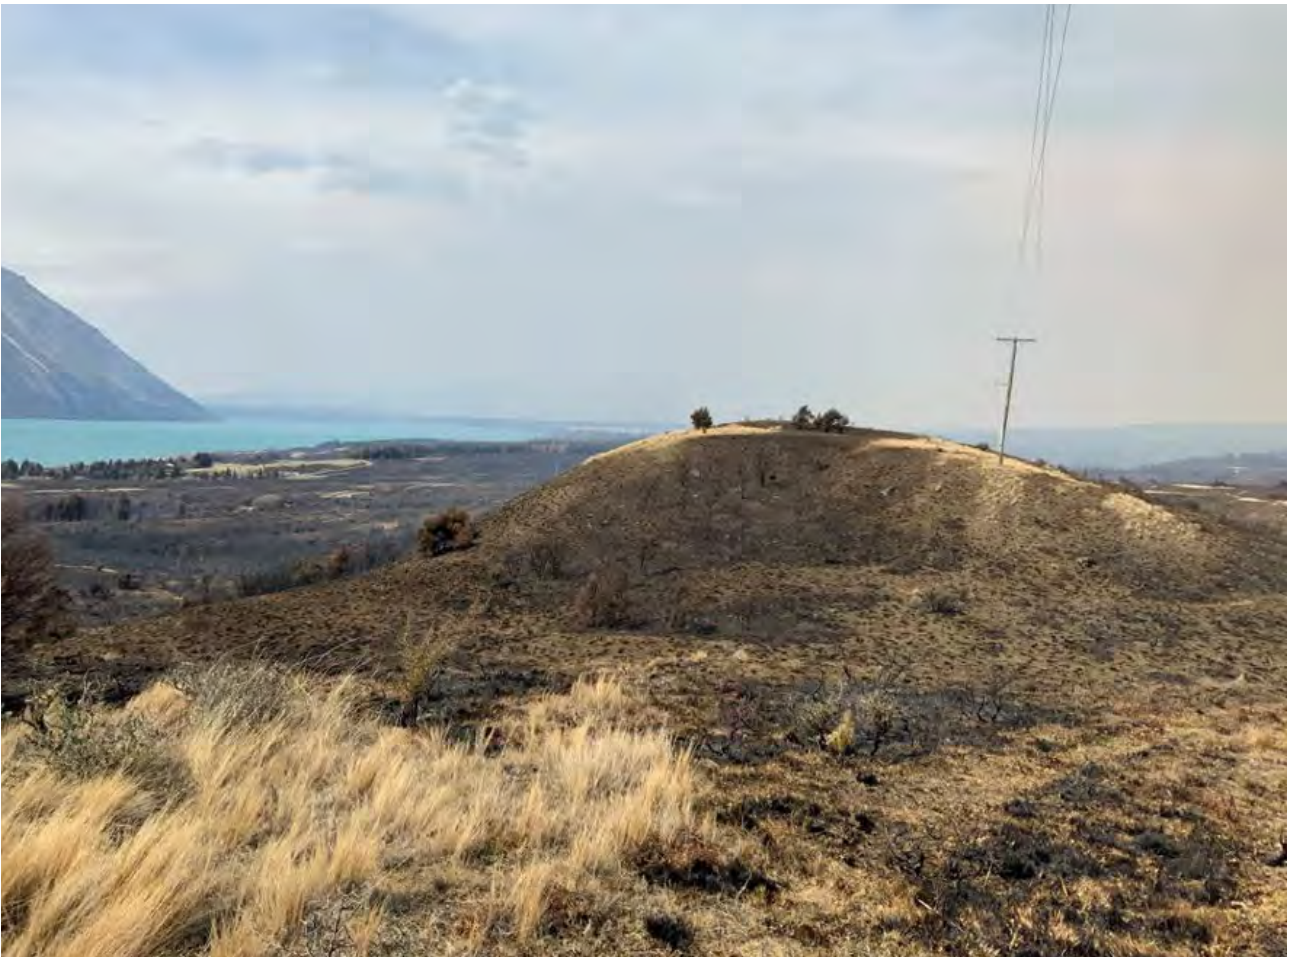
Network Waitaki advised they had inspected the three powerlines on the span between pole 35693 and pole 17408 and had reported no damage. This span is still in place. With no damage being found on the span and the fact the fire pattern demonstrated the fire had come from the north, the investigators ruled this span out as a possible ignition source. The evidence suggested the front of the fire had burned through beneath the lines, rather than a fire starting under the twisting powerlines.

Span between pole 35693 and pole 17408 shows twisted lines

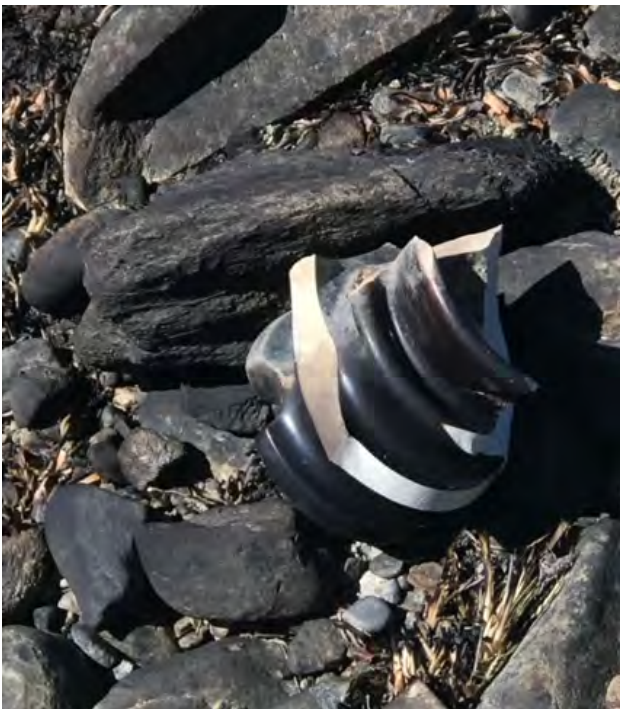
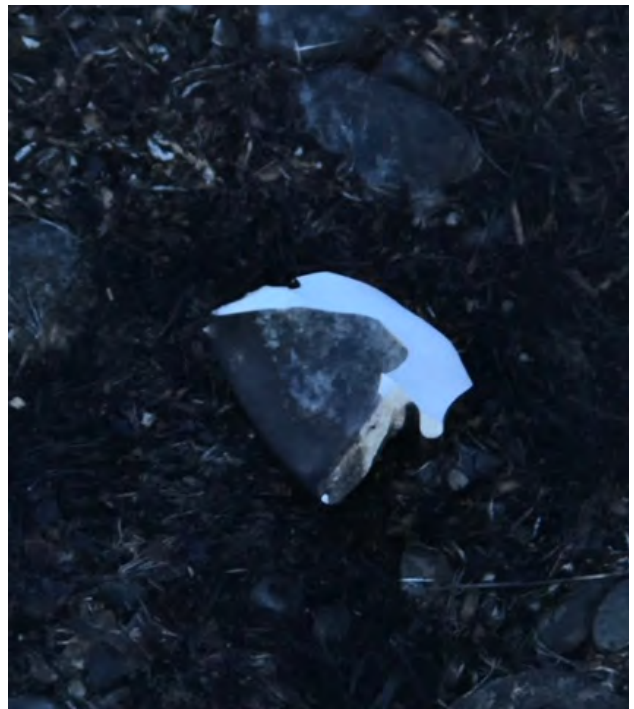
Pole 40456 broken insulator on the ground

The investigators located a broken insulator on the ground underneath pole 40456 as they tracked across the fire ground in the days after the fire. They noted due to its colour, the insulator looked as if it had broken recently.

Broken insulator located on the ground near pole 40456 (old pole number 17406).

However, the investigators found fire indicators in the area which demonstrated the front of the fire burning through the area, rather than a fire starting here.

The investigators were confident nothing occurred at this pole to cause the initial fire.

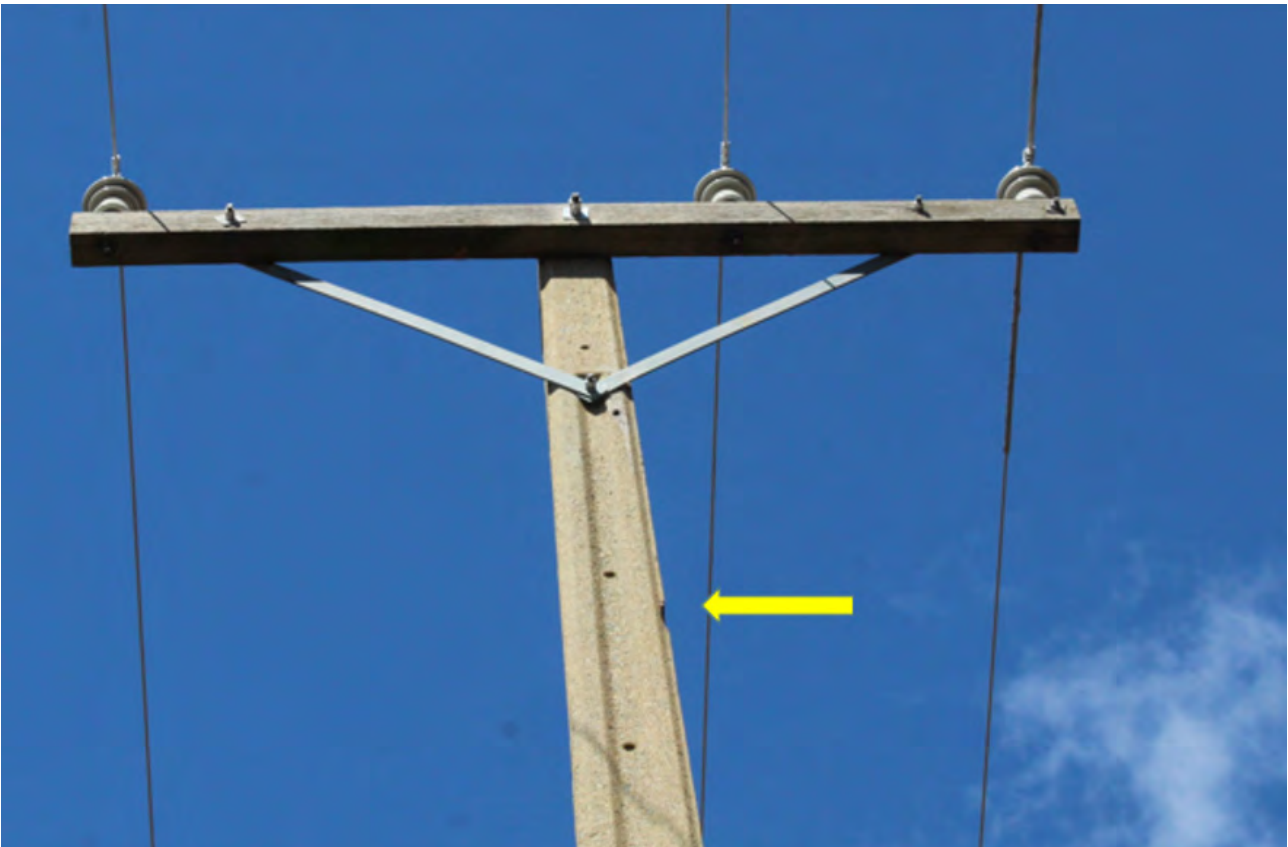
When tracking the fire ground on 7 October, the investigators noticed pole 35693 appeared to have arc or heat damage on both metal stay arms. Other than the arc marks, the pole appeared in good condition. There also appeared to be damage to the concrete pole below where the two metal stay arms are secured to the centre of the pole (yellow arrow). This appeared to the investigators to be old damage.

Upper section of pole 35693 when it was located on 7 October.

On revisiting the fire site on 16 November 2020, the investigators learned pole 35693 had been replaced which caused them to question why. Looking back through the photographs they had taken on 7 October, they identified there was more damage than just the arc marks on the metal stay arms of pole 35693 and the previously identified damage in the concrete pole. (See above photo)

There also appeared to be a scrape mark above and below the old damage on the surface of the concrete. They also identified some damage to the centre bolt and washer holding the two metal stay arms to the pole, along with scrape damage to the edge of the metal stay arm on the opposite side of the pole.

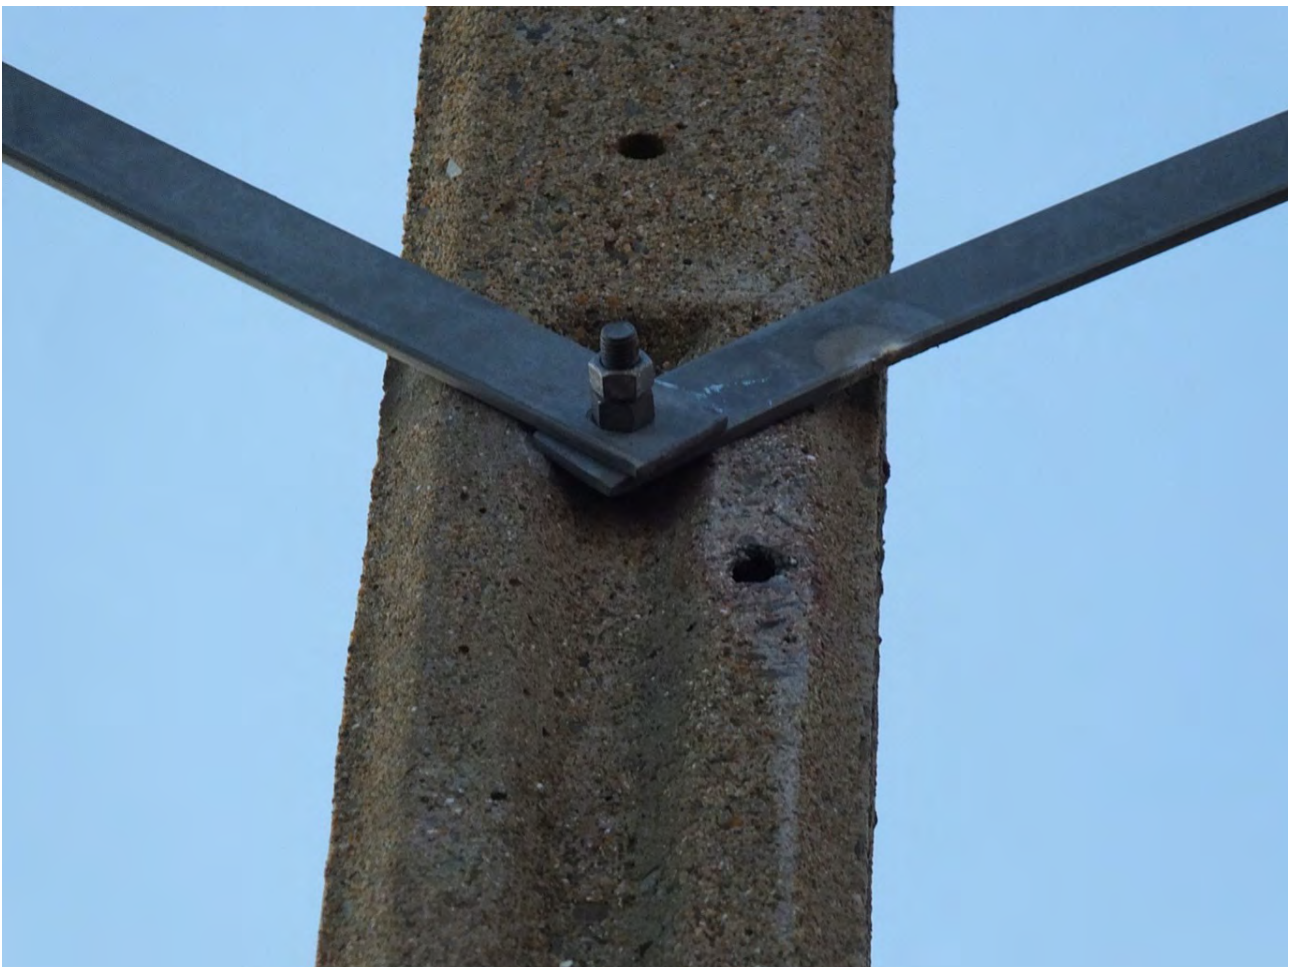
Close up of stay arms on pole 35693 showing the lower arc mark on the right metal stay arm, a hole below the stay arm and what appears to be a scrape mark below this stay arm.

On closer inspection of the photographs, they found the damage on the pole appeared to be caused by arcing which had burnt a hole into the concrete 25mm deep.

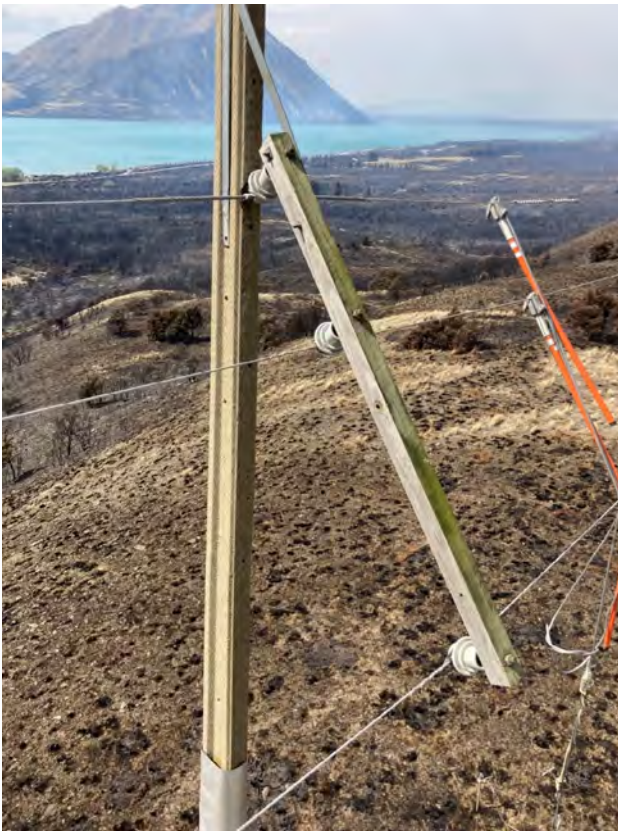
The cross-arm and stay bolts and nuts had also dislodged causing the cross-arm to partially detach from the pole and rotate from a fixed horizontal position and swing down to a vertical position against the pole.

Pole 35693 with the cross-arm rotated over.

The investigators concluded that when the storm hit the Ōhau area in the early hours of 4 October 2020, wind pressure on the powerlines began to move the dislodged cross-arm resting on the centre bolt. As the cross-arm rotated upwards one of the power lines contacted with one of the metal stay arms. This contact resulted in the metal stay arm becoming live causing the electric current to earth and create three burn holes in the concrete pole.

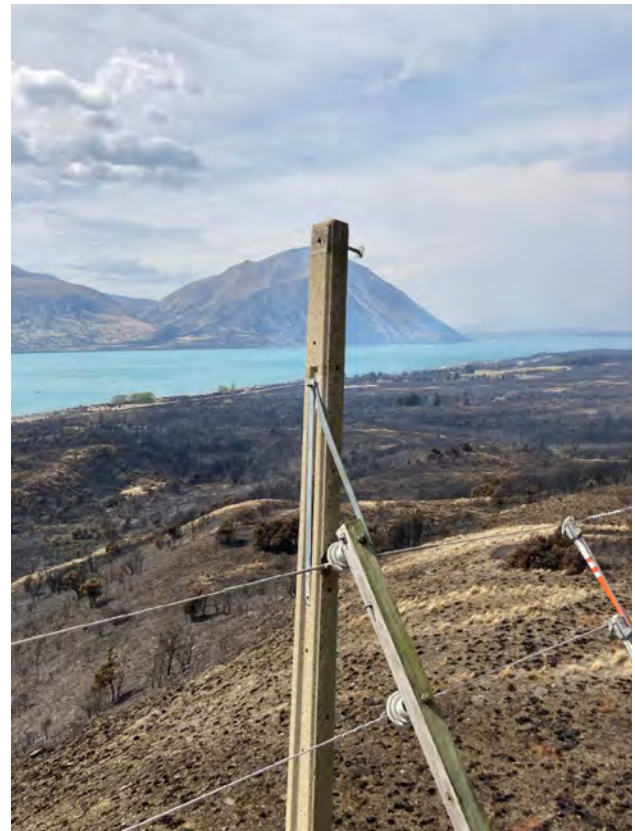
Photographs provided by Network Waitaki confirmed a metal stay arm had come free.

Pole 35693 showing the lakeside metal stay arm hanging in the centre of the pole and the centre bolt that secured the wooden cross-arm to the pole has moved backwards but remains in the pole (note bolts have a single nut).

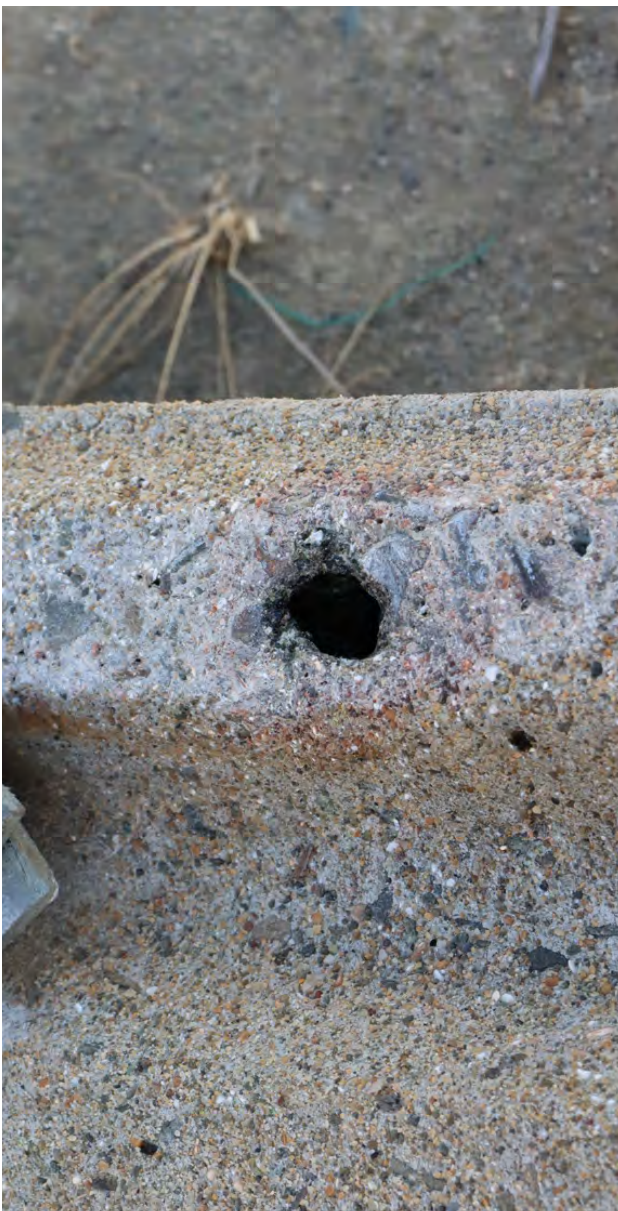
When the holes were created, the edges of the hole melted like glass and hot liquid concrete and steel most likely fell to the ground causing ignition of the vegetation below.

Close up of the burn hole on pole 35693 below the centre bolt holding the metal stay arms to the pole. It has been exposed to intense heat.

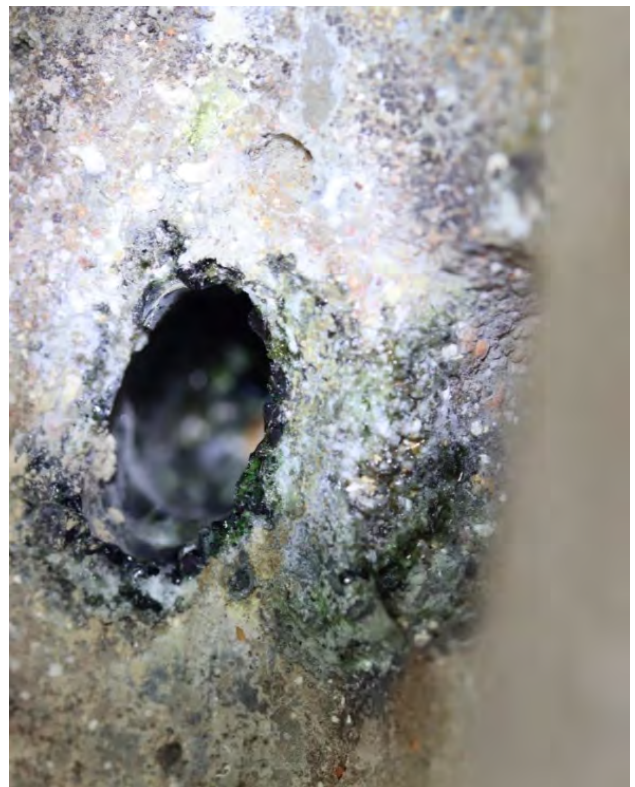
Arc damage on pole 35693.

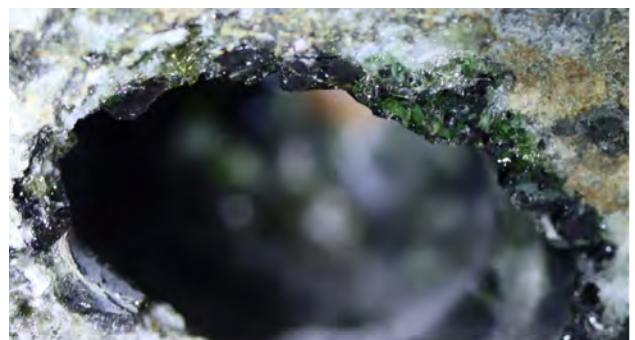
Close up of the burn hole which has melted like glass.

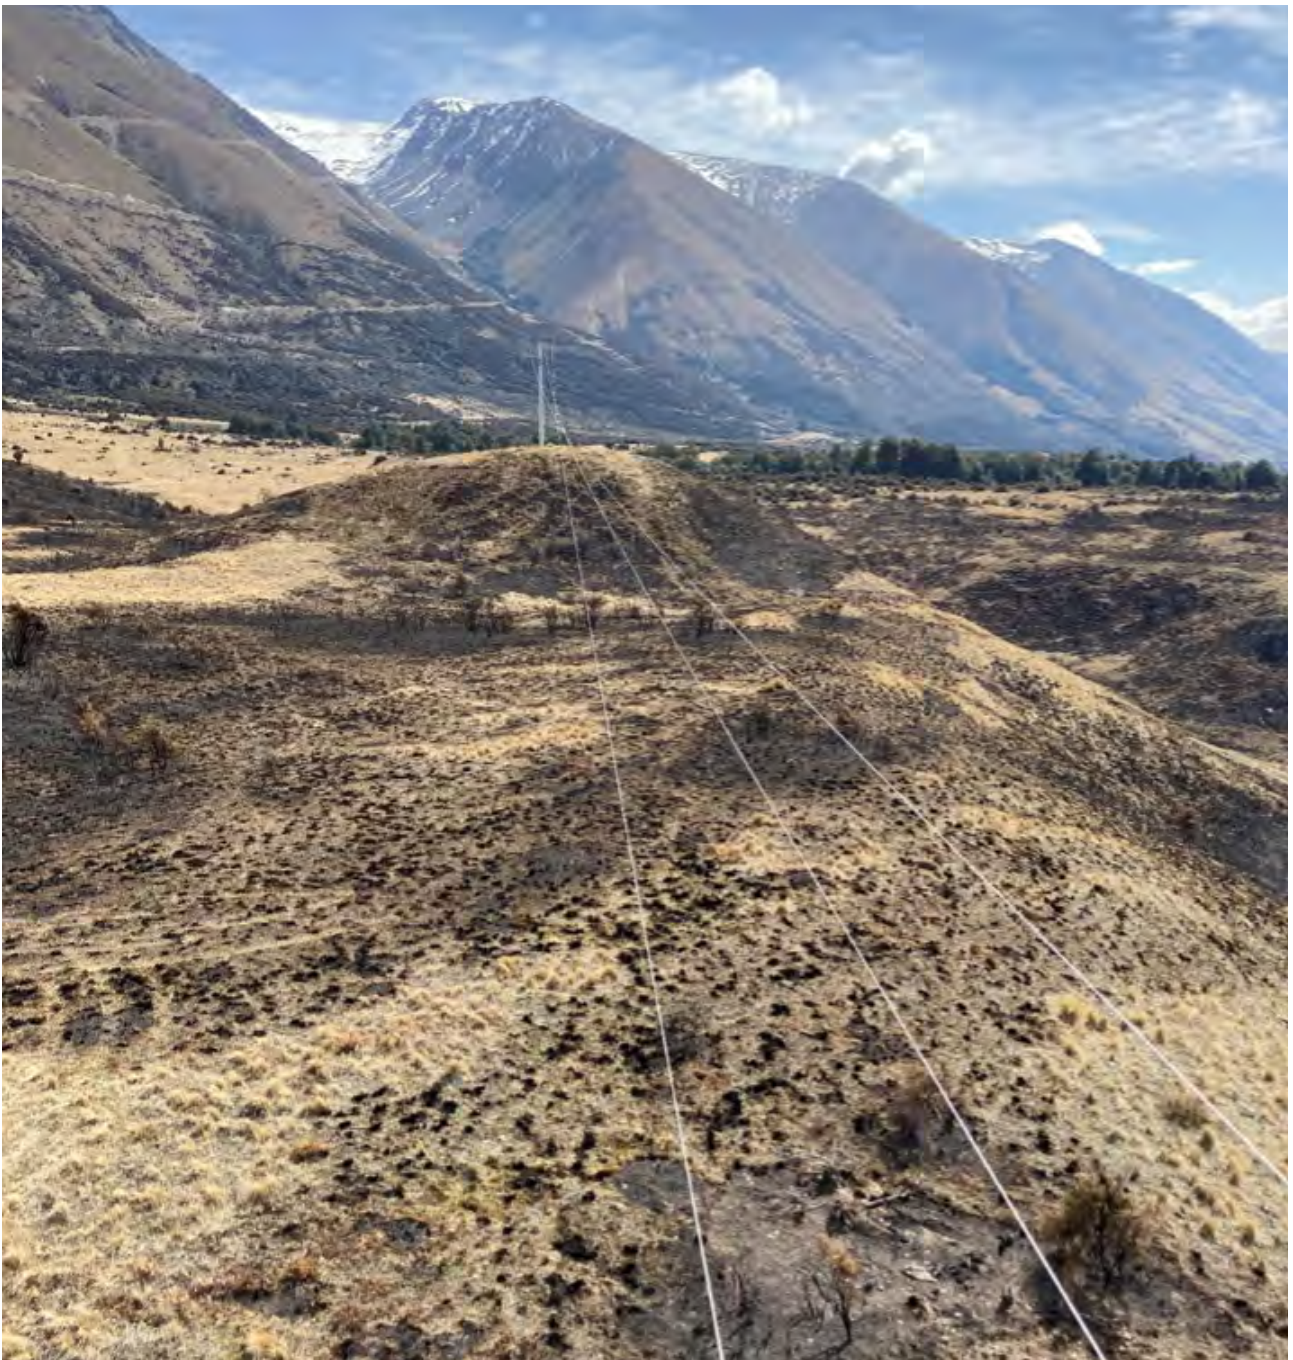
The area between pole 35693 and pole 870452 was also not eliminated as a source of ignition for the fire. The investigators concluded the flipped cross-arm caused the powerlines to twist and come into contact with each other.

Span between Pole 35693 and Pole 870452 showing the twist in the lines.

The powerlines show arc damage where they have twisted together. This is consistent with data provided by Network Waitaki which records faults with these lines at 3.23am on 4 October.

The investigators concluded the arcing of the twisted powerlines possibly resulted in a secondary ignition. This occurred after the initial fire started at around 2.10am. Fire patterns in this area also support low intensity burning, indicating a fire spreading out from this location.

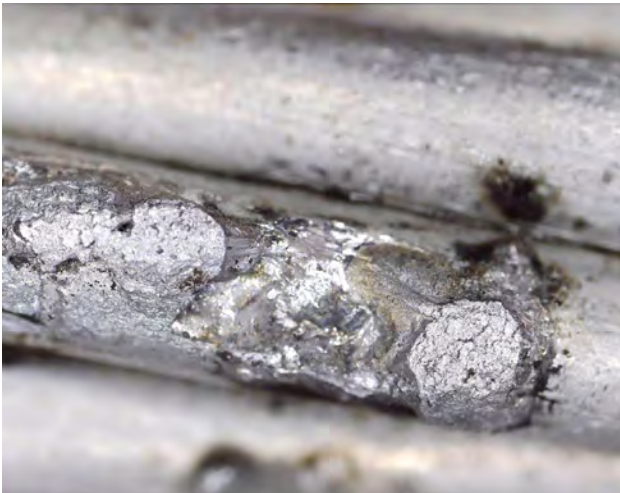
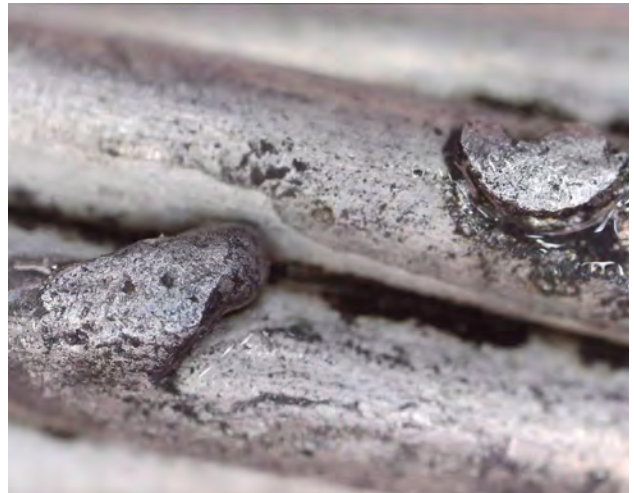
Microscope images of arcing damage on twisted lines.
