Fire Research & Investigation Unit

Heads

In April 2007 a shopping mall on the North Shore of Auckland City was filled with smoke one afternoon after a fire broke out in the store room of one of the tenancies. During a post incident audit into the event some issues were found with the smoke control and suppression systems.

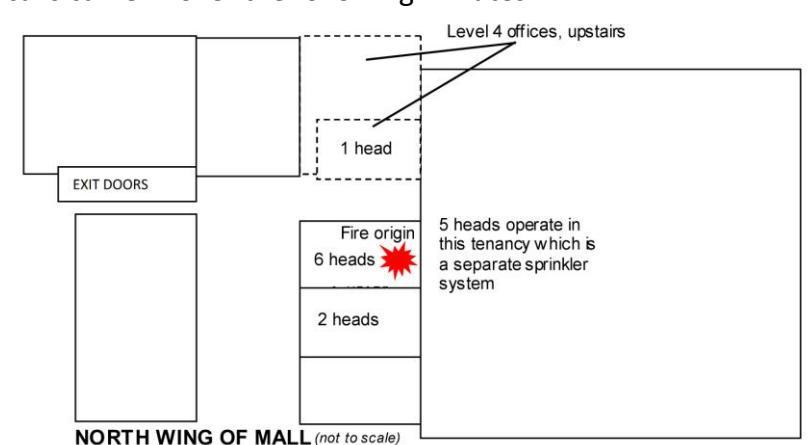
Despite the sprinkler system detecting the fire it had failed to extinguish it. The fire had spread between some tenancies, and was continuing to grow when extinguished by firefighters.

The sprinkler system was not effective, this is possibly due to heads being incorrectly placed or more likely that alterations to the building had taken place after sprinkler installations which meant that some areas had no coverage. These deficiencies had not been picked up during sprinkler system checks.

The smoke control system did not operate as it was designed and therefore did not effectively control smoke spread, it is unclear what actually caused the system to stop working.

- A thorough Sprinkler Survey of the entire complex needs to be carried out as soon as possible. This is to determine other un-permitted works that affect the performance of the sprinkler systems.

- A review of all the existing fire reports comparing them to what was required and what has been built should be carried out.
- The building as completed, does not match the consented design. The fire design engineer should inspect the finished construction and issue a producer statement that this complies with his design.
