Conducted by a joint Department of Sustainability and Environment, Country Fire Authority and New Zealand National Rural Fire Authority Investigation Team.

Date: 22 May 2007

1 EXECUTIVE SUMMARY

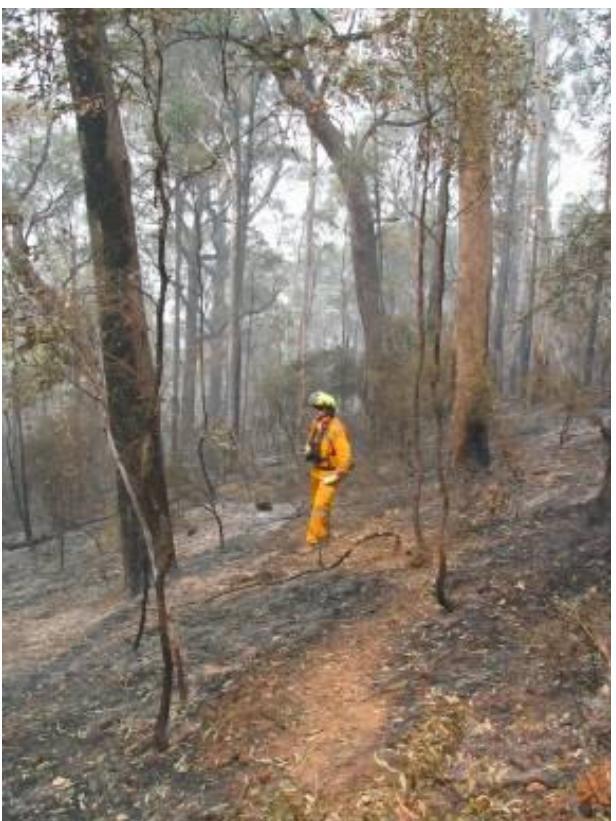
Second slop-over - looking from top of East flank down hill

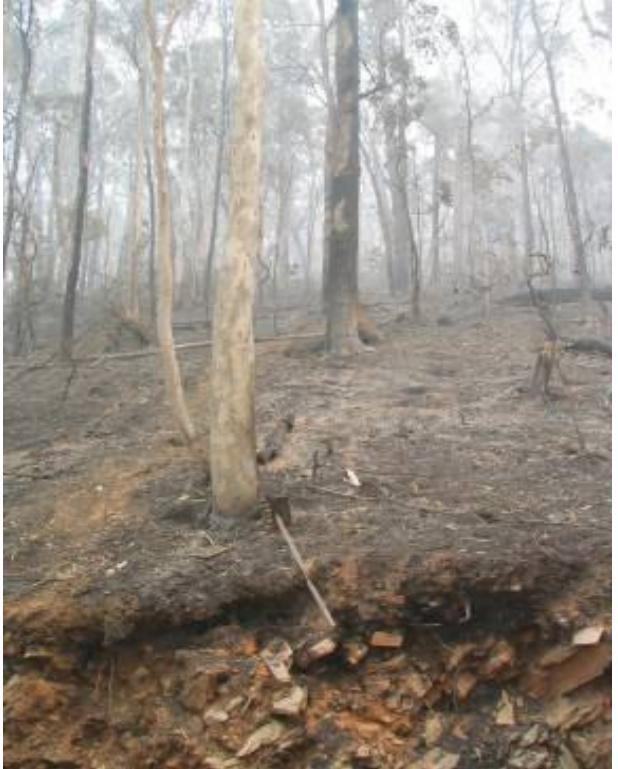
Second slop-over - Looking up East flank from Steiners Road

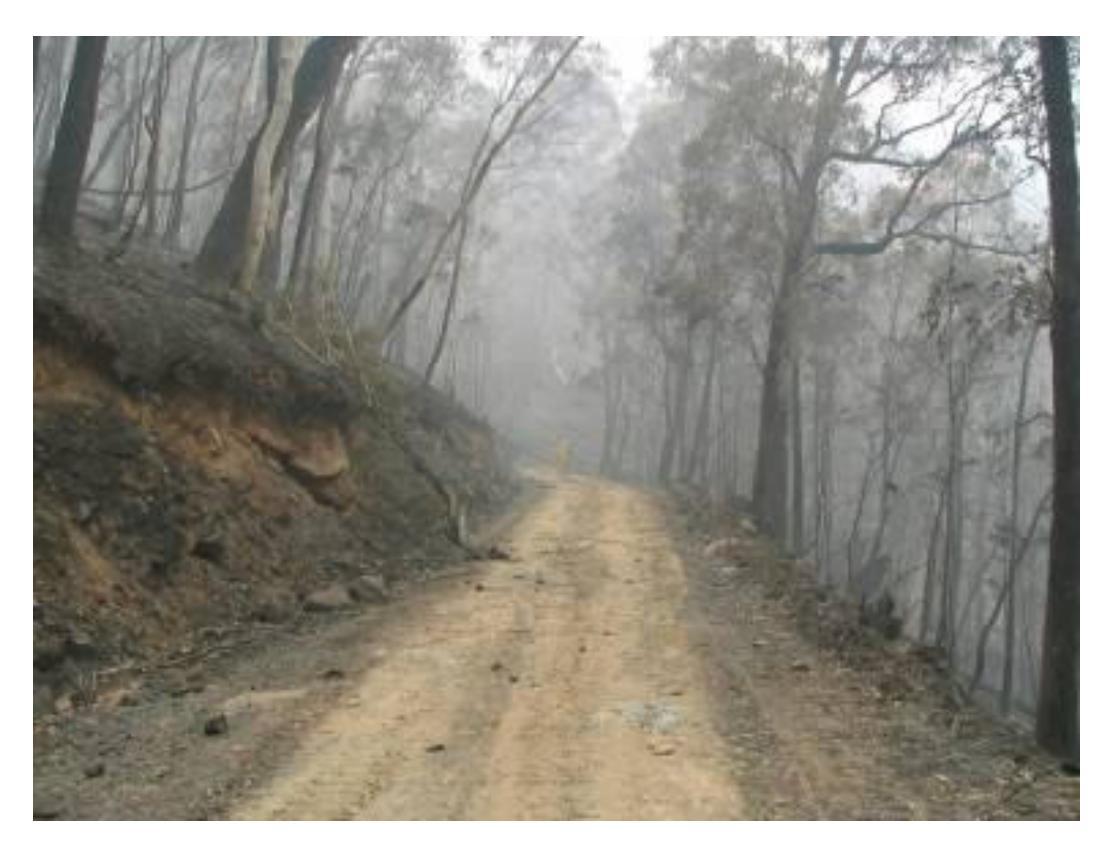
Looking East along Steiners Road from Eastern flank of second slop-over

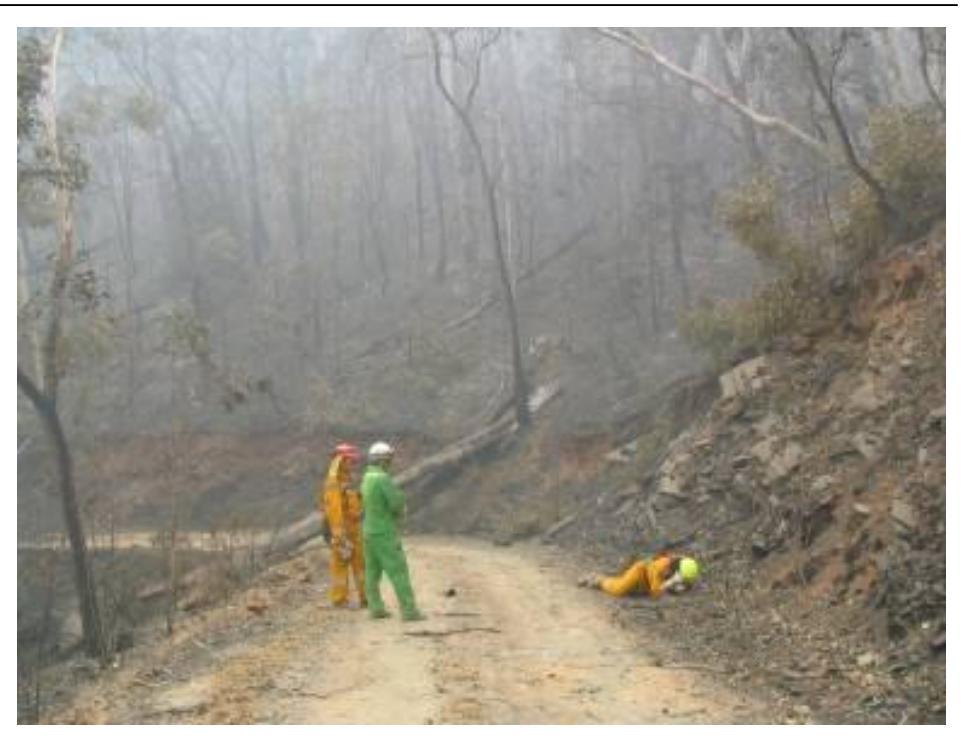
The Crew Leader directed these firefighters to take shelter on the road against the embankment. The seven firefighters were heaped together and ordered to "hold" in this position. The group stayed in this position on the ground, probably for less than a minute, until they saw a gap in fire activity up the road, at which time they were again ordered to run. The Crew Leaders in the group ensured that all firefighters were ahead of them and assisted their escape to the safe area. It was during this final run that the majority of the burns were sustained by the seven firefighters as the fire again crossed the road. The decision to shelter probably reduced the nature and extent of injuries.

Firefighter demonstrating how crew members took refuge at actual site

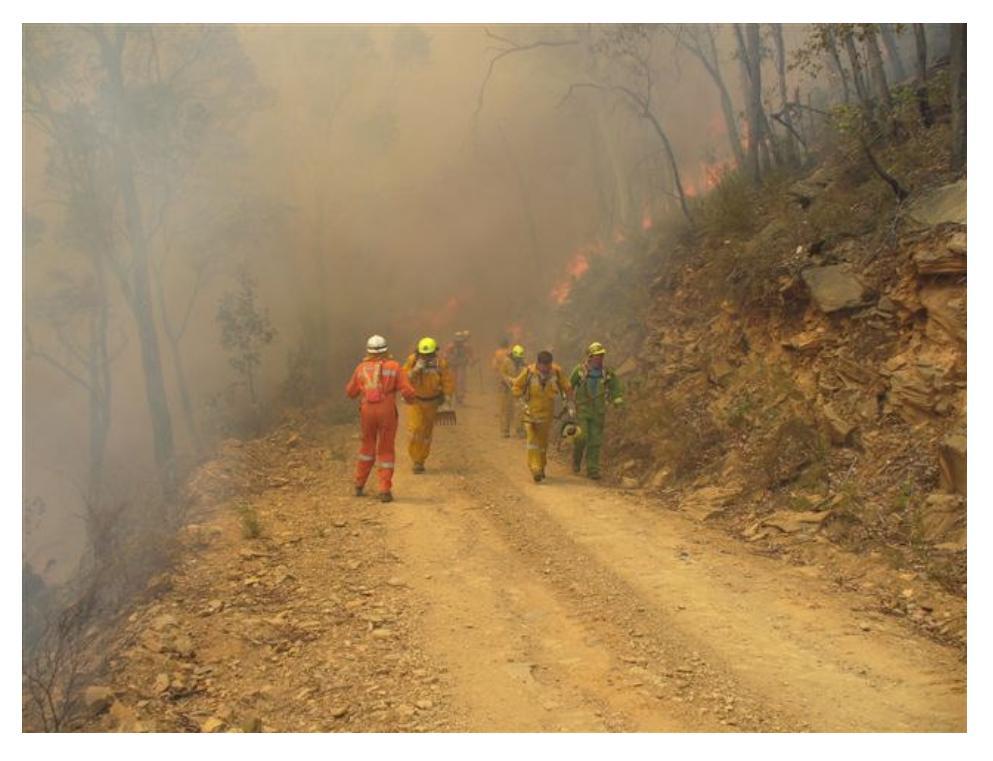
Firefighters emerging from the burnover having taken shelter and made a second run to safety

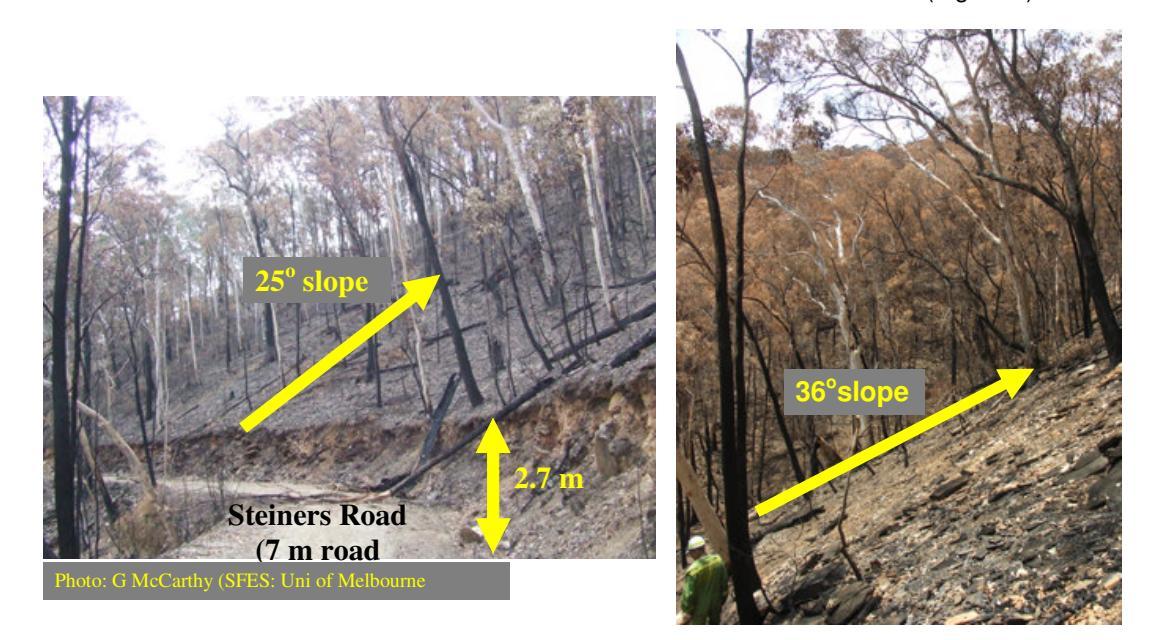
Figure 1: The road side cut near the vicinity of the burn over site illustrating the slope above and below the road surface. At the incident site the road surface was approximately 7 m wide.

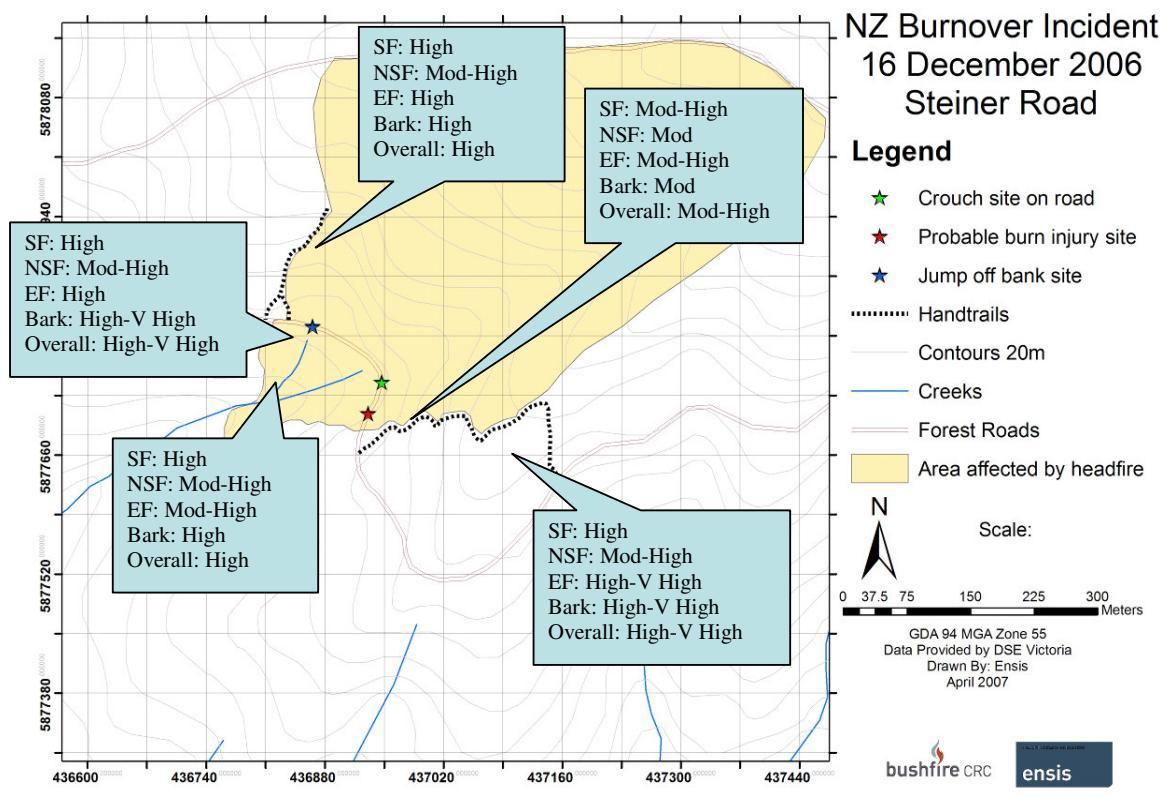
Surface fuel 10 t/ha Near-surface fuel (adjust the surface by one class) 6 t/ha Elevated fuel 2-6 t/ha Bark 2-5 t/ha

Figure 2. Estimated pre-burn overall fuel hazard levels SF (Surface fuel), NSF (Near-surface fuel), EF (Elevated fuel) and bark fuel.

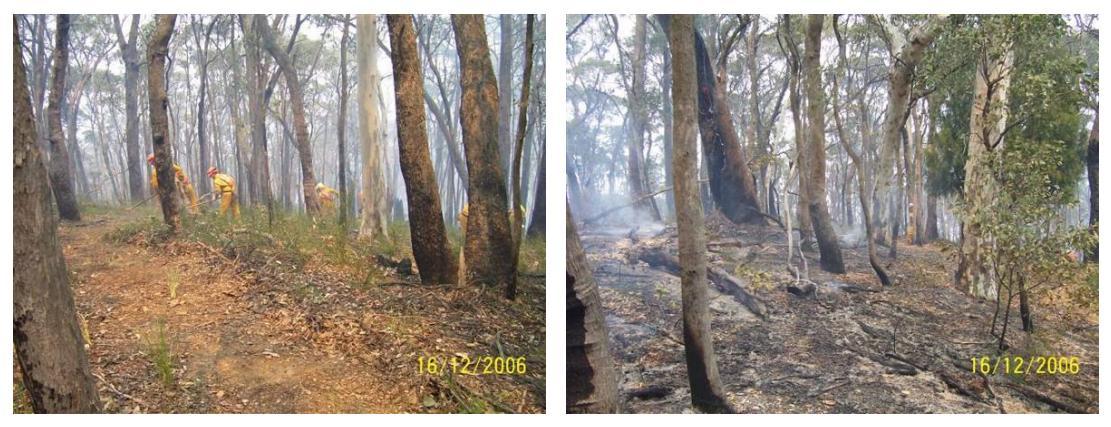
Figure 3. Construction of a hand trail showing the understorey fuel structure on the northern site of Steiners Road at slop-over 1 (estimates elevated fuel hazards of HIGH) (left) and low char height in the spot fire burn area (right). These photographs were taken between 1300 and 1320 hours..

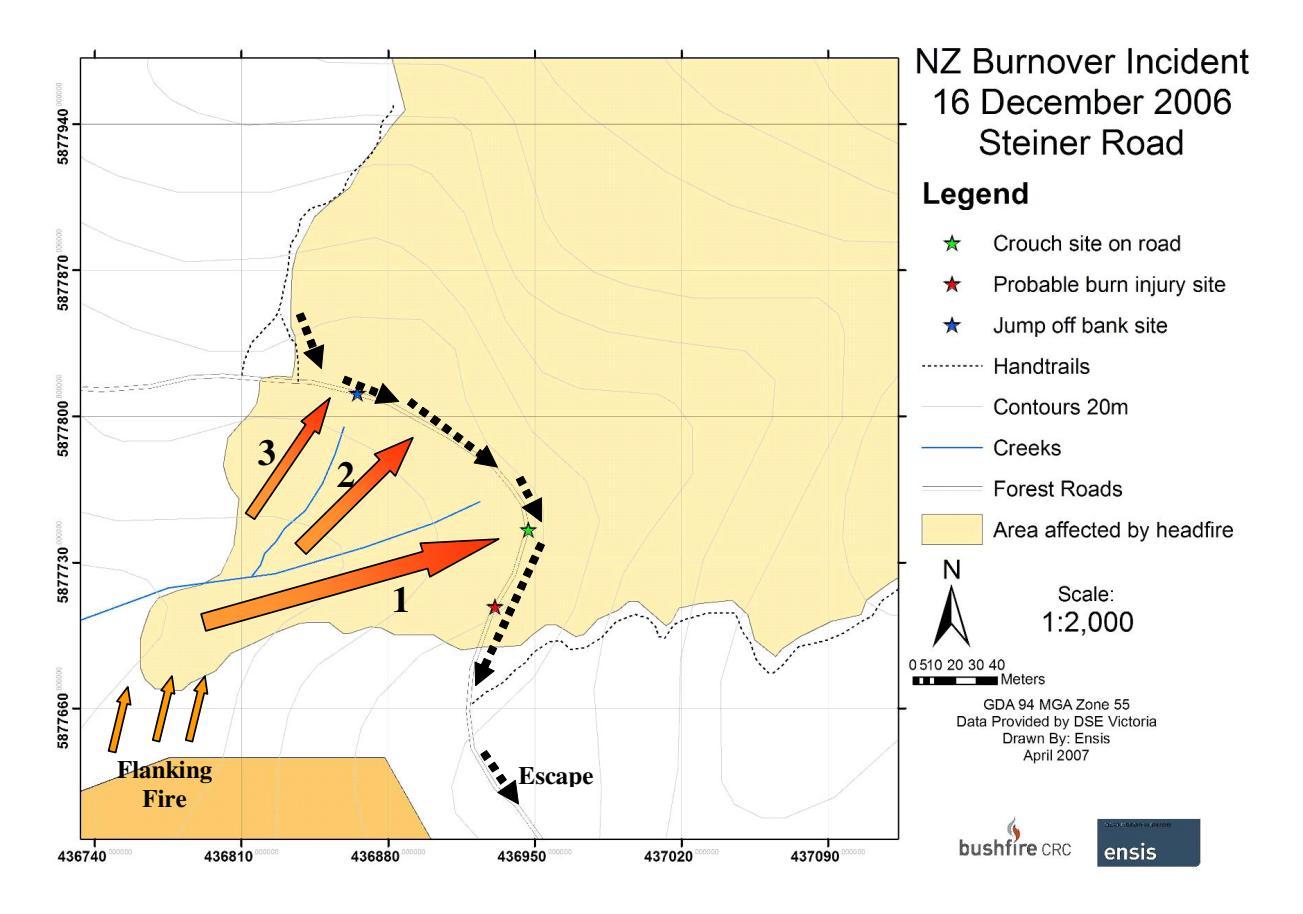
Figure 4. Progression of the flanking fire and sequence of 3 fire blow outs toward Steiners Road with run one (1) over running the fire fighters on their escape route

The distance from this increasing fire intensity to Steiners Road is 180 m on a 35° slope. At the rate of spread predicted on level ground of 270 m hr⁻¹ the fire would have taken over 40 minutes to travel to Steiners Road but, when the rate of spread is corrected for 35° slope this time is reduced to less than 5 minutes.

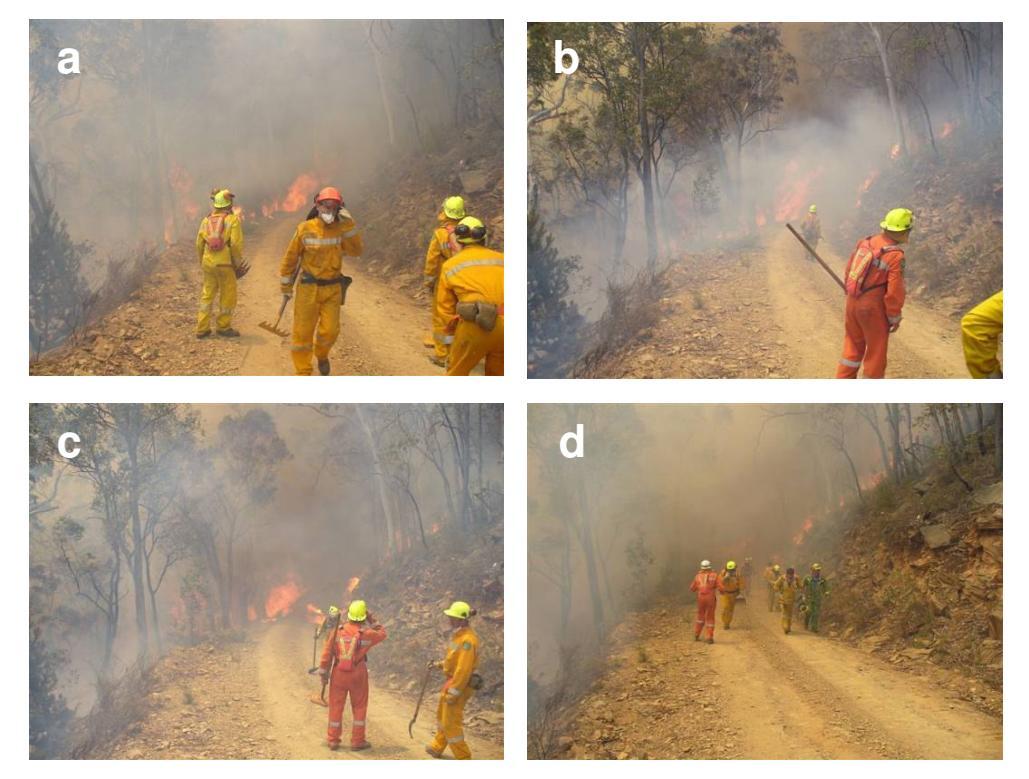
Field observation from the fire crew indicated there were three separate up slope runs to Steiners Road. The photograph sequences shown in Figure 5 were taken approximately at 1406 hours showing flames over the road. Because of the three separate runs up slope in a series of narrow tongues, the head fire probably did not reach its full potential rate of spread. Observation on the western edge of the fire run noted the third run was approximately 10 minutes later and took longer to spread up to the road.

Figure 5. Sequence of photographs showing the flame crossing Steiners Road and the smoke (d) when the last of the crew walk out towards their safety zone.
