## Fire Research & Investigation Unit

# Heads Up

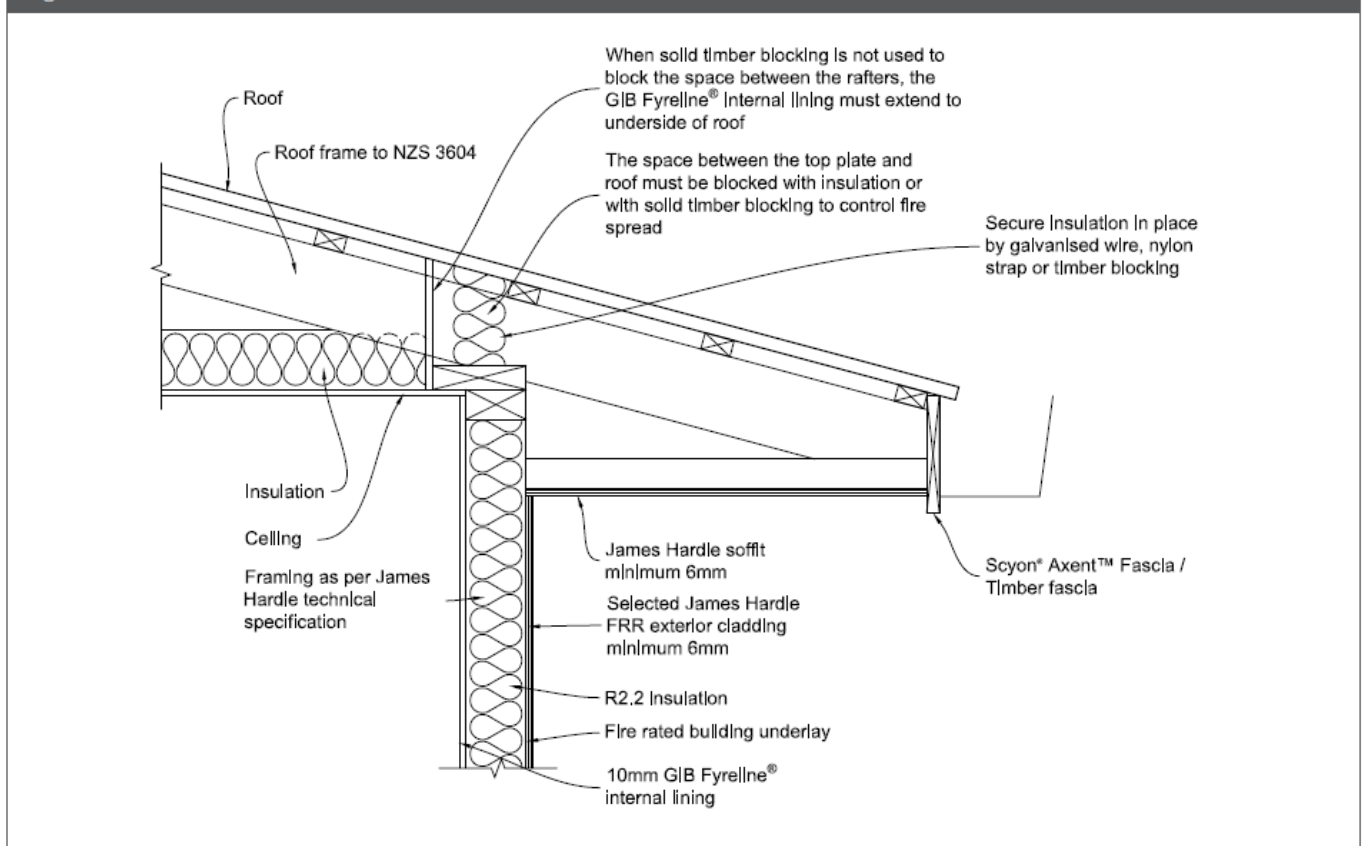
*A manufacturer's specification showing soffit installation which maintains fire separation.*

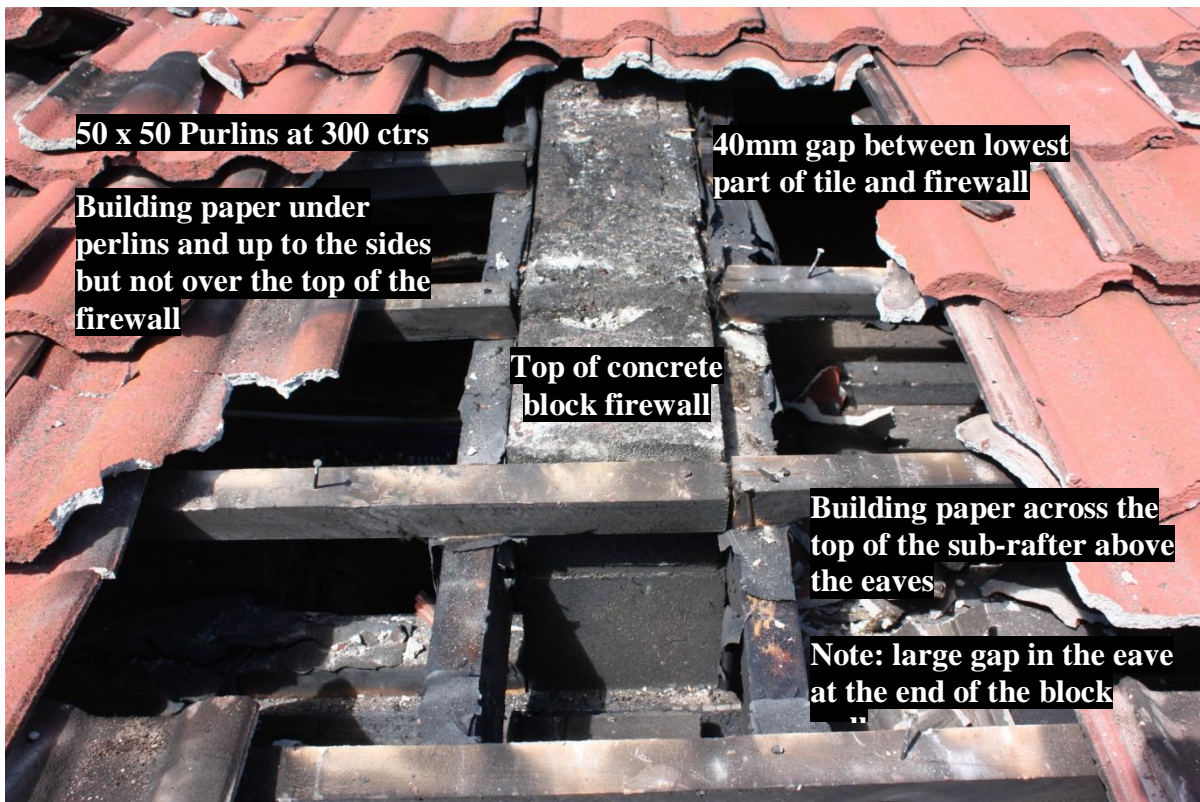
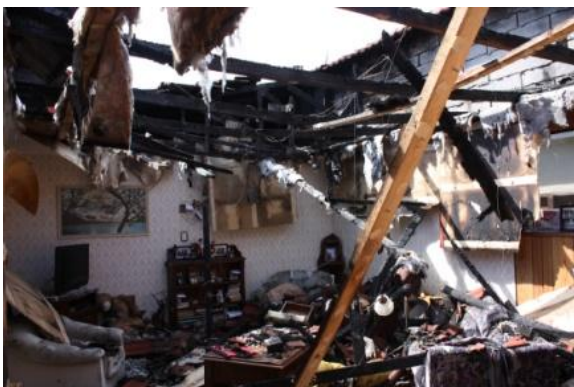
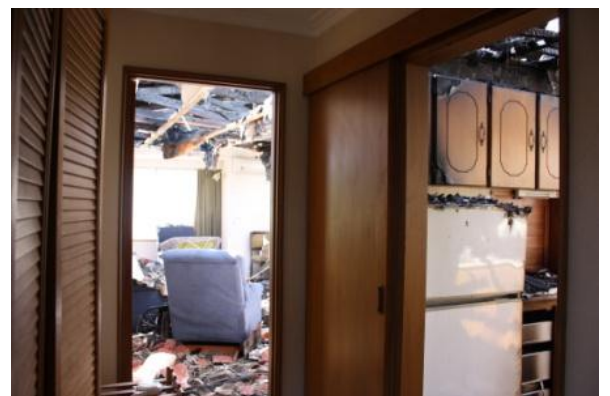
A recent house fire investigated by the Fire Service involved fire travel, through roof eaves and across firecell boundaries due to the fire separations not being extended into the eaves spaces (see below). Drop down burning occurred into multiple residential units causing significant damage to the building and property

Photos showing damage in adjacent units as a result of fire spread.

These instances have highlighted the need for building owners, inspectors and NZFS staff to be aware of the risk of fire spread via roof eaves.

- Building designers should include specific construction details to address fire spread by this path.
- Building inspectors should be vigilant for non-compliant designs and construction
- NZFS staff should be vigilant for fire spread across firecells resulting from this form of construction
