# FIRE INVESTIGATION REPORT

State Highway 47, National Park, 3989

Incident Information:  
F4353497  
Vegetation Fire  
01:11 PM 08 December 2025

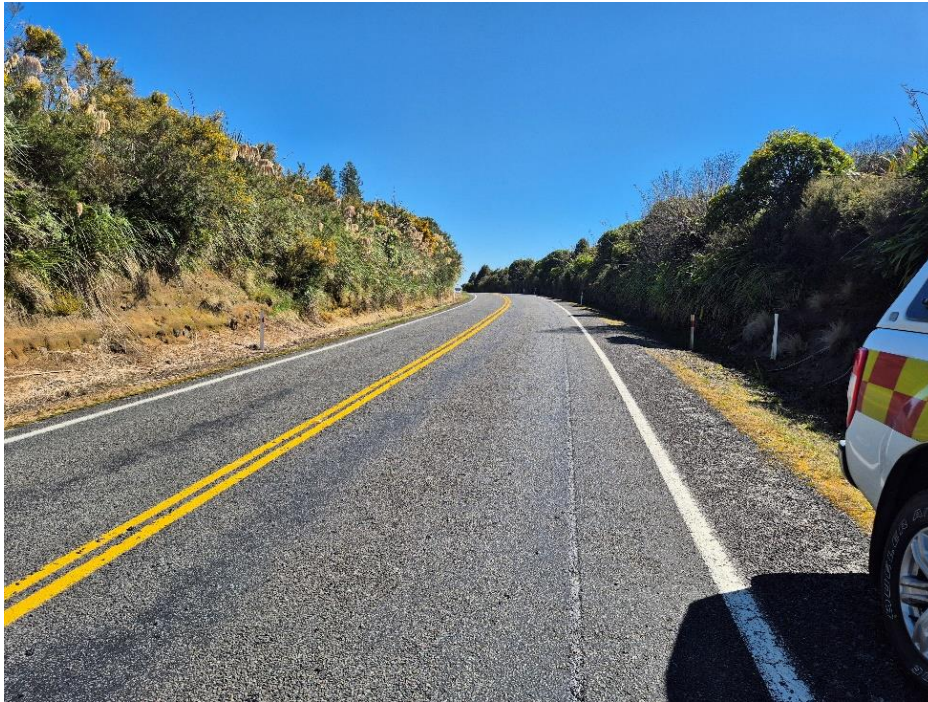
Just south of this intersection deep cuts into the road surface with large amounts of displaced roading material showed where the axle broke on the trailer which would have caused the overside of the trailer and broken axle to come in contact with the road surface, due to the speed of the towing vehicle this would have resulted in sparks being produced.

Damage to the road surface was also observed at multiple points along the 4.5Km stretch of SH47 from the first marks observed on the road to where the camper and trailer stopped at the intersection of SH47 and SH48

The use of a magnet and metal detector confirmed the presentence of metal filings and steel pieces in and around these drag marks, most showing they had been subjected to high temperature.

Figure 4. and 5. Road damage caused by broken trailer axle

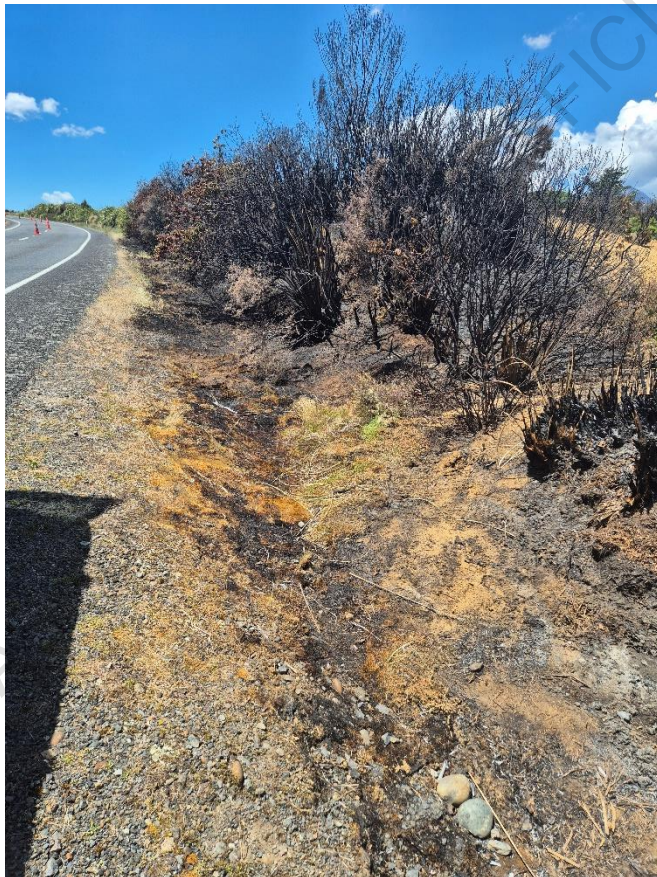
Figure 7. Southern fire start

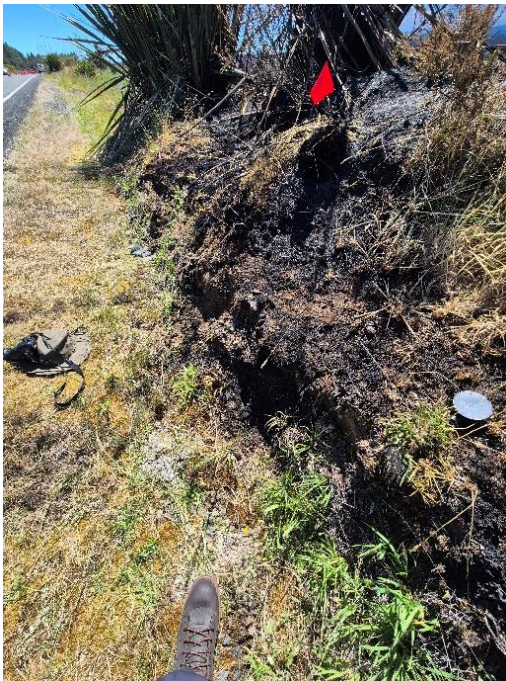
Where possible fire directional indicators were identified to confirm these, the indicators identified were protection, angle of charr, charring and grass stem fall.

This information confirmed the specific origin area in all four cases; it also identified a possible fifth that had quickly merged with one of the others.

*Figure 8. Shows ignition area and fire progression from roadside up the bank into a higher fuel load.*

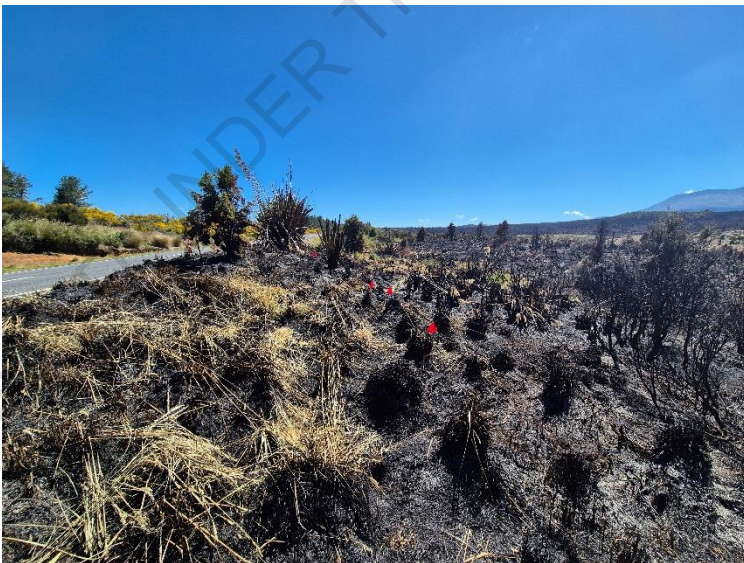
*Figure 9. Shows fire progression in Fig 8. from the top of the bank out into the general origin area.*
