Fire Research & Investigation Unit

Heads Up

BACKGROUND

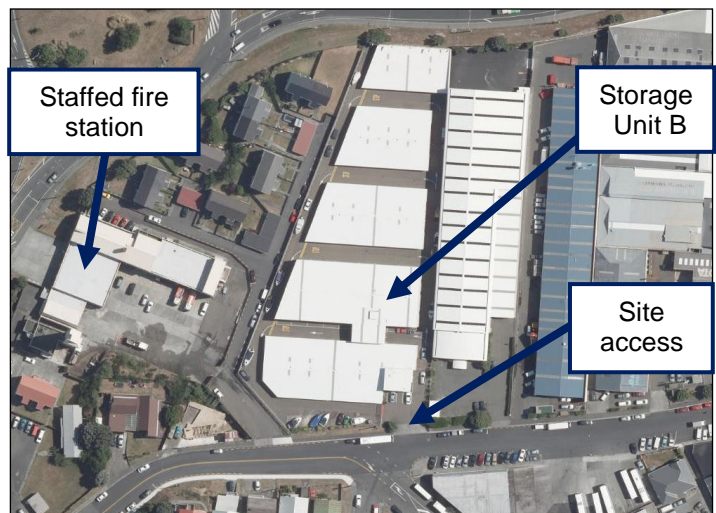
The building construction was concrete floor and end-walls, the side walls and roof were constructed of a steel-frame with external steel cladding. The interior of the building had a full-extent intermediate floor and both the lower and upper levels were sub-divided into secure storage units: approximately 200 on each of the lower and upper levels. Each unit was secured with a lock provided by the client. The first picture (below) shows a view of a corridor in a relatively undamaged part of the lower level. The second picture shows a similar view in a fire-damaged area.
