FIRE INVESTIGATION REPORT

2 College Hill, Freemans Bay, Auckland, 1011

F4235145

Melville, Colin, Fire Investigator

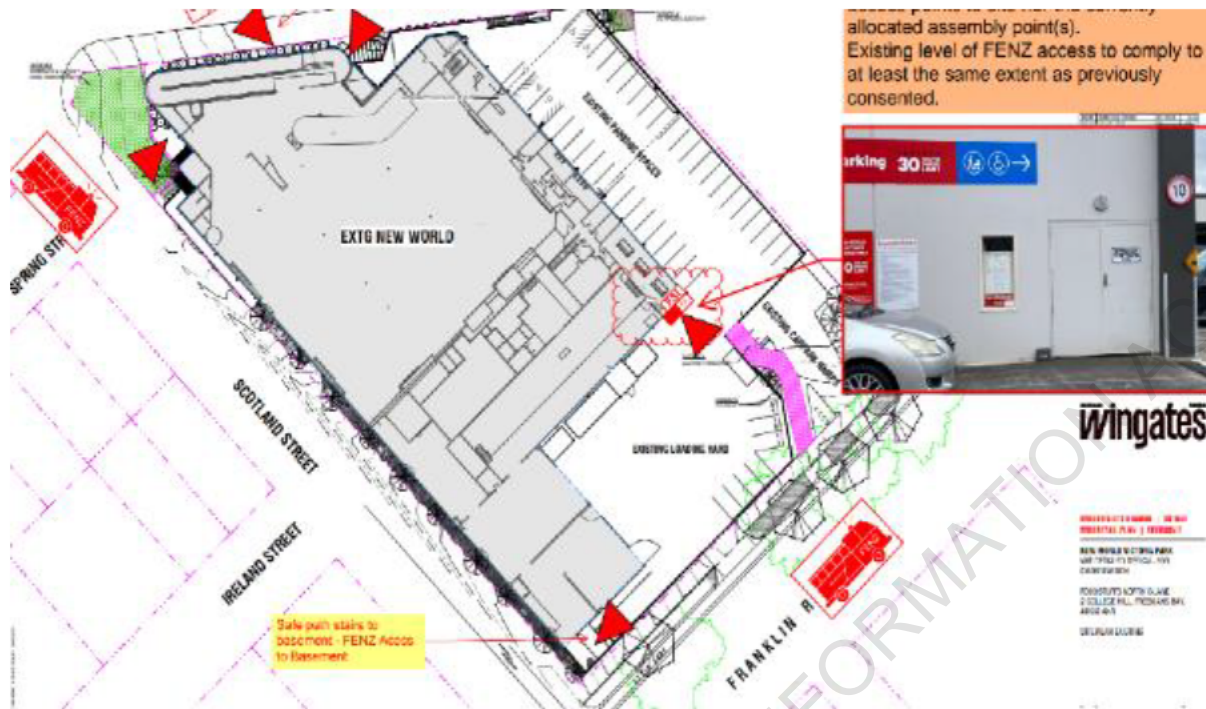
Image Number 2: Floor Plan. (Obtained from building plans).
