FIRE INVESTIGATION REPORT

87-93 Wellesley Street West, Auckland Central, Auckland

F2866954

Report completed by:

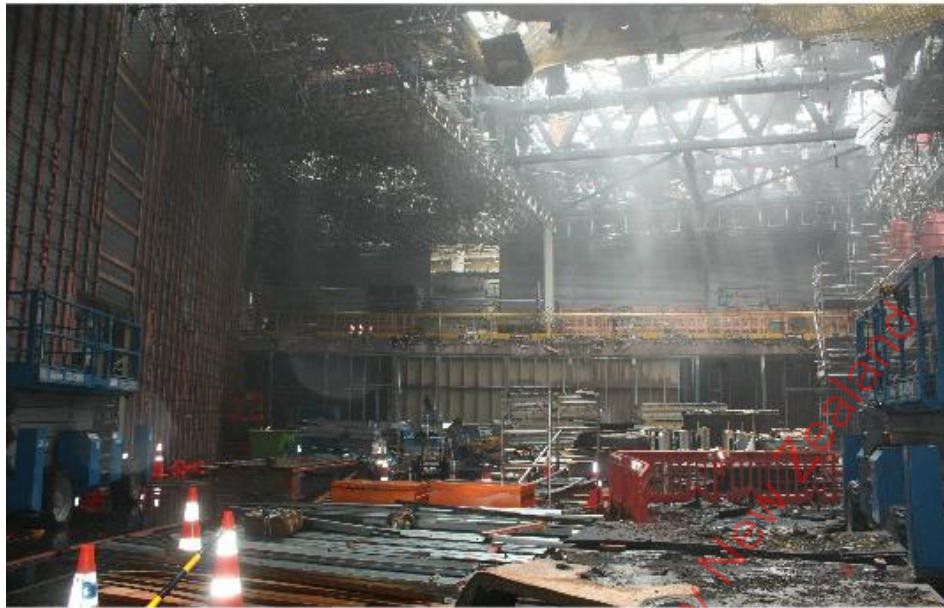
Photo 3: View of Level 5 atrium from the south side looking north.

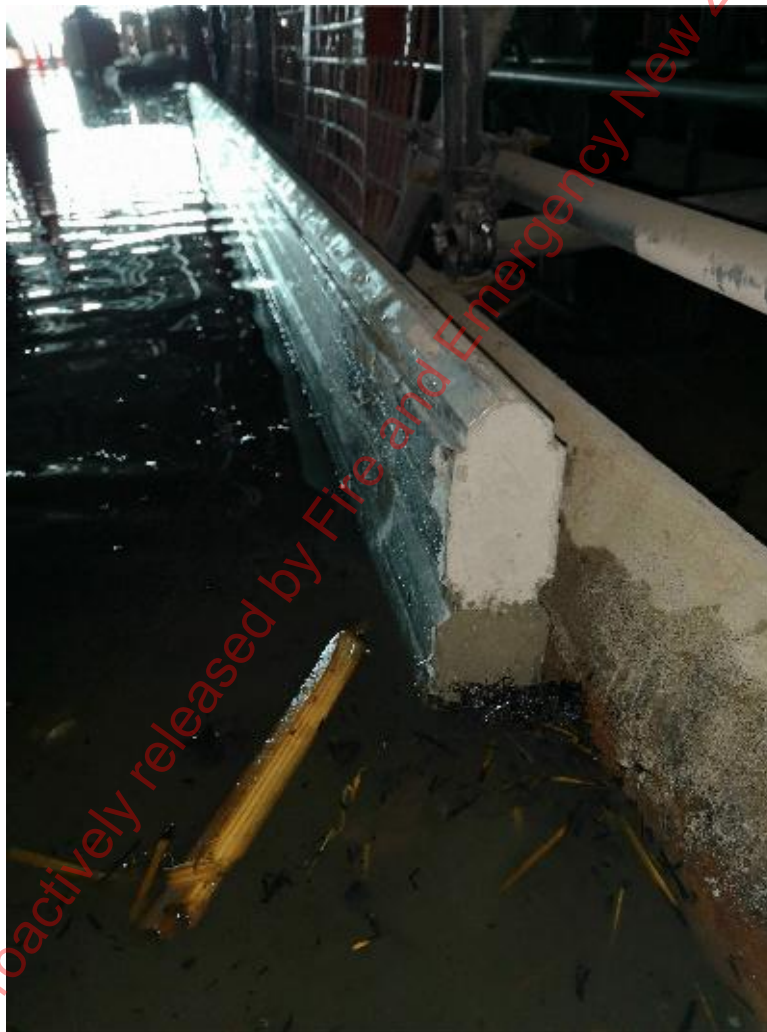
Photo 8: Example of a length of the non-combustible Speed Wall.

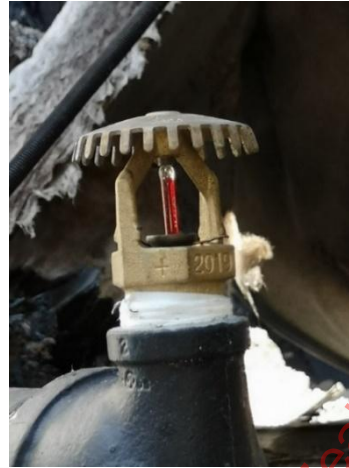
Photo 17: Example of a quick response sprinkler head under the ceiling in the area of origin with bulb still intact.

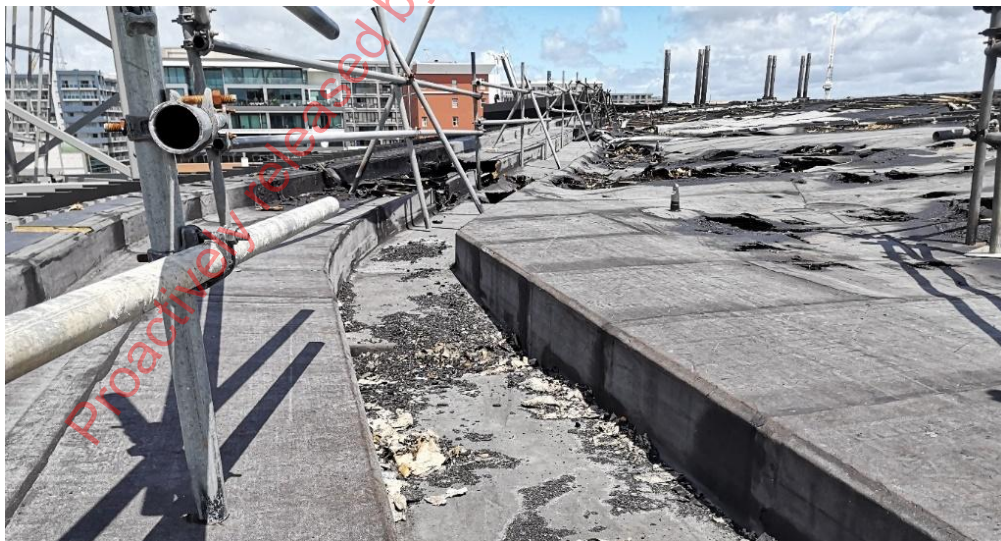
Photo 20: Shows a comparable view of the gutter on the east side of the Level 7 roof after the fire showing the Base Sheet installed. The Cap Sheet had not been applied in this location.

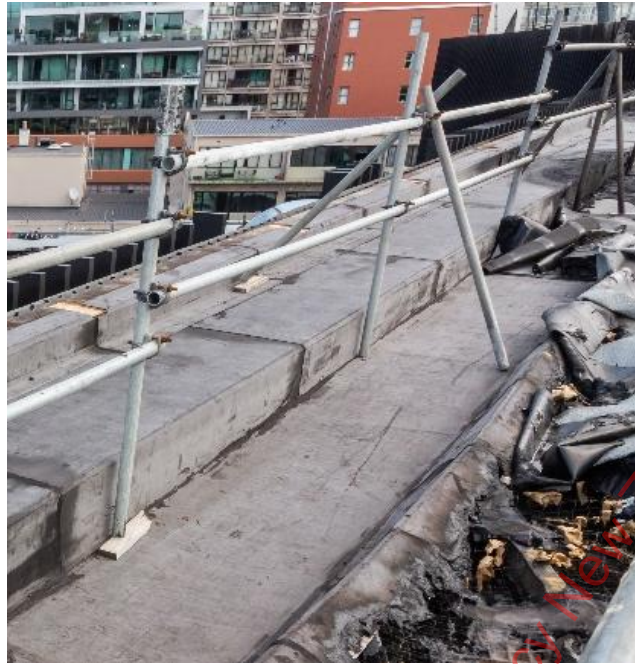
Photo 25: Example of guttering on eastern side of Level 7 with Base Sheet complete.

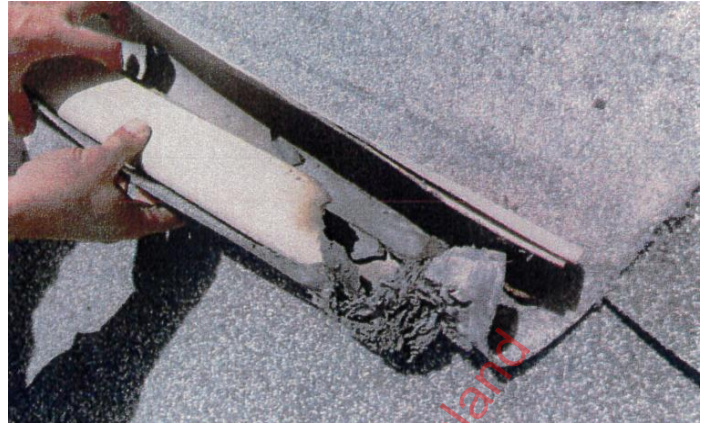
Photo 27: Shows cardboard Centre of a roll of membrane from 15 November 2019 fire reported to investigation team. Photo supplied by [REDACTED].

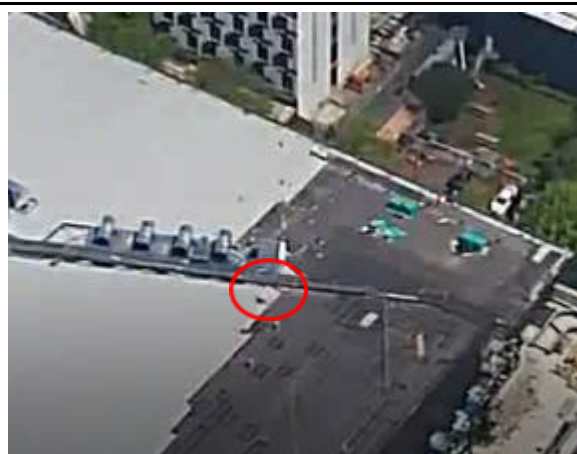
12:17 p.m.	Cap Sheet visible not completely finished to gutter (Photos 19 and 21, 33 and 34).
12:20 p.m.	Cap Sheet laid to gutter. Worker leaves the gutter area for the final time and visits gas cylinder for ~30 s.

Photo 33: Shows Cap Sheet at 12:17 p.m. incomplete to gutter edge.

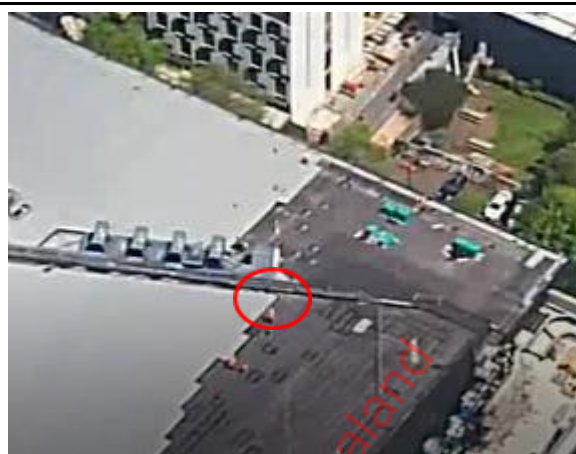
Photo 34: Shows Cap Sheet complete to gutter edge at 12:20 p.m.

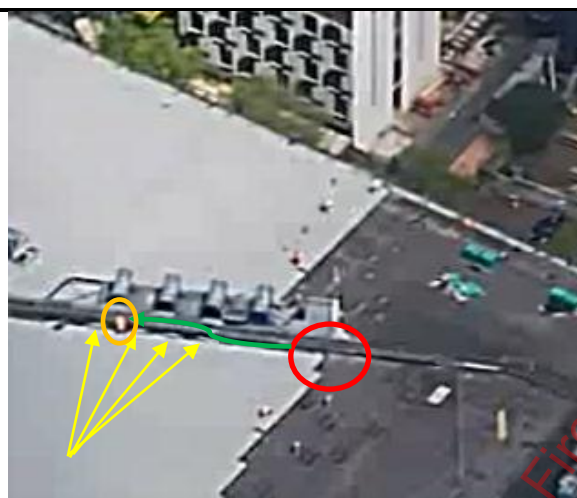
12:06 p.m.	Worker returns to gutter area where a short length (~3 m) is required, for about 25 s; then departs and walks south along the gutter passing several rolls of membrane lying in the gutter (Photos 35 - 36). Stoops and retrieves an object and returns to area of work.

Photo 35: 12:07.10 p.m. Roofer (orange circle) leaves area where a short length is required (red circle) and walks along gutter passing several rolls of membrane (yellow arrows).

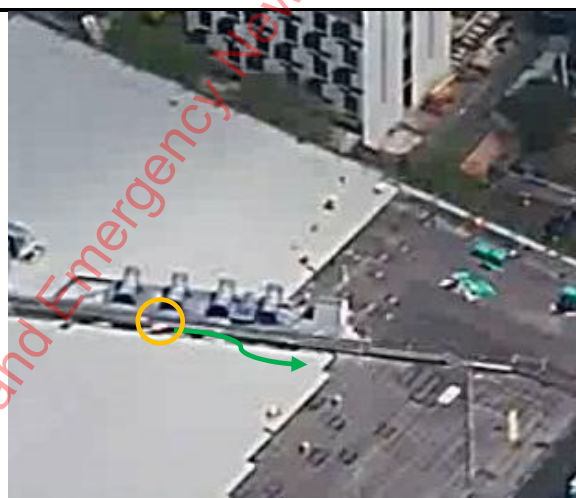
Photo 36: 12:07.14 p.m. Roofer stoops in gutter, presumably to uplift a roll and returns to the area of work.

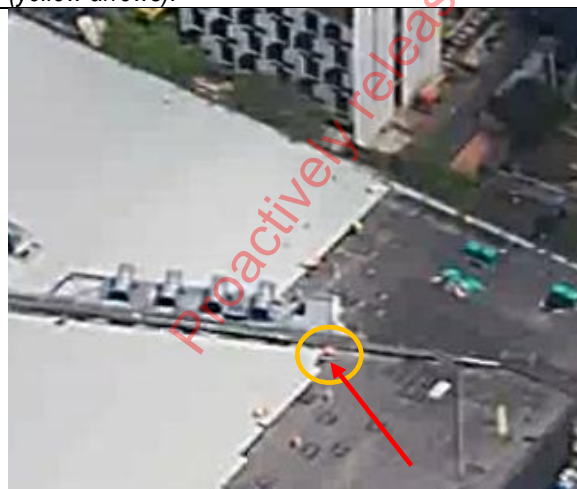
12:07 p.m.	Worker deposits object and rolls out Cap Sheet (Photos 37 - 38).
12:13 p.m.	Departs gutter area, visits gas cylinder briefly twice.
12:14 p.m.	Returns to gutter area.

Photo 37: Roofer deposits horizontal object (red arrow), believed to be a roll of Cap Sheet.

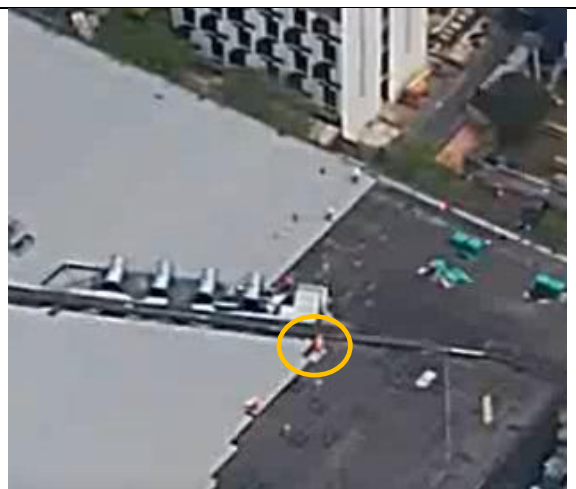
Photo 38: Roofer extends Cap Sheet to gutter while walking behind it. This would exclude the Cap Sheet being an unrolled section which could not be positioned if the worker was standing on it.

Evidence of a Cap Sheet roll being transported to and used in the immediate vicinity of the area of fire origin places a cardboard centre in this location.

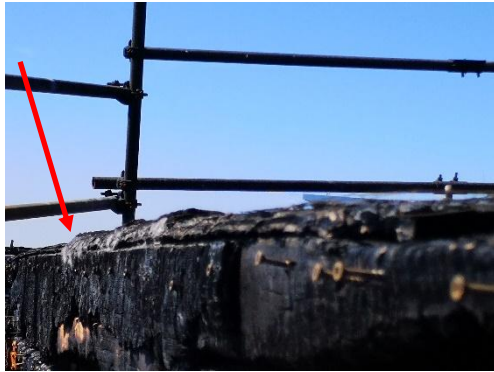
Photo 41: Example of roof on western side of Level 7 near the area of origin with top plywood sheets overlapping vertical plywood.

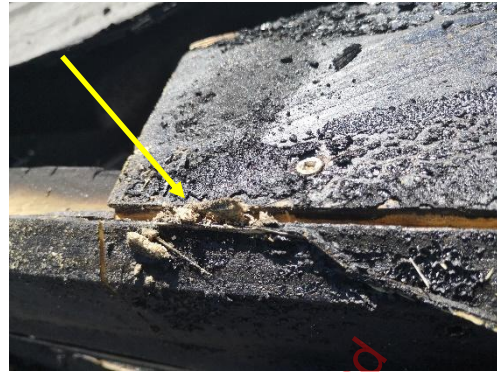
Ignition of fine fuels under the membrane was considered. Examination of an unburned section of roofing on the eastern side of Level 7 showed the edges of the plywood generally butted together tightly however there were instances observed of 2–4 mm gaps between sections of plywood. Small amounts of sawdust were observed trapped in these gaps. It was noted the configuration of plywood construction differed to the area of origin. Near the area of origin on the western side of Level 7 the top horizontal sheets of plywood overlapped the vertical plywood which made up the walls of the gutter, refer Photo 41. On the eastern side of Level 7 the vertical gutter walls reached the top of the horizontal plywood sheets making collection of sawdust more likely, refer Photo 42.

Photo 42: Example of roof on eastern side of Level 7, with residue sawdust in space between joints of plywood sheets (yellow arrow) extracted by investigators.

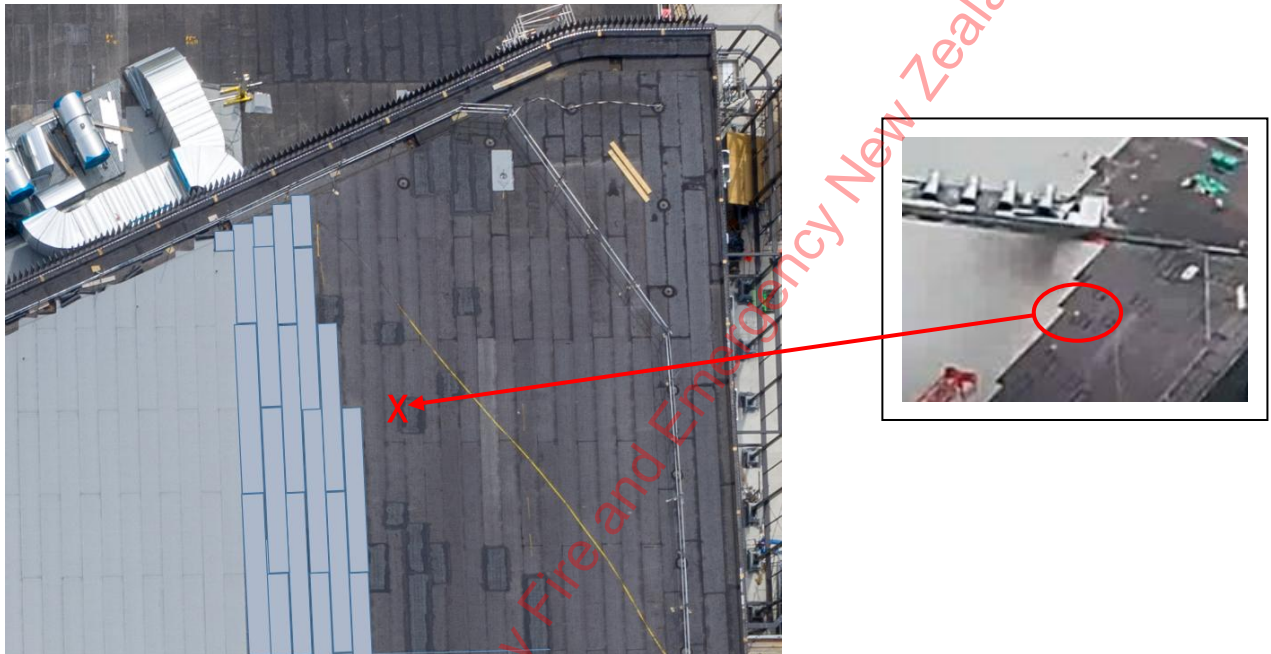
At 12:20 p.m. on 22 October 2019 the worker left the gutter area and travelled to the nearest cylinder. At 12:25 p.m. on 22 October 2019 the worker moved the gas cylinder to a more central location on the roof to enable work in that area. The gas cylinders' final locations prior to the fire were 11.6 m and 16.9 m respectively from the western gutter. Video show both workers laying another full length of Cap Sheet. No further work was done in the gutter area and workers left Level 7 at 12:39 p.m. on 22 October 2019. Once the fire reached the locations of the gas cylinders on Level 7 they fell horizontally landing on the burned debris and wiring netting on the roof. The final location of the gas cylinders prior to the fire was identified by examining key markers on the roof such as membrane patches clearly visible in a range of pre-fire photographs and comparing these to the video that captured the first sighting of the fire.

Photo 44: Showing last location of gas cylinder (marked 'X') nearest point of origin while in the vertical position prior to the fire. Photo supplied by Fletcher Construction and modified by Fire and Emergency.

Inset image shows gas cylinder at time of fire. Video image from ATOC.

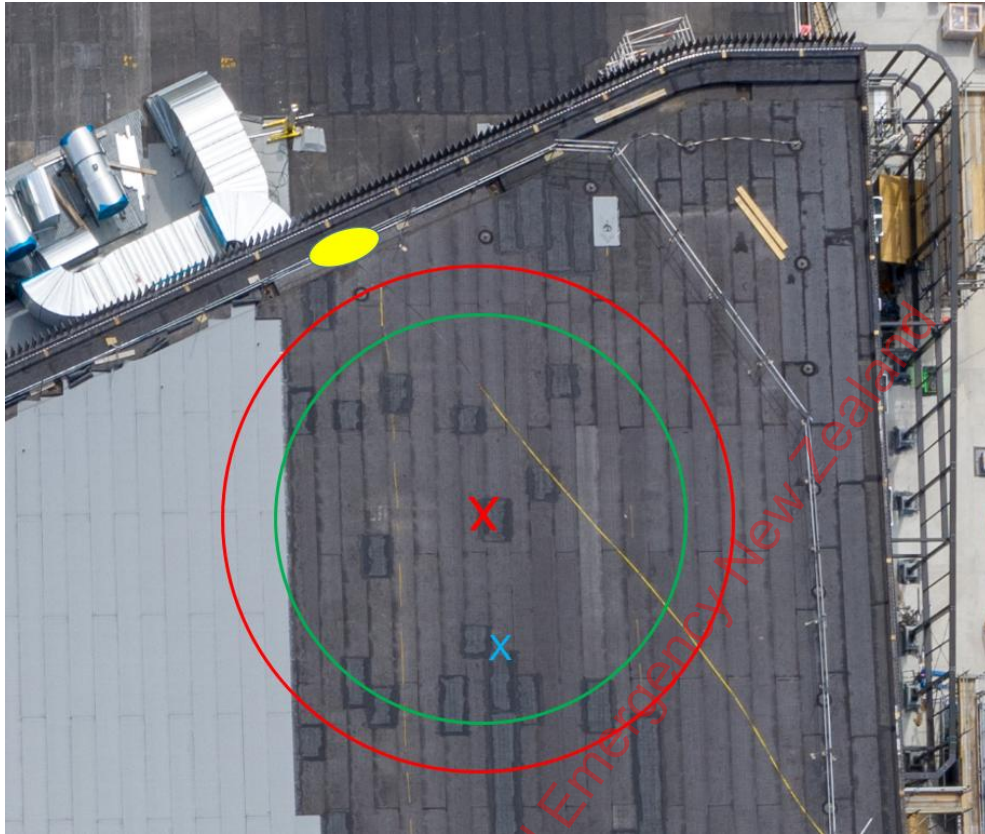
Flex in the hose also reduces the un-tensioned length of the hose 0.3 m - 0.5 m. In an un-tensioned state, a 10 m hose can be expected to reach less than 9 m.

Photo 46: Indicates a 10 m radius (red) and 8 m radius (green) indicating the maximum reach of a gas hose line from the gas cylinder (red 'X') closest to the area where the fire started (yellow ellipse). The adjacent gas cylinder location is marked with blue 'X'

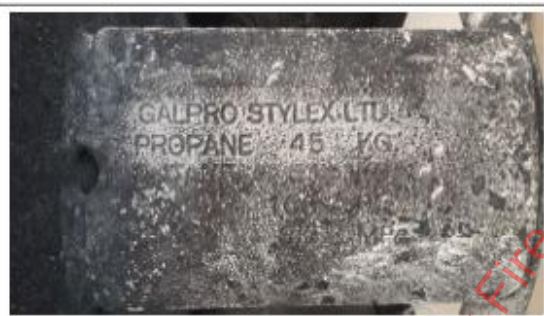
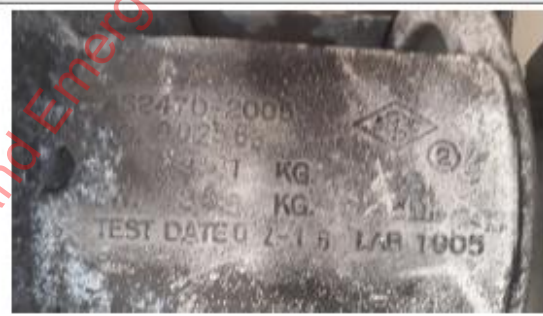
Figure 2: Cylinder 105484

The 2 cylinders were tagged by client; ID: 105484 and 105485, photos of the cylinder identification can be found in figure 2 and 3.

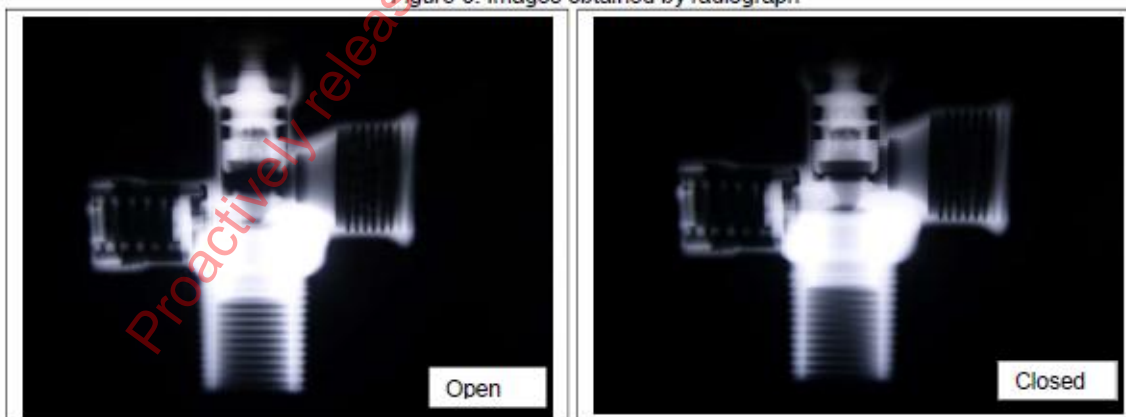
One of the cylinders (105484) had the manufacturer ID of 'Galpro' stamped into the cylinder. The manufacturer was located and contacted, and new replacement valve purchased for comparison in the open and closed position. (Figure 6 and 7). No manufacturer was able to be located for the other cylinder (105485) for a comparison valve.

Figure 6: Images of the new valve obtained from the manufacturer in open and closed positions

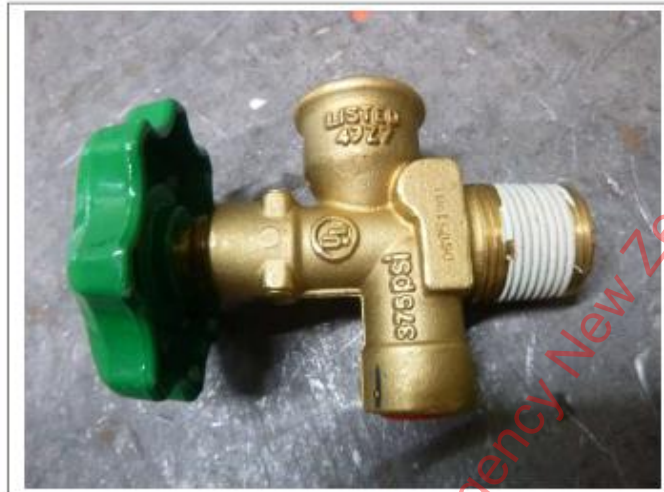
Figure 7: New valve obtained from Galpro
