FIRE
EMERGENCY

The Lake Ōhau Fire

A Summary of Events

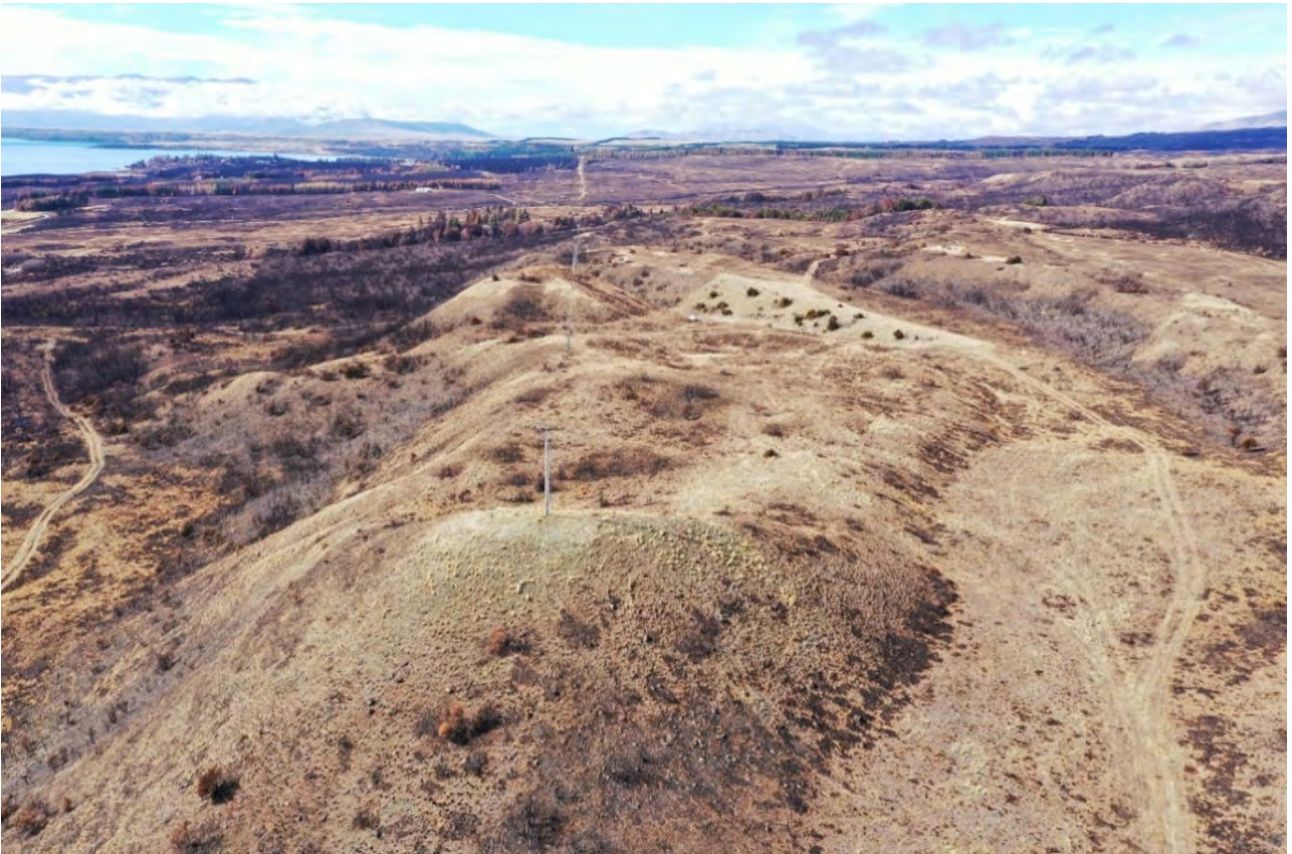
Each pole supports three 11kV power lines running through insulators attached to its wooden cross-arm which is bolted to the top of the pole. Each cross-arm is supported by two metal stays which are bolted to the cross-arm and to the centre of each pole.
