Fire Research & Investigation Unit

Heads

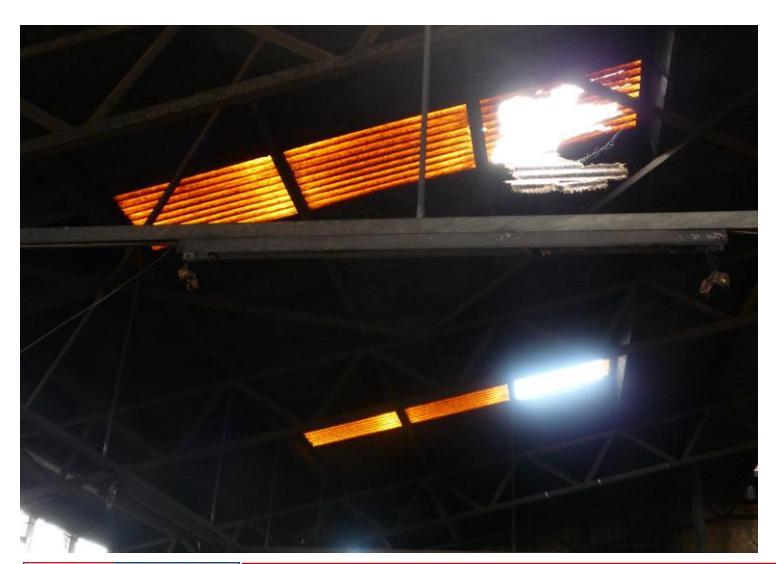
Shortly before the end of a business day a fire broke out near the front of a large hardware retailer. The building was approximately 60m x 60m and the stock was displayed in typical 2.4m high display rack shelving. Fire travelled vertically then across the underside of the roof spreading to stock across the entire area of the store. The roof was asbestos Fibrolite (typical of the building period) with skylights, the plastic skylights did not melt despite the spread of fire beneath them.

Plastic sheeting panels forcibly opened by NZFS crews on roof

In order to create an opening allowing fire products to be exhausted naturally by convection currents created by a fire, simple ventilation systems commonly rely on the effects of heat from a fire to activate a fusible link securing a panel or melt a building product, such as plastic sheeting. However experience at fires has revealed that unless these systems are specifically designed for purpose, they may be unpredictable in operating and their effectiveness limited.

Fire-fighters are frequently required to access roof areas and use tools to forcibly open plastic skylights to create exhaust ports.

In many instances plastic sheeting has been under-laid by wire mesh used to support building paper and as a safety net for people working on roofs. The mesh has been observed supporting plastic sheeting and preventing its collapse.

Experience at large fires in New Zealand shows the unpredictability of plastic sheeting in fire conditions makes it an unreliable form of effective fire ventilation. Due to this unpredictability, it can not be relied upon to effectively achieve its intended purpose.

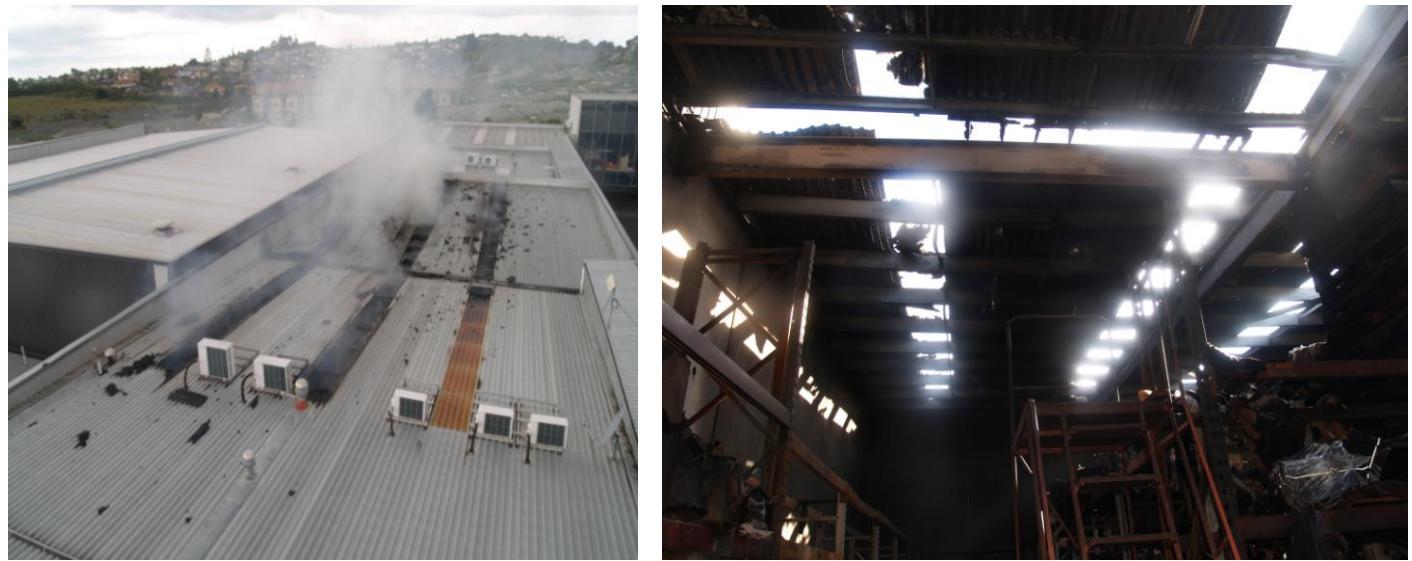
While a plastic skylight panel immediately above the seat of the fire collapsed, the remaining panels stayed intact. Modern construction of concrete tilt slab walls and long run iron roofing and limited ventilation led to significant build up of heat and smoke in the building. Fire Service operations used aerial appliances (Cherry Pickers etc) to forcibly open the plastic sheeting components in the roof to allow ventilation to occur and assist with fire suppression.

Plastic sheeting forcibly opened by NZFS using aerial appliances
