Fire Related Product Recall Notice

Date issued: 6 September 2017

Milwaukee M18™ Redlithium-Ion High Demand™ 9.0ah Battery Pack

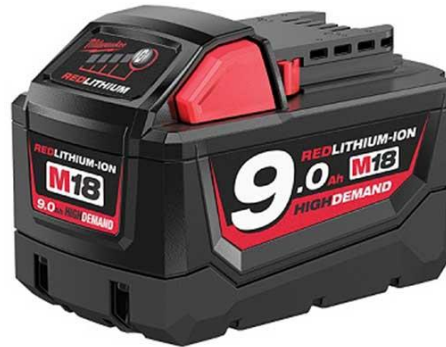
If highly conductive or corrosive fluid (liquid) gets into the battery pack through the vents in sufficient quantities, it can cause the battery pack to short-circuit.

Short-circuit can, in extreme situations, result in smoking or fire, even when the battery is not in use.

Examples of highly conductive or corrosive fluids include seawater, certain industrial chemicals and bleach or bleach-containing products.

Users are advised to read and add the following safety instructions to the M18B9 battery manual:

- Never immerse your tool, battery pack or charger in fluid or allow a fluid to flow inside them.
- Conductive or corrosive fluids, such as seawater, certain industrial chemicals, and bleach or bleach containing products, etc., can cause a short circuit.

Please follow these instructions to reduce the risk of fire, personal injury, and product damage due to a short circuit.
